**PROPOSED
RESIDENTIAL REDEVELOPMENT
(ADDRESS)**

**GEOTECHNICAL ASSESSMENT
AND AS2870 SITE CLASSIFICATION**

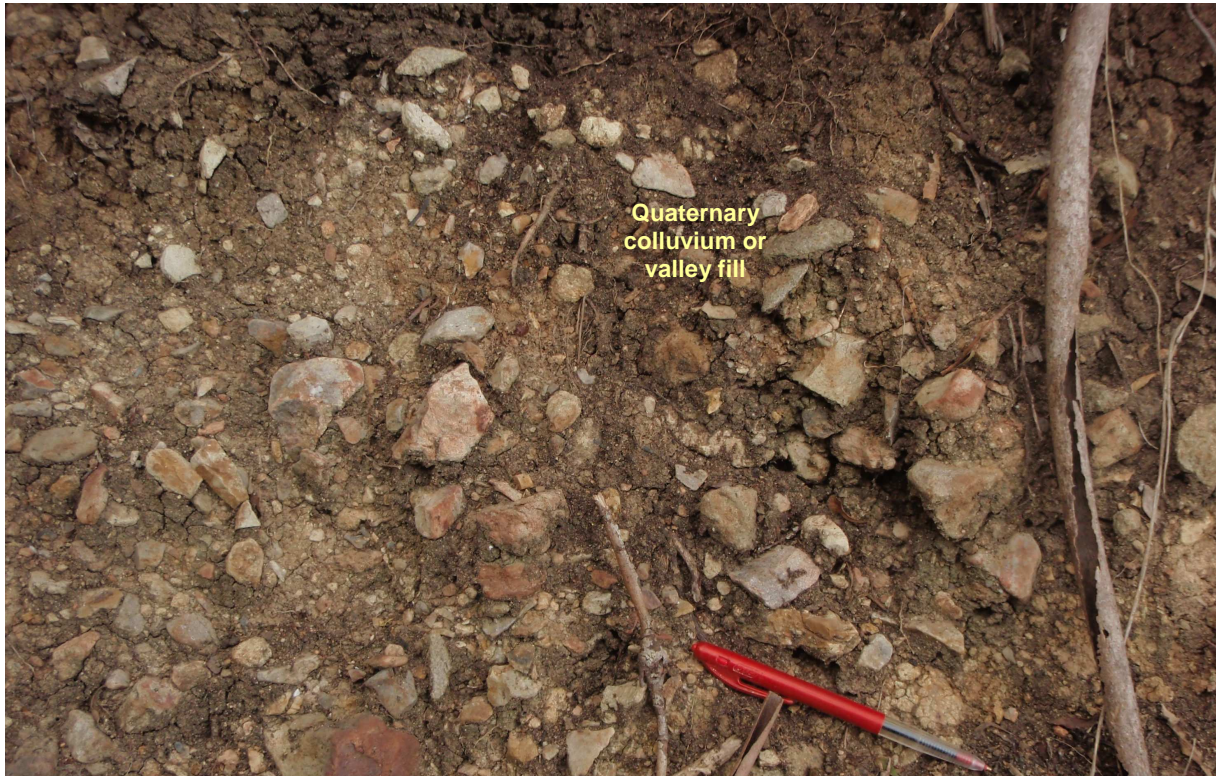
Plate 6 (above). Detail of the weakly consolidated material interpreted as Quaternary colluvium or valley fill, exposed on the (deleted). The material is a near-clast supported conglomerate of 50% angular Permian sandstone and siltstone clasts to 0.1m, and subrounded dolerite clasts to 0.2m, in a moderate plasticity gravelly clay. The proportion of sedimentary to dolerite clasts is about 3:1. Shown here is mostly the former.

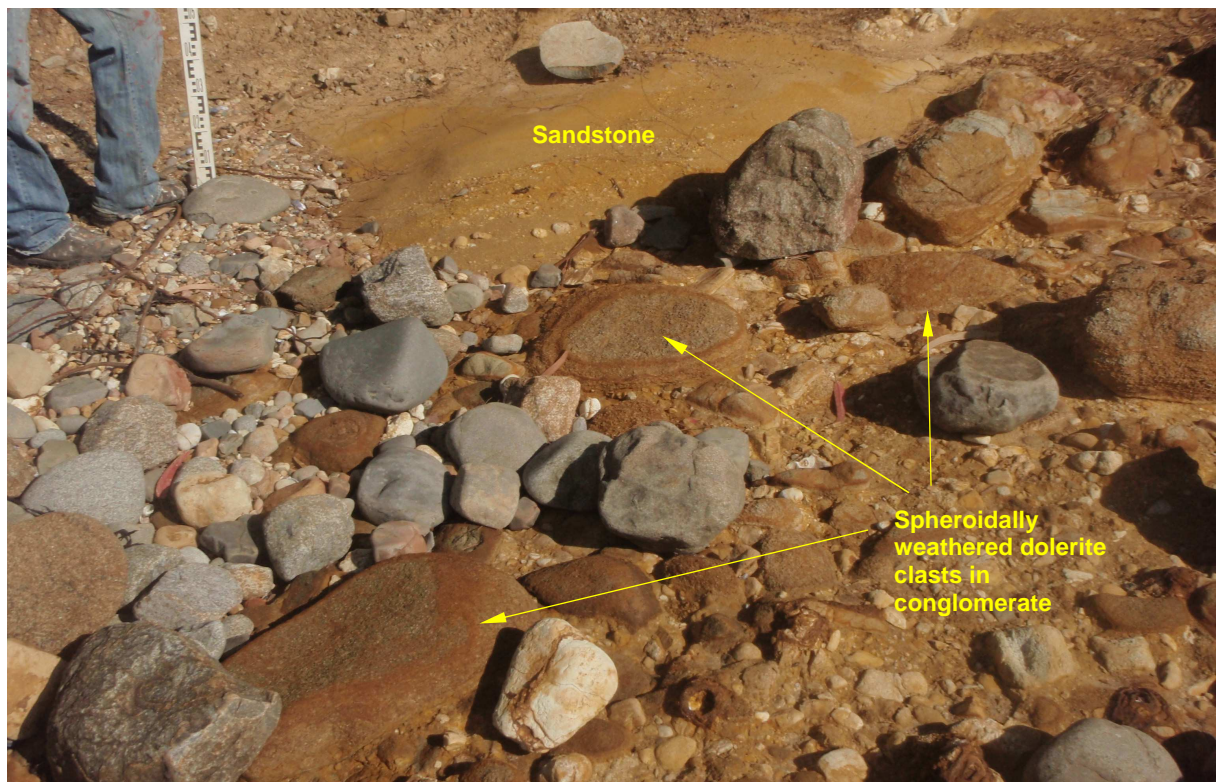
Plate 12 (above). Detail of the base of the coastal escarpment up to 15m high in front of (address). The staff is 1.3m high. Quaternary colluvium or valley fill overlies conglomerate and sandstone.

Plate 13 (below). Detail of Tertiary sandstone, and conglomerate (Tcbd) with spheroidally weathered dolerite clasts on the foreshore below (address).

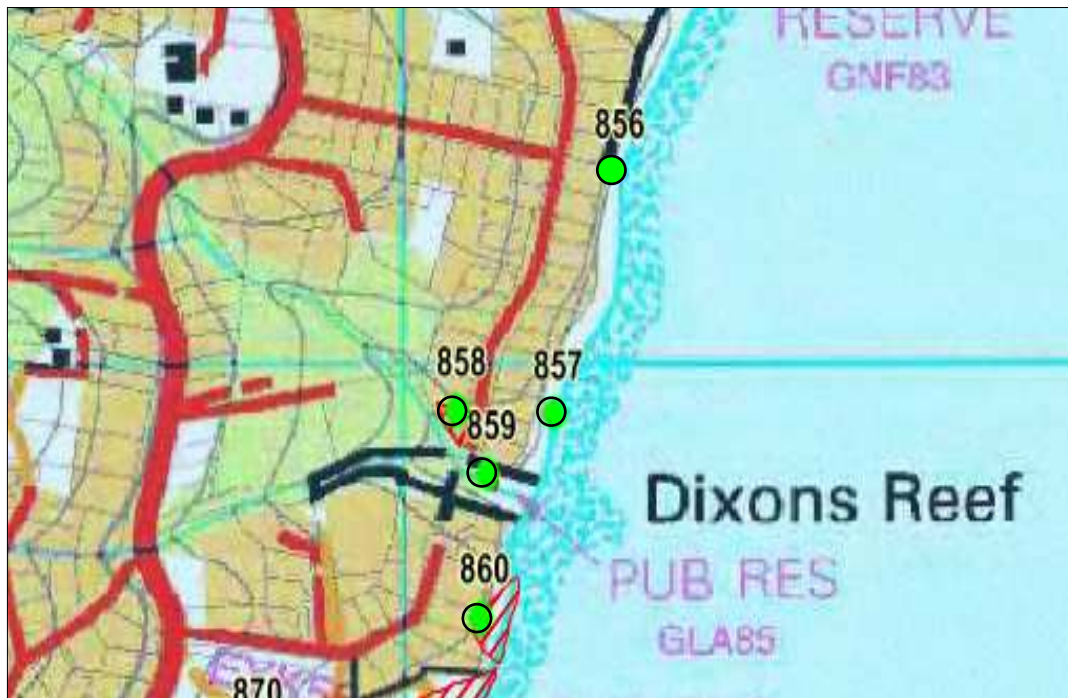
Figure 7.1. The Mineral Resources Tasmania landslide map near (address)

Location numbers 856 – 860 are also shown on the landslide map on the Mineral Resources Tasmania website⁸ which is reproduced here as Figure 5.1 (green circles added for clarity).

Landslide 860 gets a brief but specific mention on page 20 of Latinovic *et al* (2001). It occurred perhaps 12 years or so ago and involved failure of Tssl sandstone along a steeply east dipping and slightly curved joint surface, probably lubricated by excess water from rain and (reportedly) stormwater. It involved at least 100m³ of rock and soil, and has blocked foreshore access.

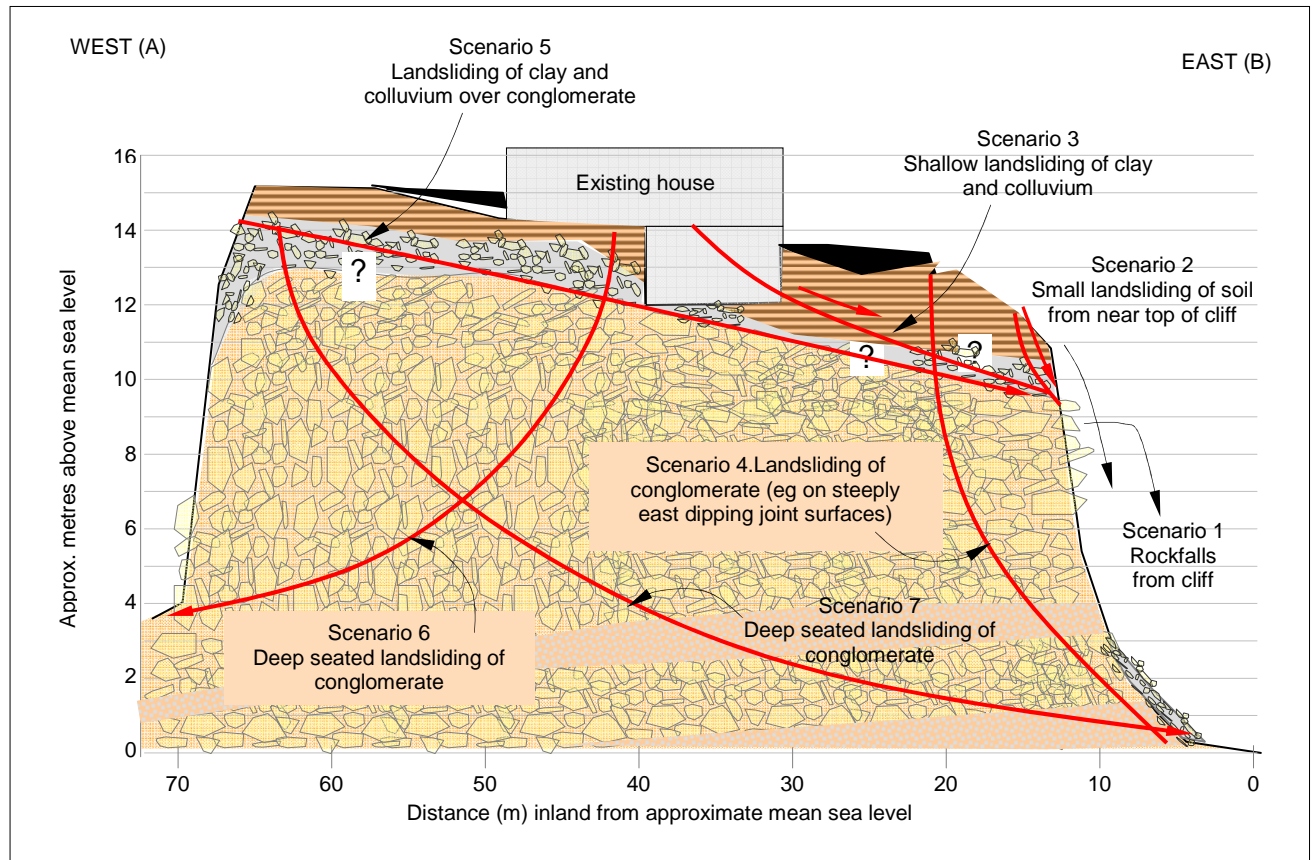
Figure 7.2. East-west interpretative cross section showing potential slope instability scenarios (V/H = 2.5)
Add approx. 0.6m to correspond to floor elevations by architects (name)

Based on the foregoing, Figure 7.2 shows seven potential slope instability scenarios ("issues") affecting residential development of (name). Note that scenarios 6 and 7 are essentially the same, and are treated together. The red lines in Figure 7.1 are schematic only, and are intended to represent classes of scenarios, not necessarily actual failure surfaces.

It is strongly recommended that footings for the new house be piered into the Tertiary conglomerate (Tcbd). The depth to Tcbd is uncertain, and an excavator larger than 1.5t could be used prior to final design to investigate this issue.
