ECoast Homes Pty Ltd

EASTMAN'S GREEN SUBDIVISION  
PENQUITE ROAD, NEWSTEAD

GEOTECHNICAL ASSESSMENT

ADDENDUM REPORT  
MAY 2011

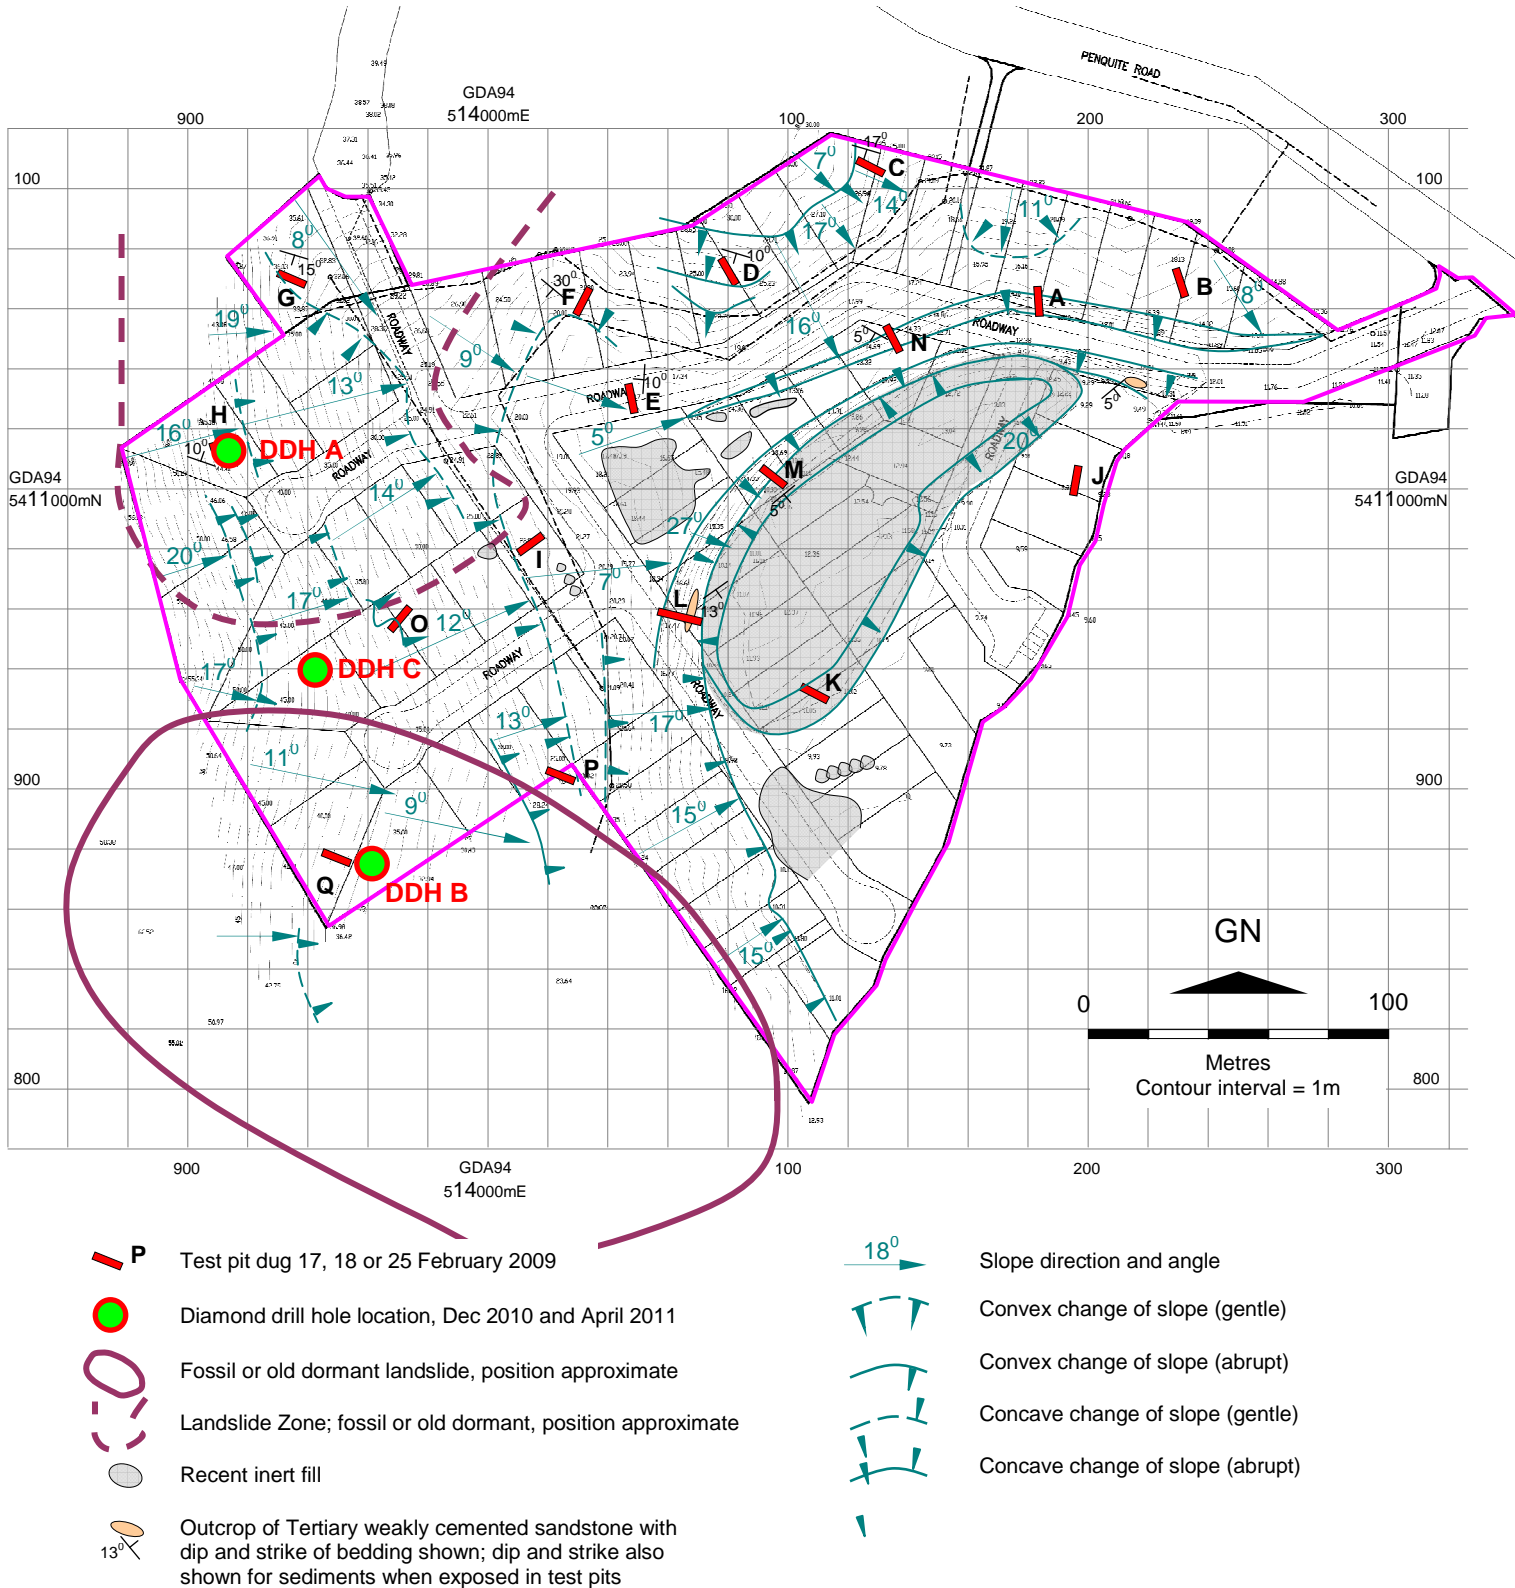
#### Geotechnical sketch map of the proposal showing topography, 2009 test pit locations, and 2010 – 2011 diamond drill hole locations DDH A, DDH B AND DDH C

- Mineral Resources Tasmania (MRT) Landslide Hazard mapping shows that the higher, western parts of the proposal include both a fossil or old dormant landslide zone, and a fossil or old dormant landslide. The approximate locations of these features are shown here in Attachment 5, and were included in Attachment 5 of the April 2009 report.

- The same MRT maps show recent or active shallow landslides, and fossil or old dormant shallow landslides, near but not within the subdivision. Subsequent to the April 2009 report, land clearing on slopes below DDH A and DDH C exposed a topographic irregularity which appears to be a recent or dormant shallow landslide.

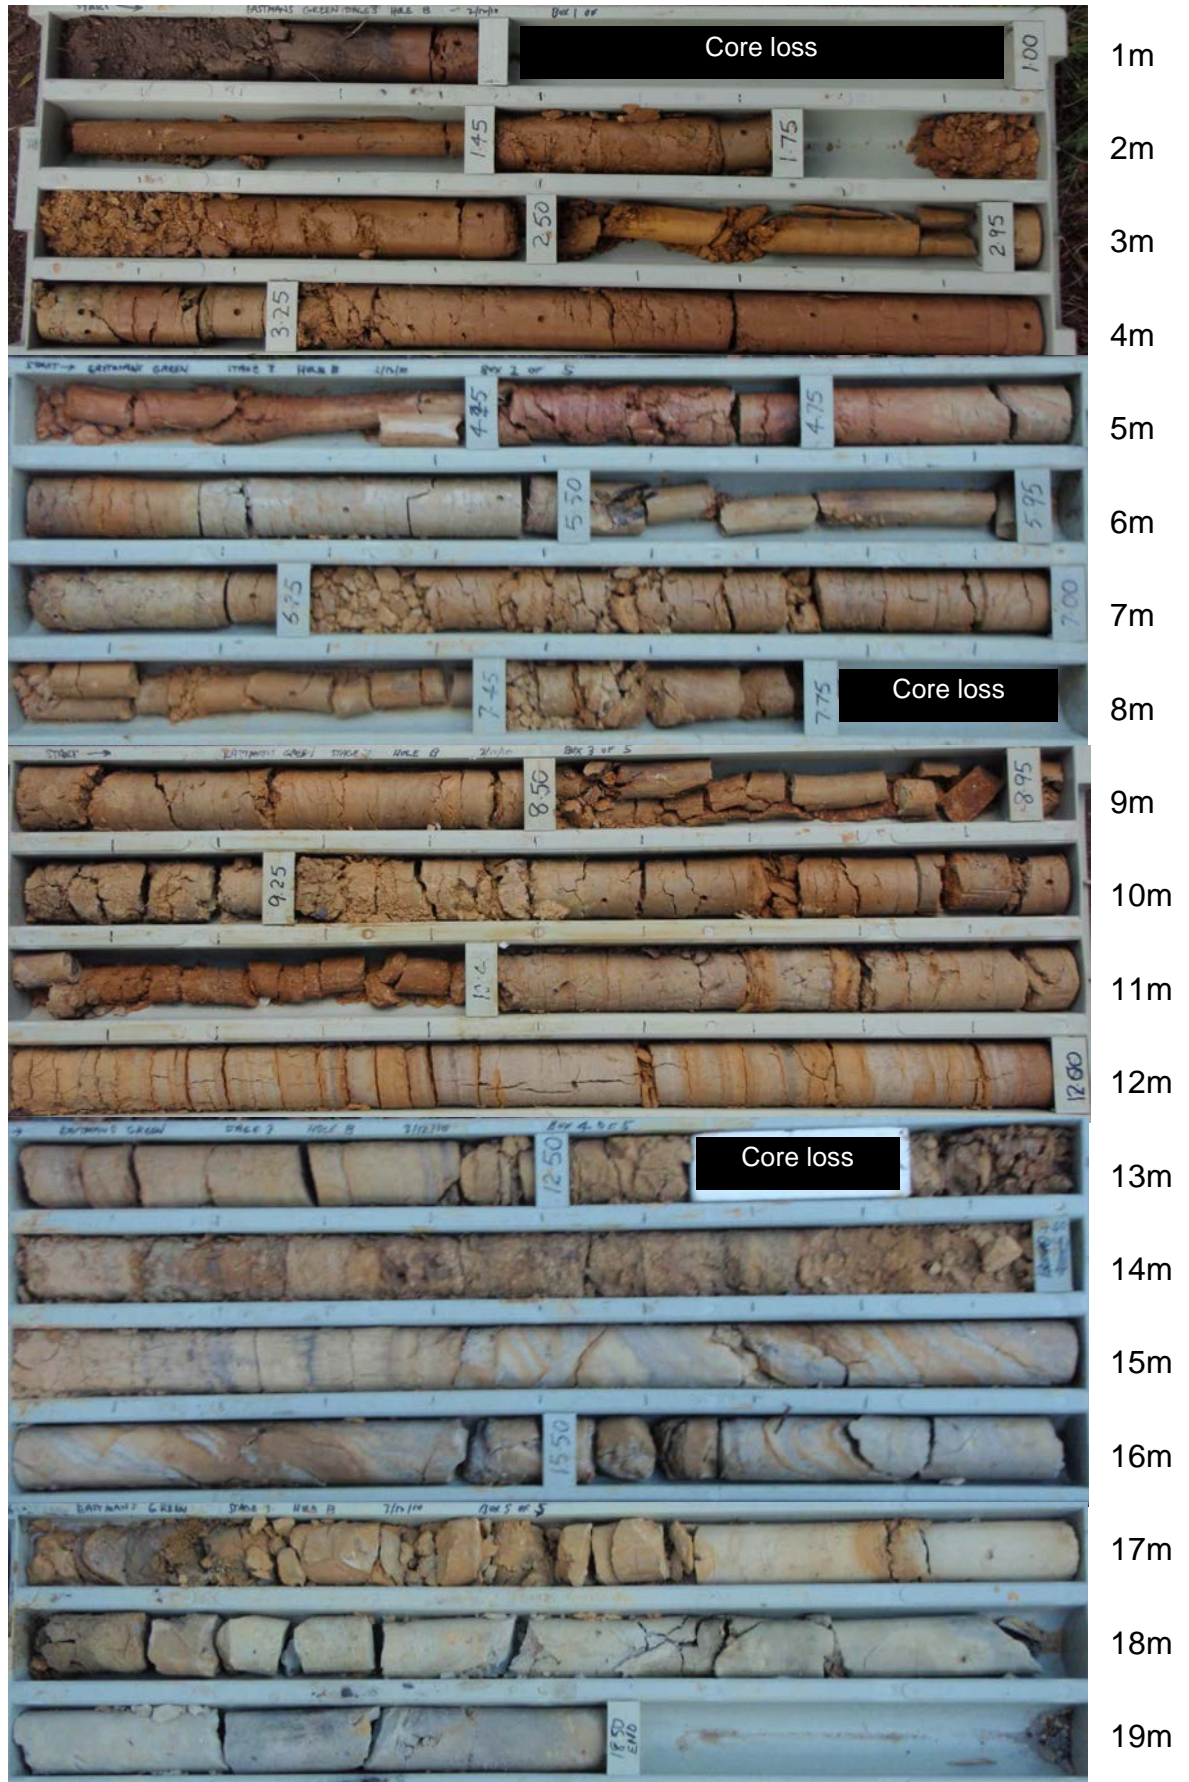
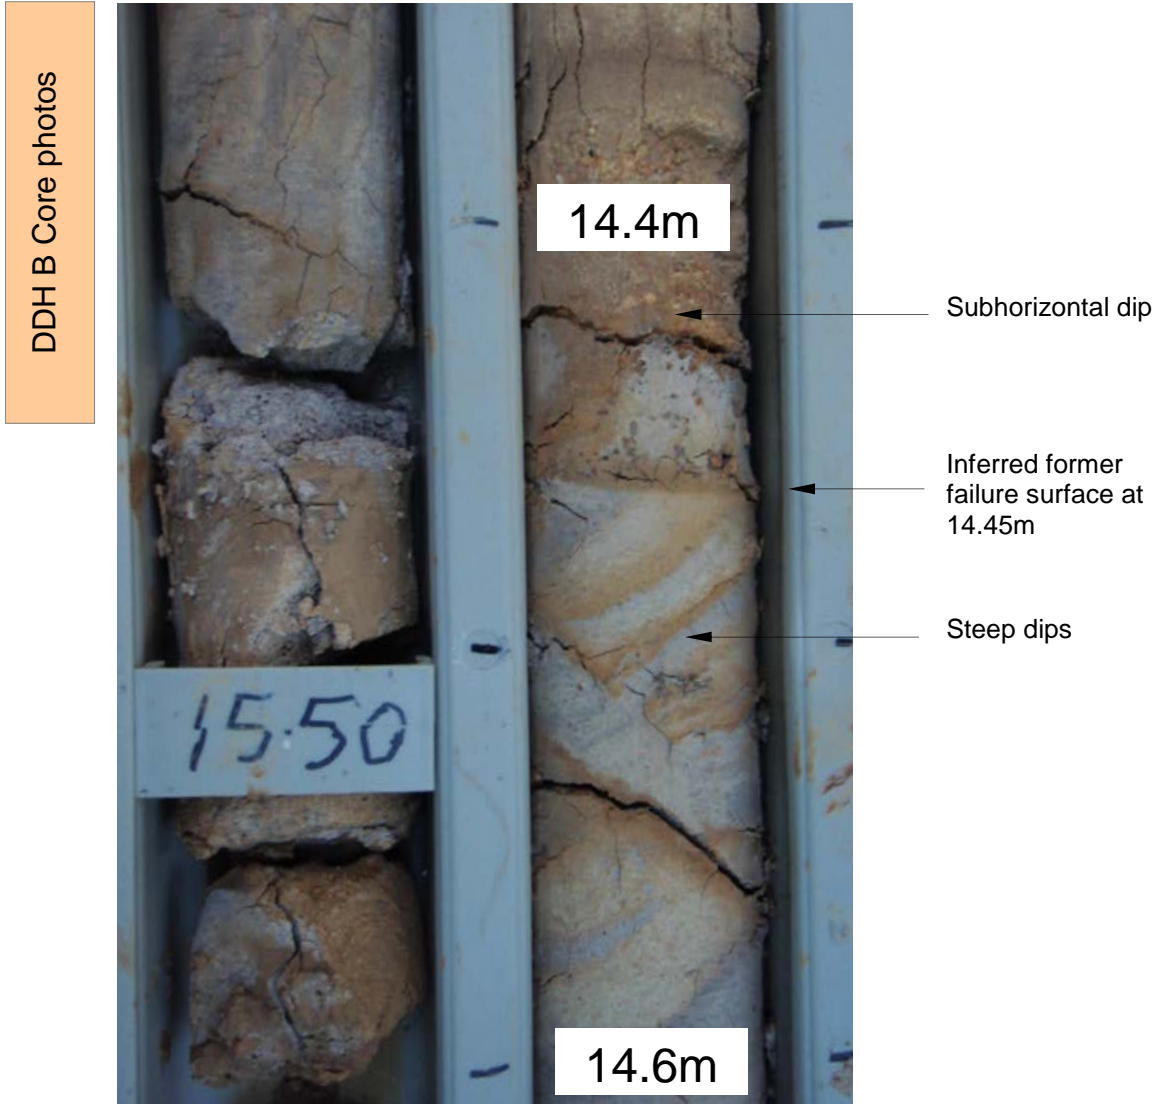
DDH B Core photos

The variability also suggested that angled diamond drilling to estimate true dip would add little to the overall structural picture. Core from the vertical diamond holes generally show low angle dips around  $5^{\circ}$ , but two instances of steep dips beneath subhorizontal dips were observed – at 14.4m in DDH B, and 10.5m in DDH C. Photographs of the cores near these depths are shown in Attachment 6.

In both instances the surface separating the two dip angles are interpreted as failure surfaces. In each instance, the failure surface and the materials above and below were of relatively high strength and weakly cemented, suggesting they are old features with no recent movement.

- Subhorizontal surfaces at around 14.4m in DDH B and 10.5m in DDH C separating disparate dip directions are interpreted as former failure surfaces. They are tight and sealed, suggesting ancient, not recent, deep seated movement.

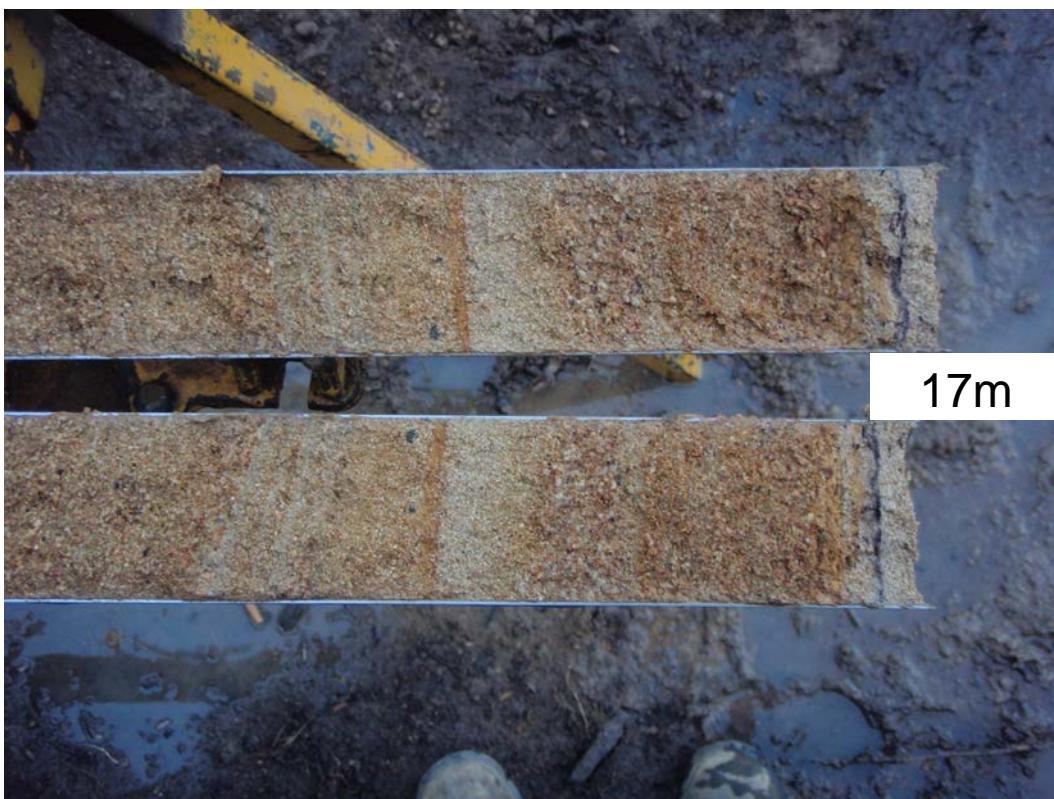
Weakly cemented low strength and coarse grained sandstone in DDH C near 17m.
