**FARM HILL
RESIDENTIAL SUBDIVISION
WEST HOBART**

**LOT 47
GEOTECHNICAL REPORT
ADDENDUM TO 1995 GEOTECHNICAL REPORT**

This report is an Addendum to a 1995 geotechnical report.

It specifies a building envelope and conditions for residential development on Lot 47 of the Farm Hill Subdivision off Forest Road in West Hobart.

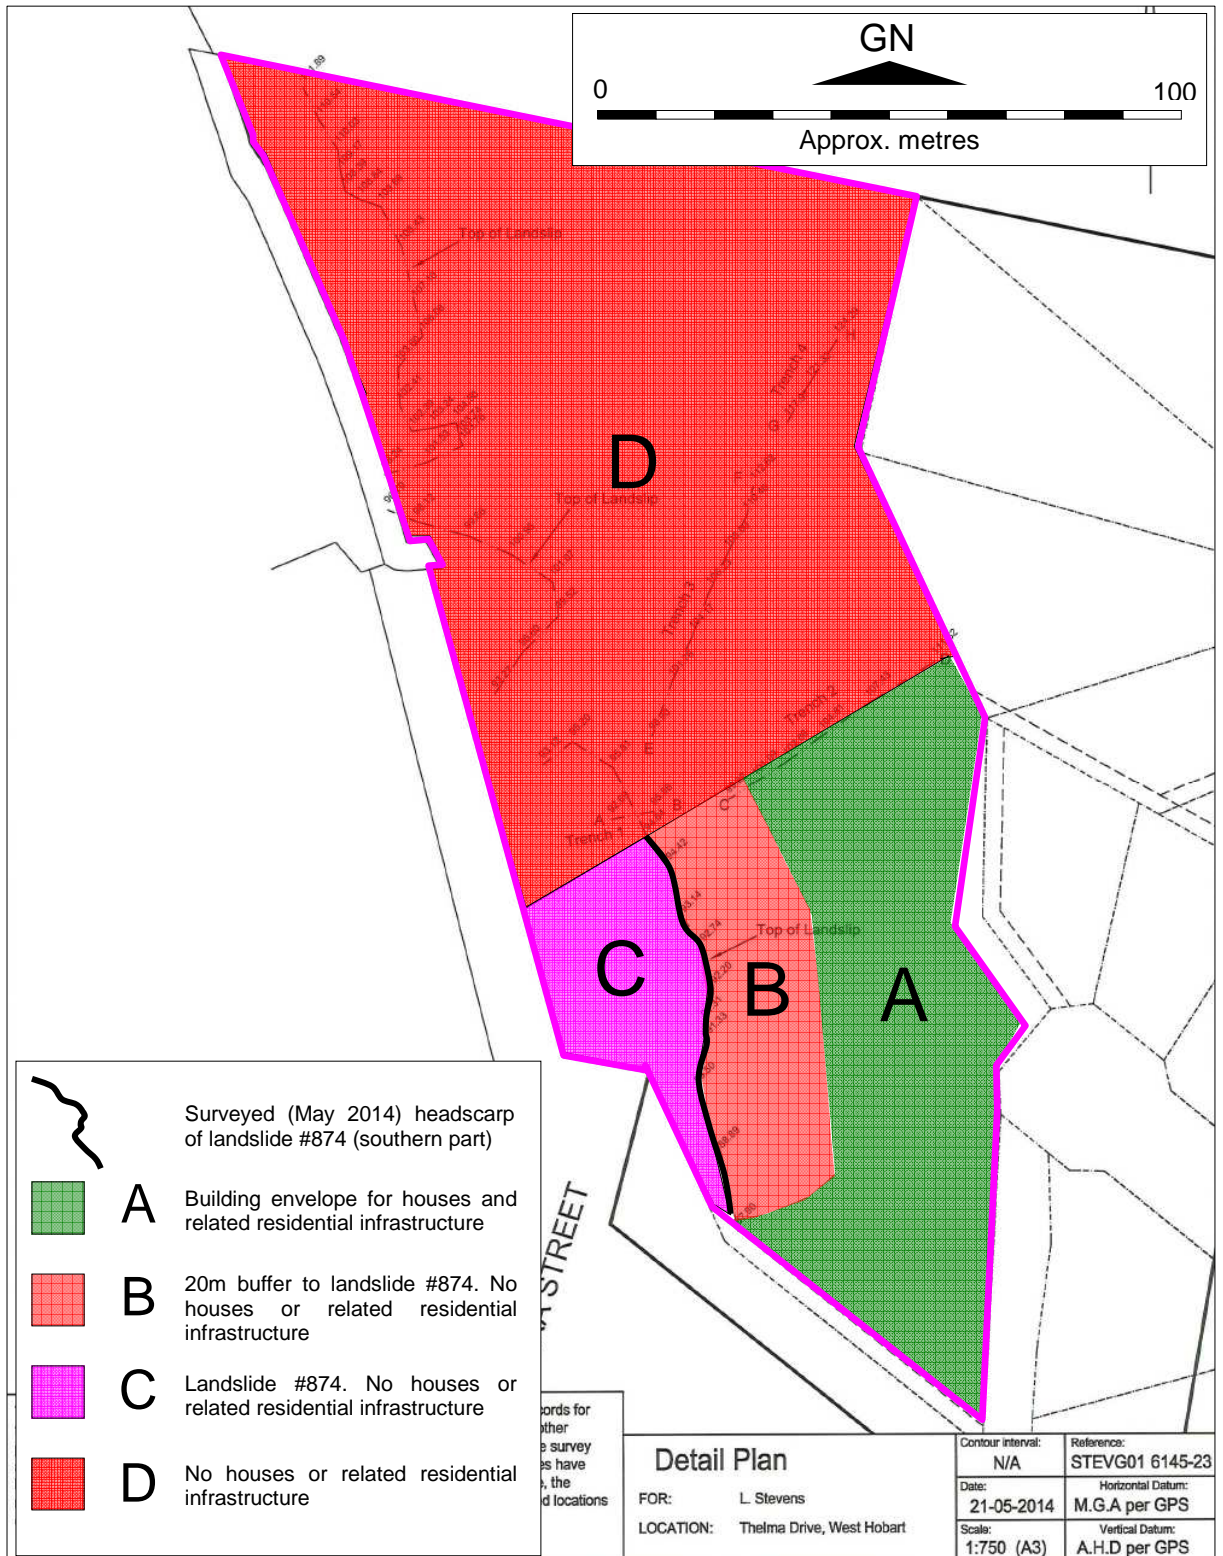
Figure 1. Recommended building envelope (A) and no-development areas (B, C, D) for residential development of Lot 47 in Stage 4 of the Farm Hill subdivision.
 This diagram also appears as Figure 10.5 in Attachment 10 of this report.

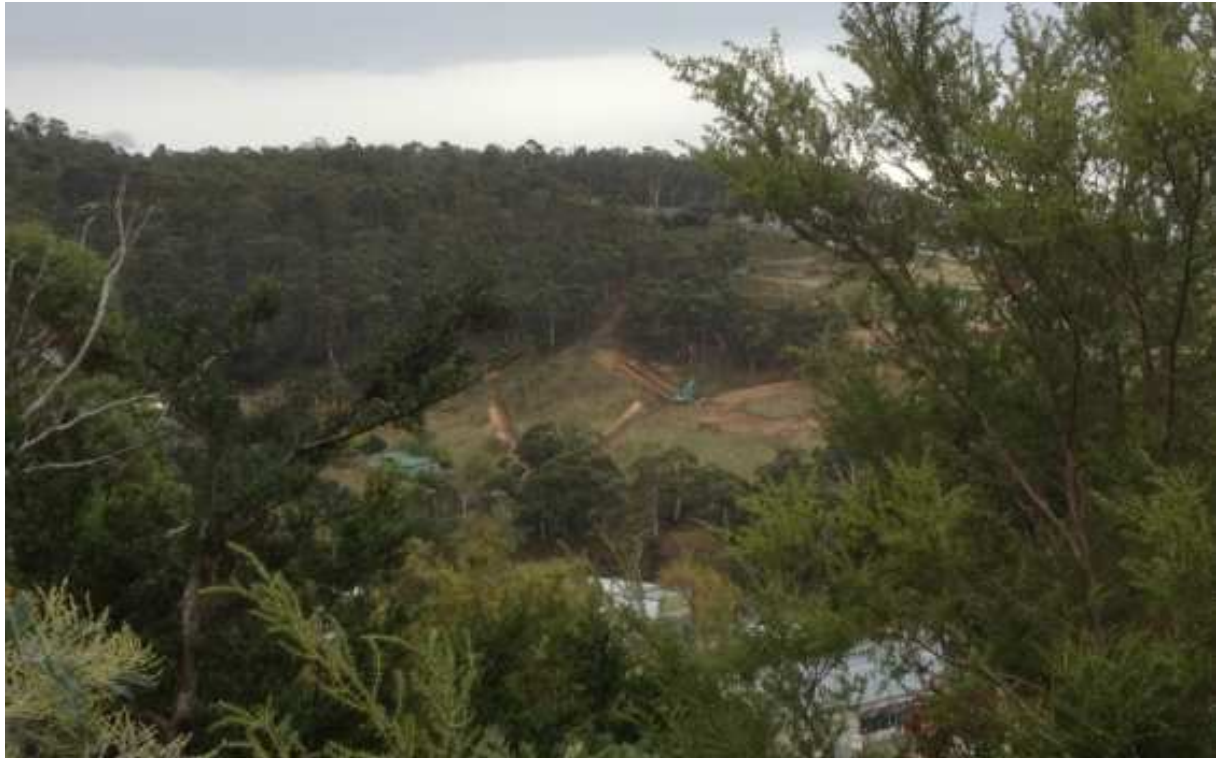
Plate 1 (above). View north from Wellerslie Park in South Hobart to Lot 47 on the Farm Hill Subdivision in April 2014, showing service trenches (right) and investigation trenches B and D ("V"-shaped).

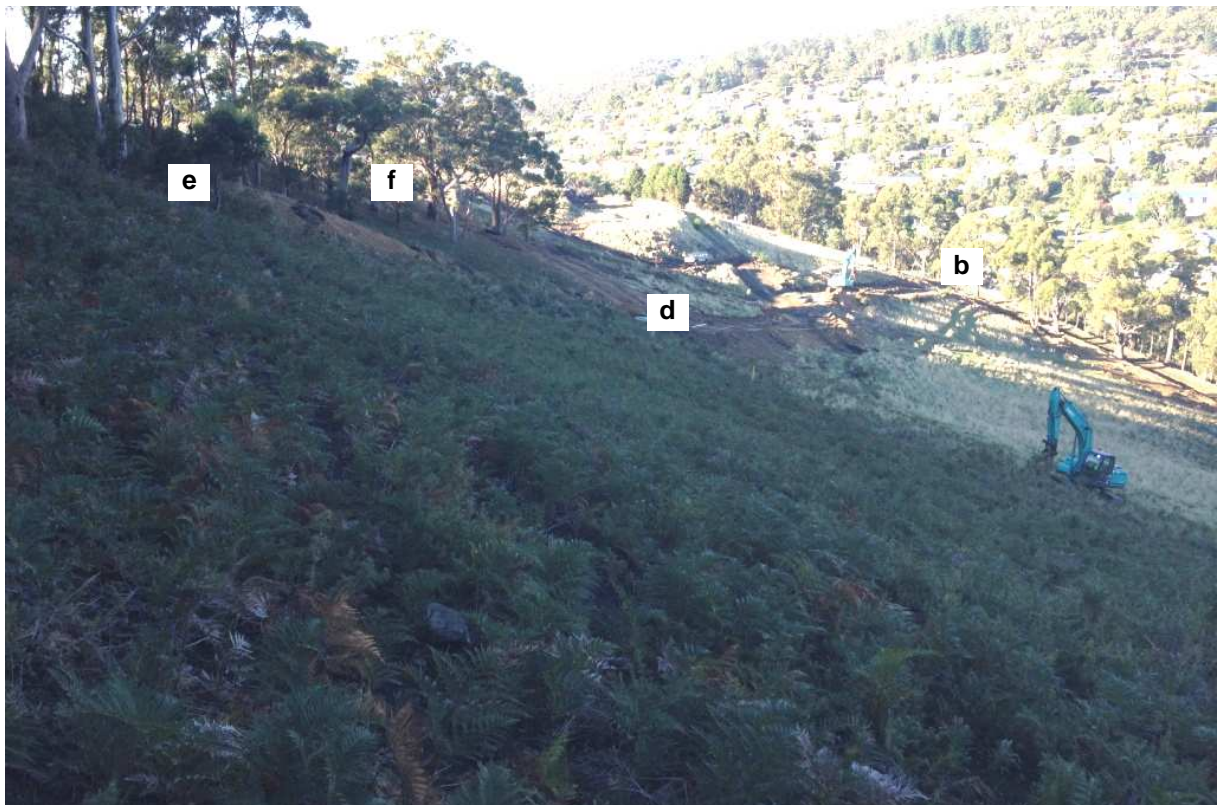
Plate 2 (below). View southeast from the northwestern corner of Lot 47 at Farm Hill, over 25 – 30° slopes in the foreground, towards service trenches a....f (see Attachment 7).

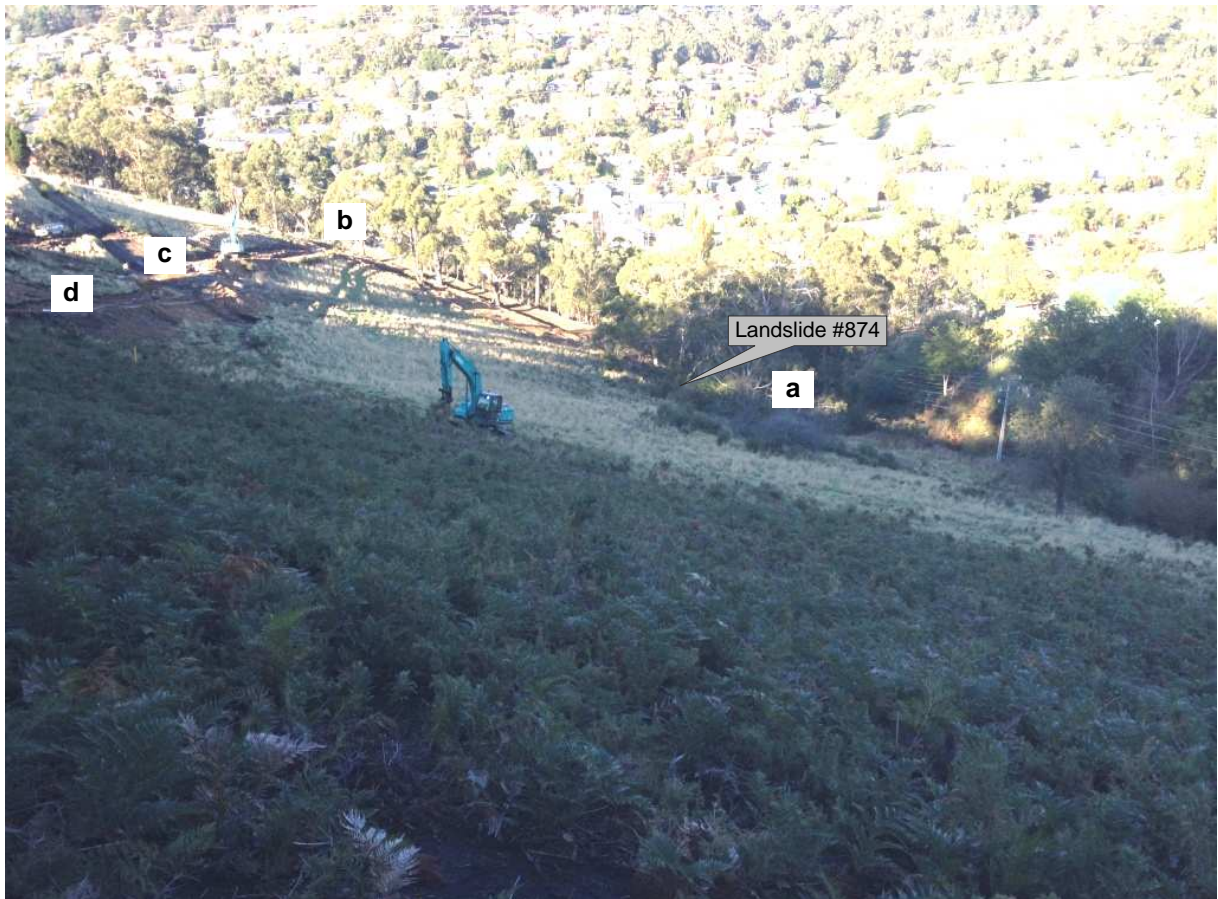
Plate 3 (above). View south southeast from the northwestern corner of Lot 47 at Farm Hill, over 25 – 30° slopes in the foreground, towards service trenches a...f (see Attachment 7). The higher edge of the tree line in the centre of the photo marks the headscarp of landslide #874 (see Map 1 of Attachment 5).

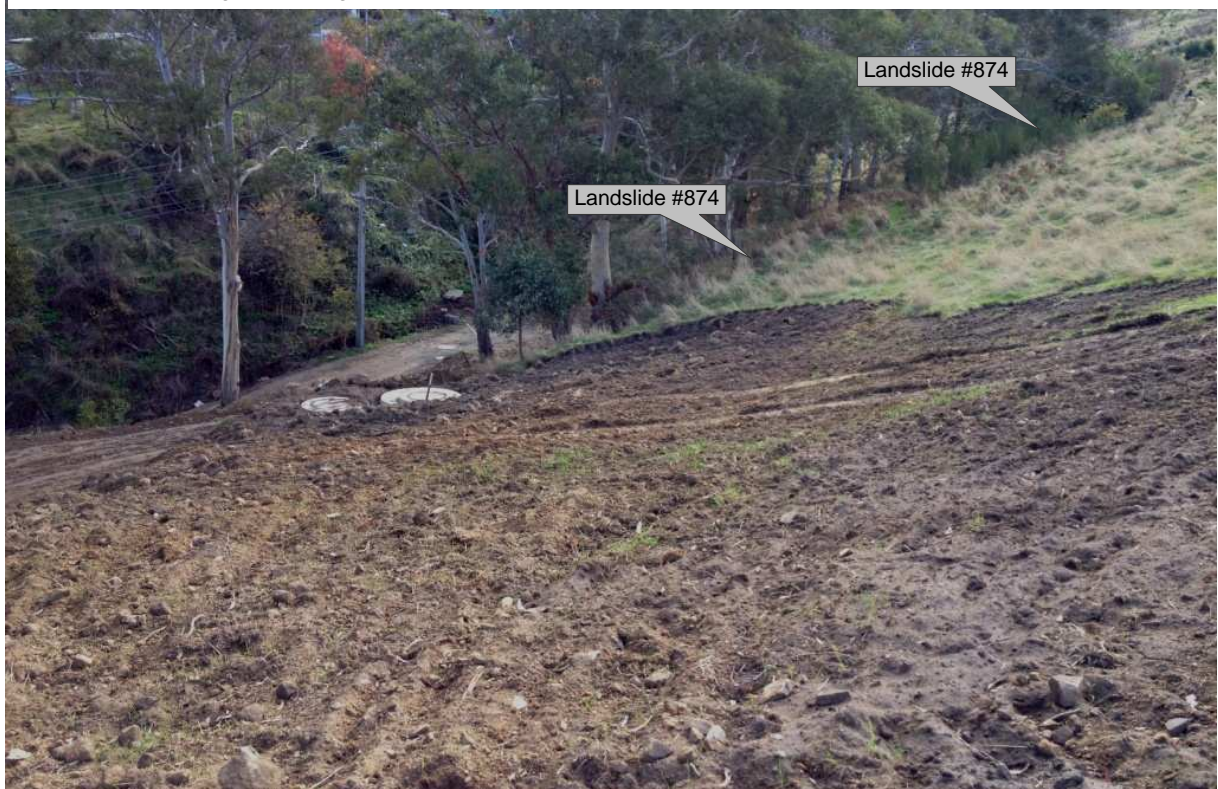
Plate 4 (below). View northwest and downslope to the lower, southwestern corner of Lot 47. The higher edge of the tree line in the right middle ground marks the headscarp of landslide #874 (see Map 1 of Attachment 5).

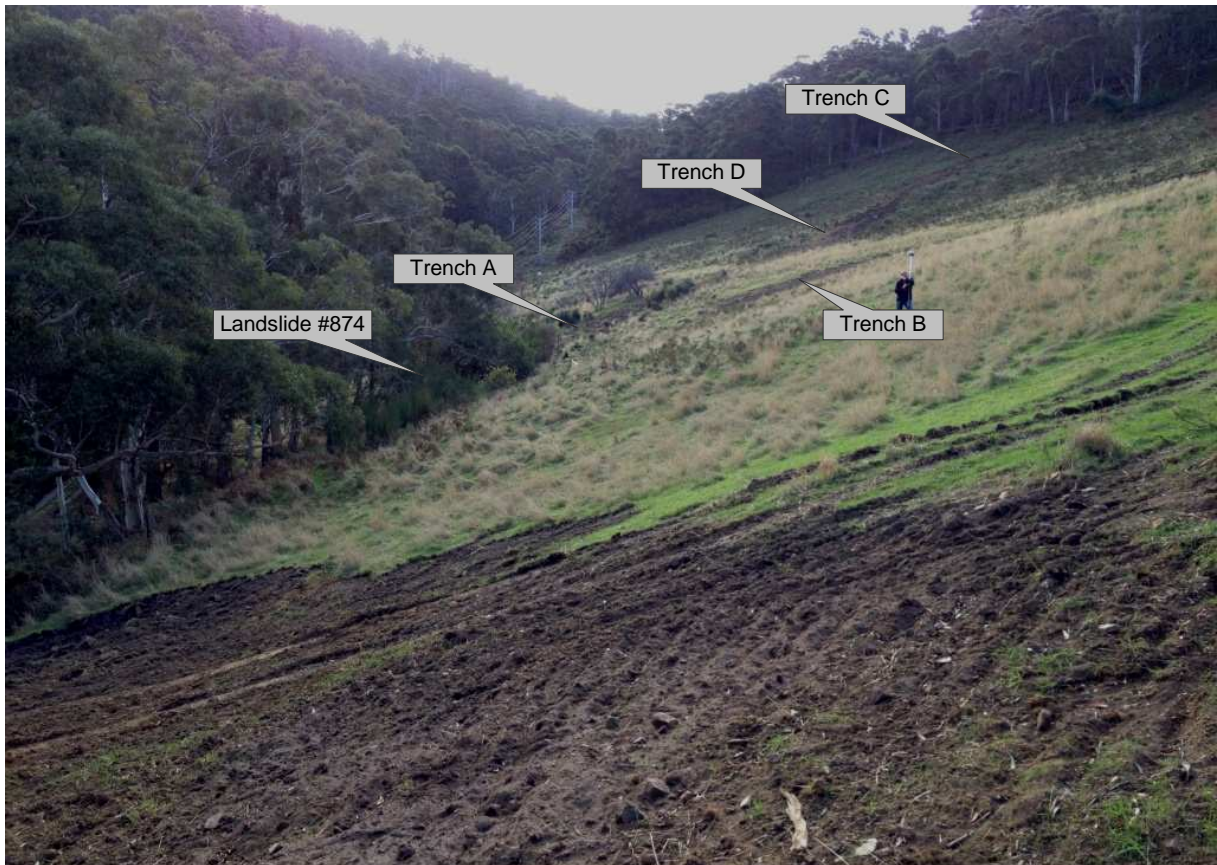
Plate 5 (above). View north over Lot 47 from its lower, southern boundary. The higher edge of the tree line in the left middle ground marks the headscarp of landslide #874 (see Map 1 of Attachment 5). Investigation trenches A,B, C and D are indicated.

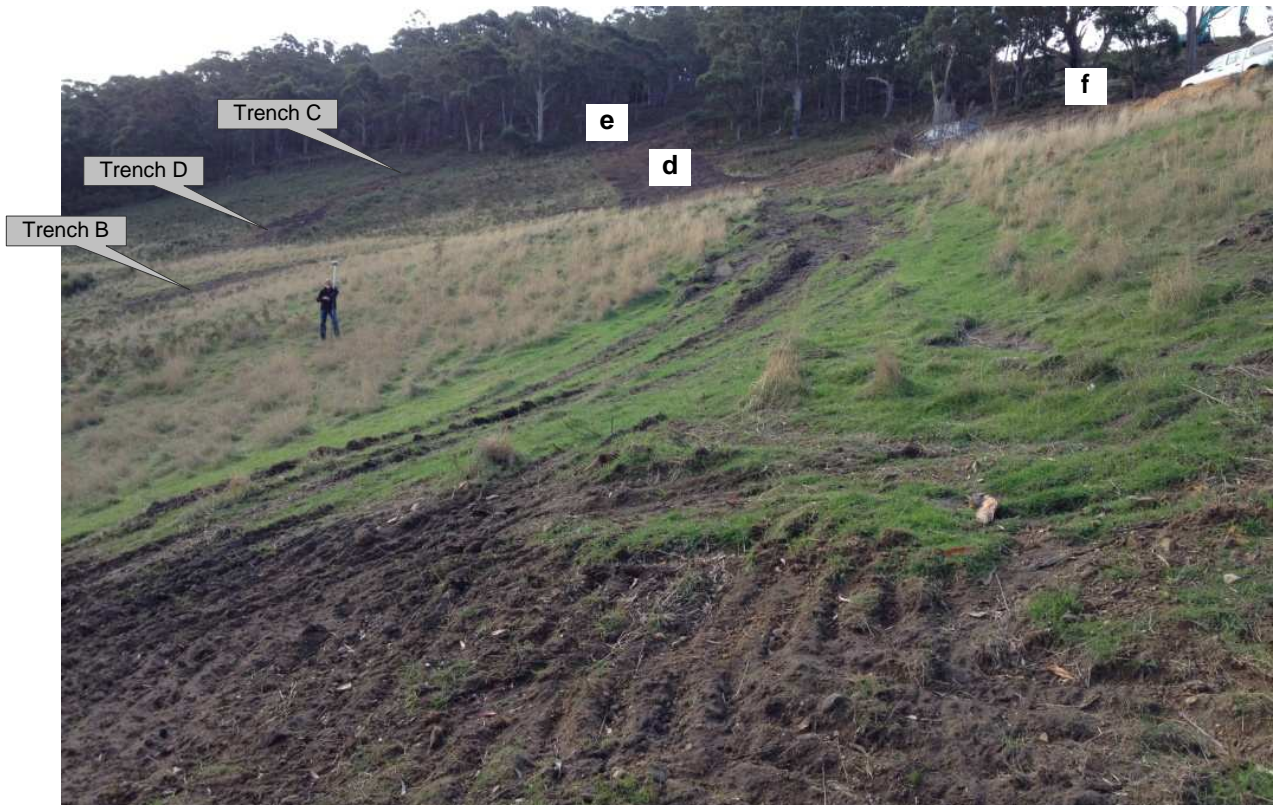
Plate 6 (below). View northeast and upslope over Lot 47 from its lower, southern boundary. Investigation trenches B, C and D are indicated. Service trench a...f is partly shown.

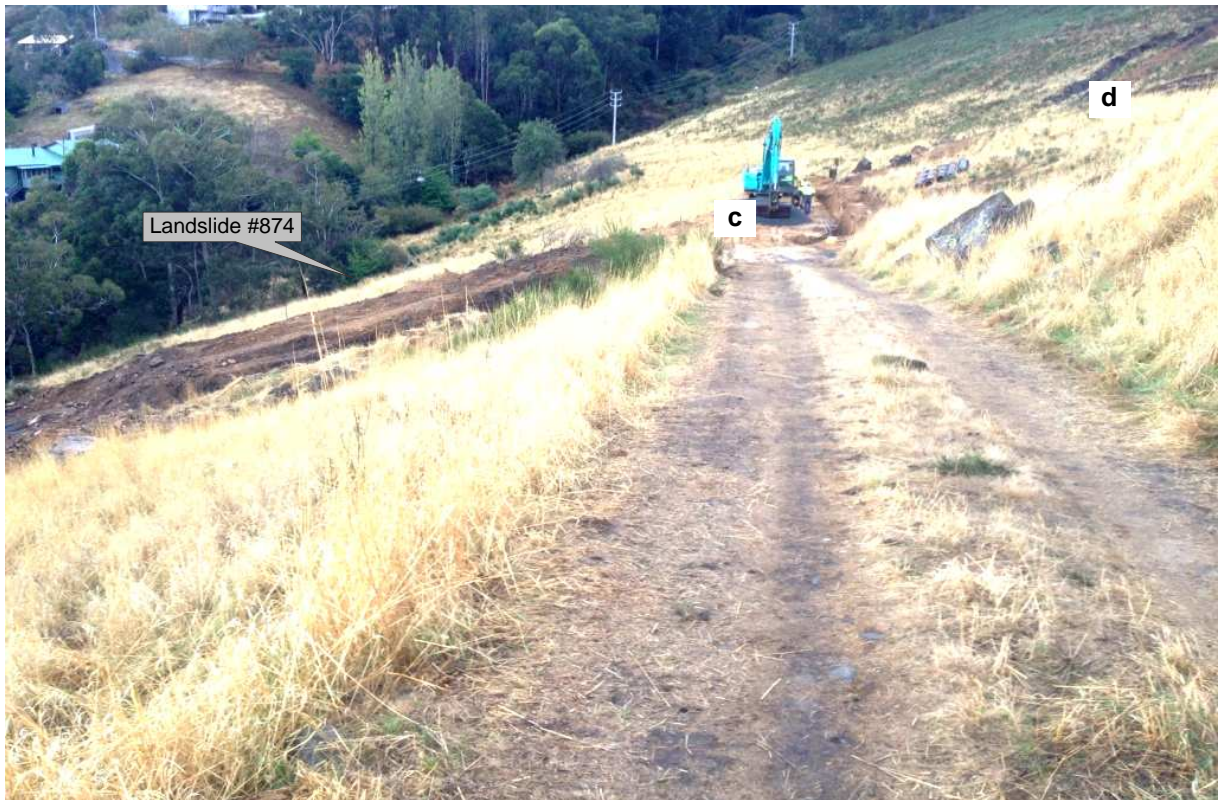
Plate 9 (above). Service trench abcdef at b, 28 March 2014. Subhorizontal Triassic sandstone bedrock exposed at depths less than 0.5m.

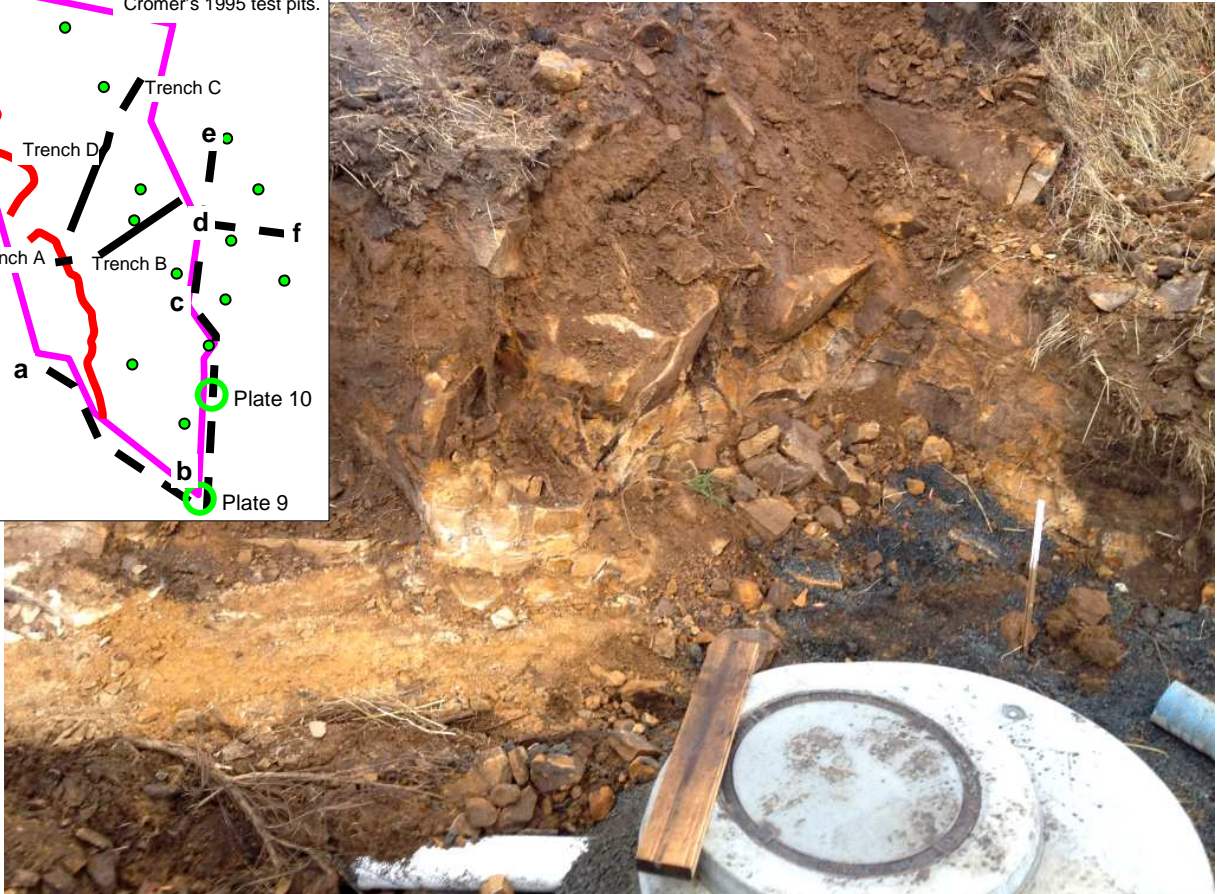
Plate 10 (below). Service trench abcdef between b and c. Subhorizontal Triassic sandstone bedrock exposed at depths less than 1m.

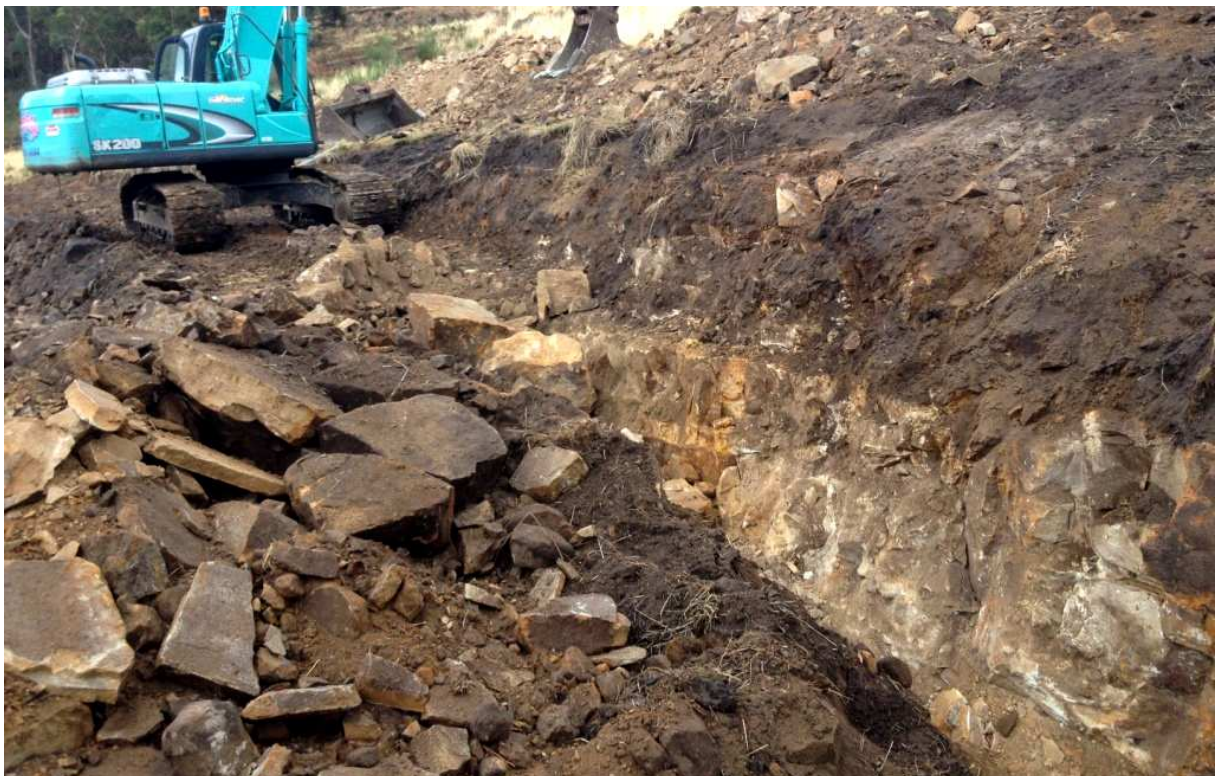
Plate 11 (above). Service trench abcdef at c. Subhorizontal Triassic sandstone bedrock exposed at depths less than 1m, but bedrock is interspersed with zones of colluvium comprising dry, friable to dense non-plastic to low plasticity sandy gravel-gravelly sand and clayey varieties.

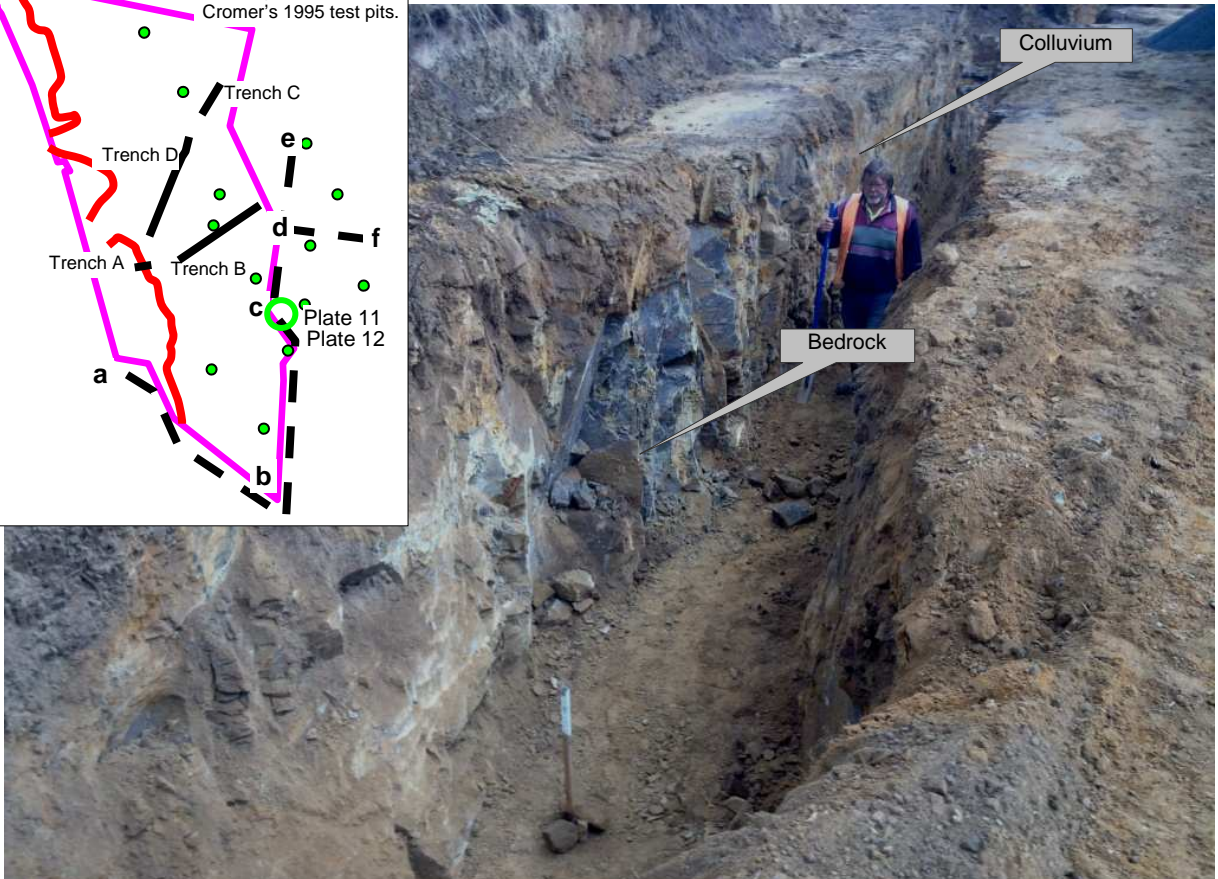
Plate 12 (below). Service trench abcdef at c, but opposite side of trench to that in Plate 11.

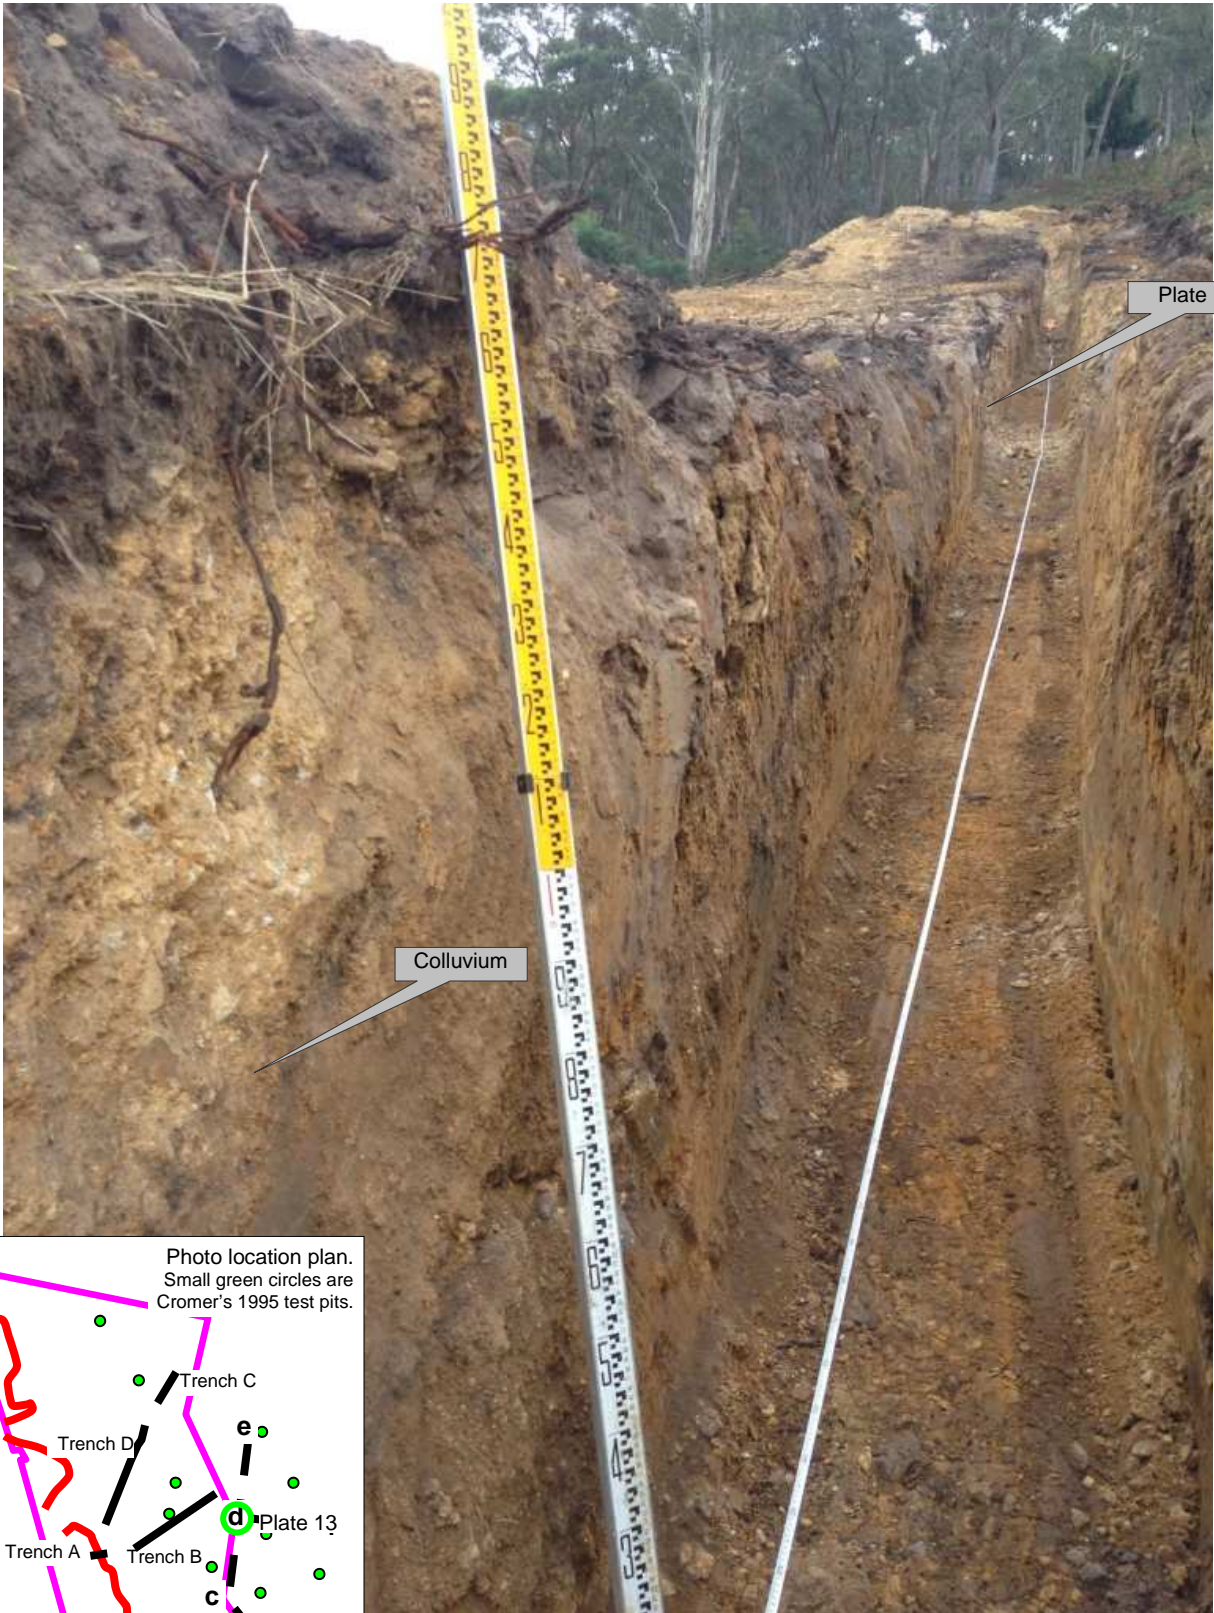
Plate 13. Service trench abcdef at d, looking upslope to e. The profile is mainly dry non-plastic colluvium, interspersed with patches of strongly fractured sandstone which may be in-situ bedrock, and other patches of strongly fractured sandstone underlain by colluvial material and therefore not in-situ.

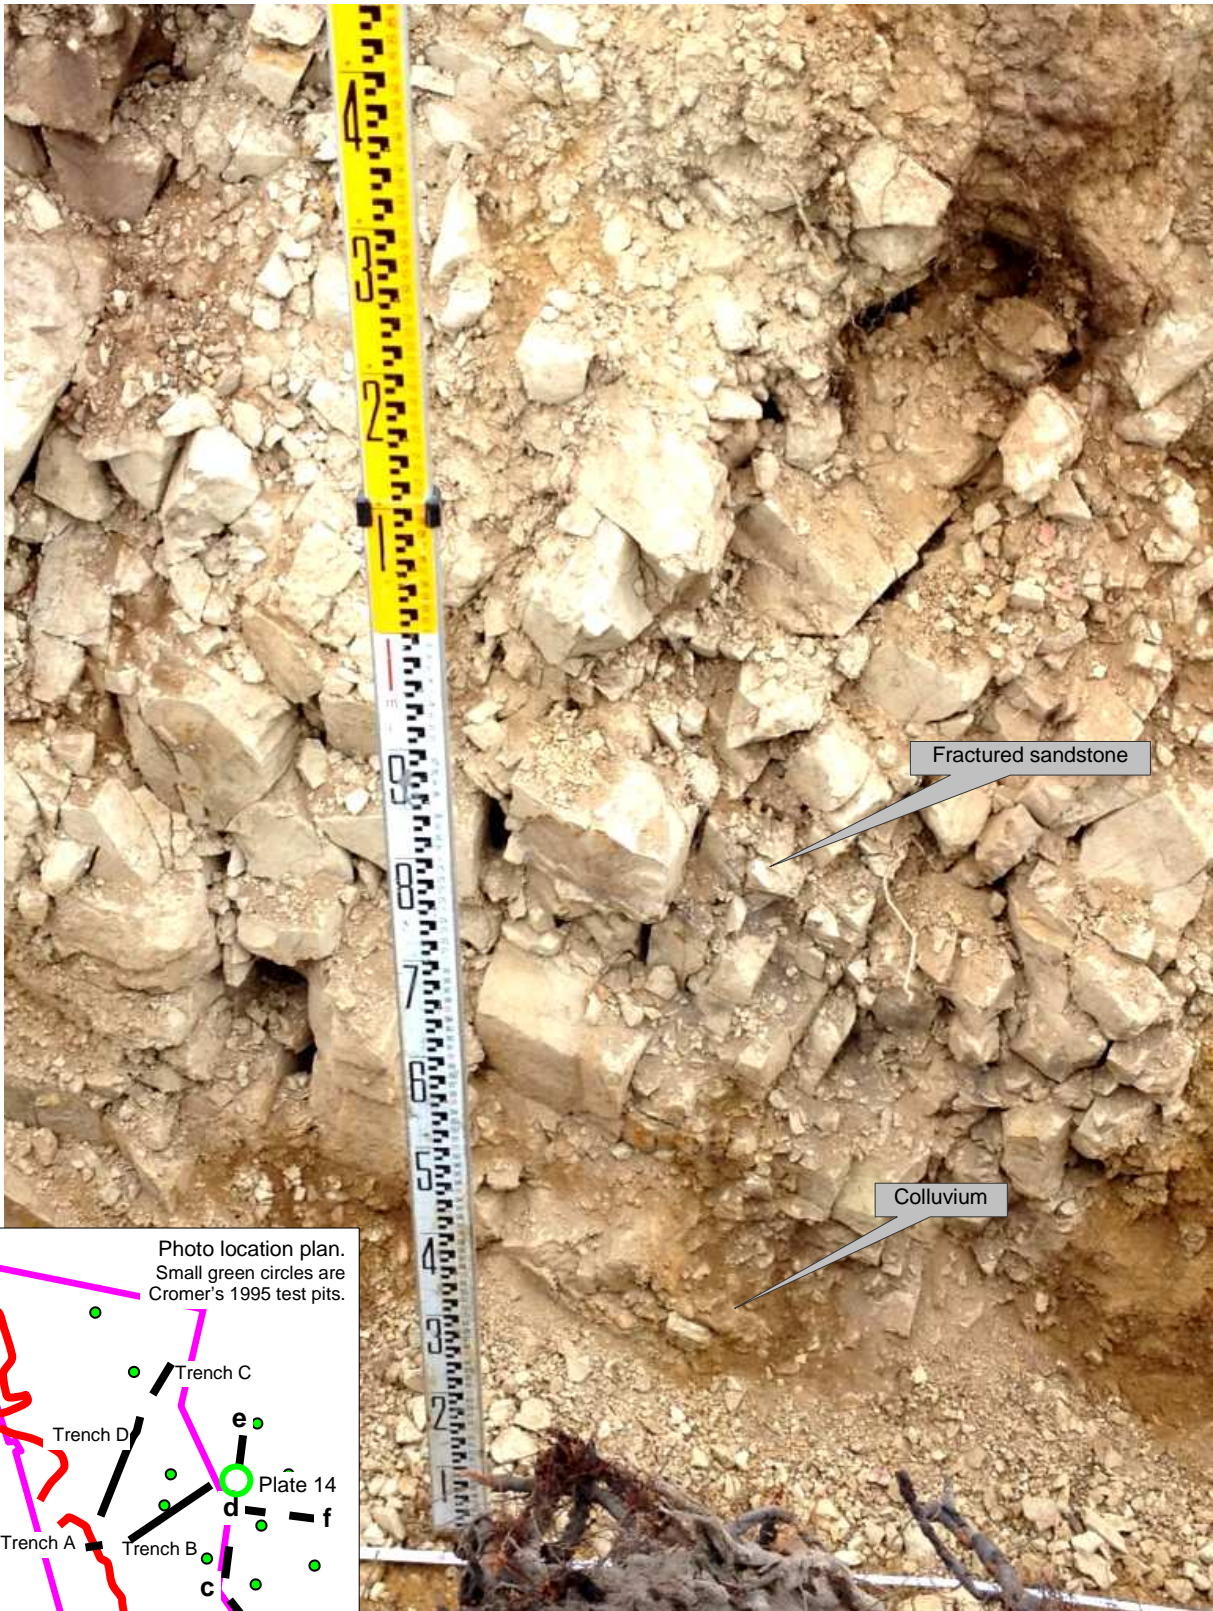
Plate 14. Service trench abcdef between d and e. A patch of strongly fractured sandstone showing joint alignment (and therefore minor bulk disruption and probably minimal downslope transport) is underlain by colluvial material.

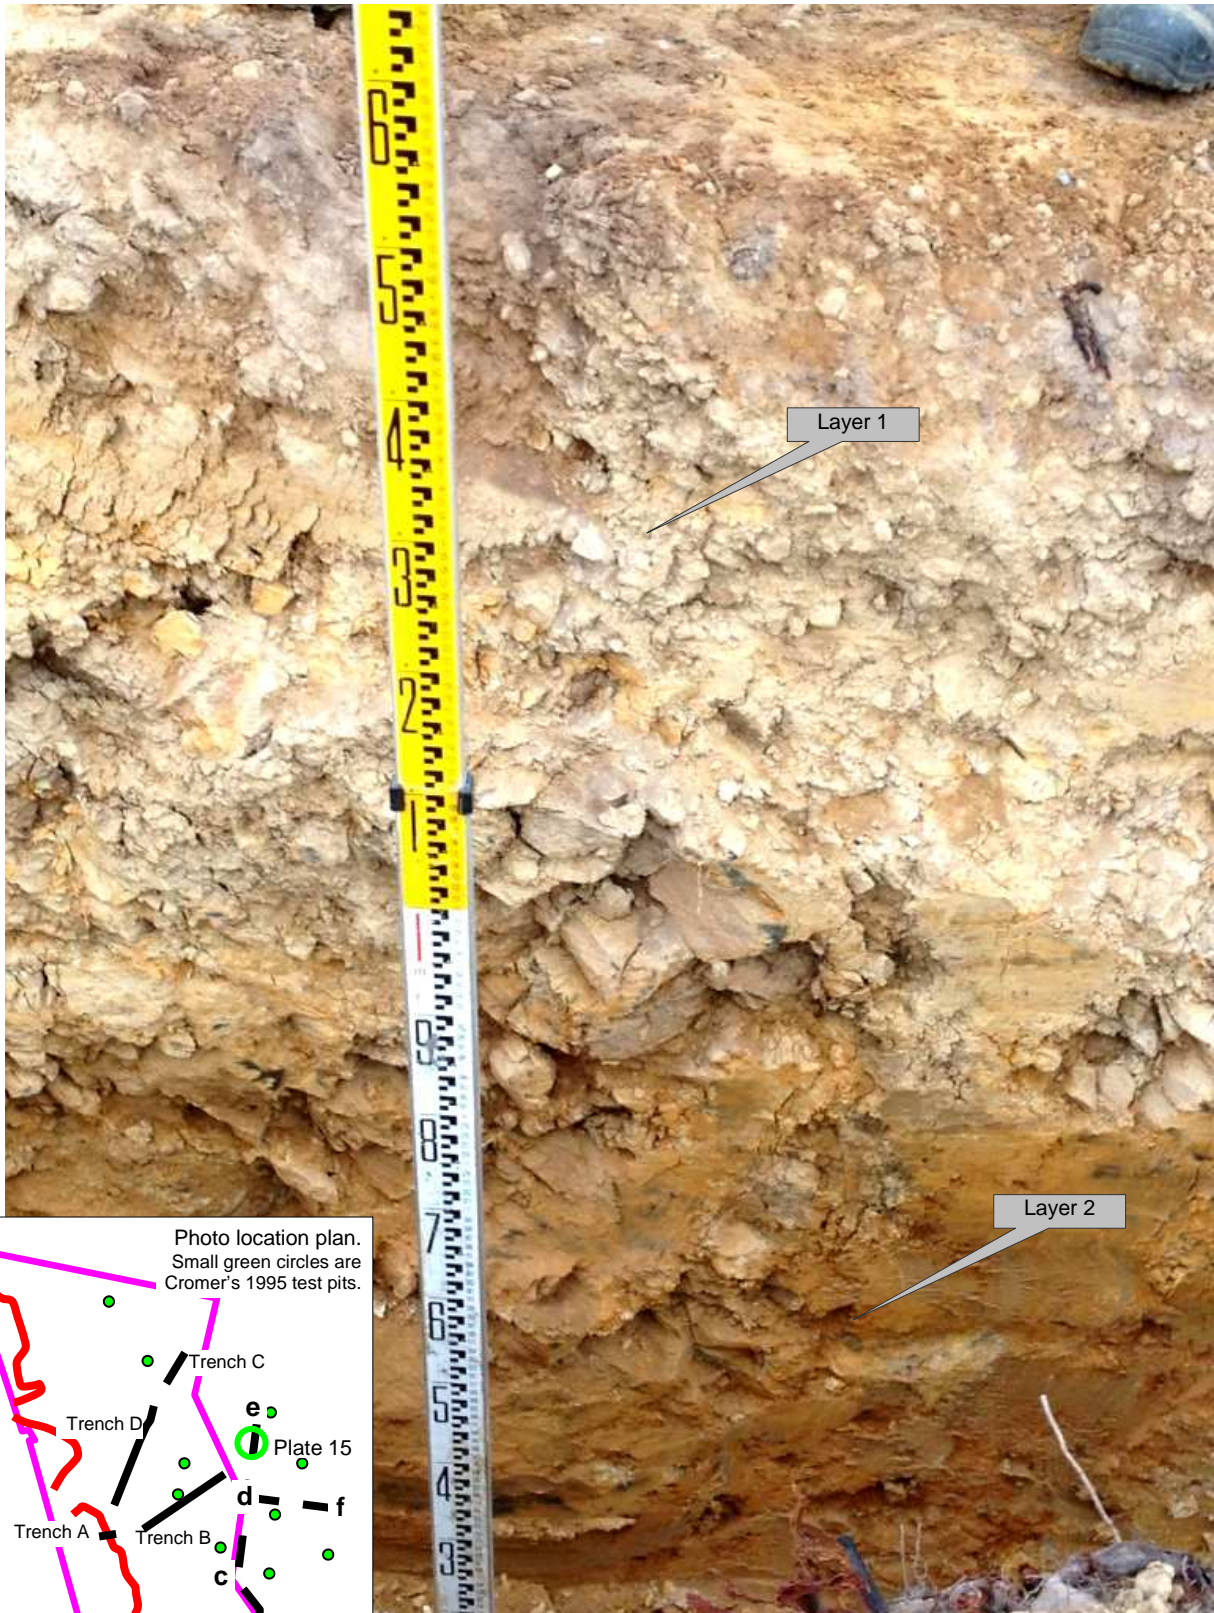
Plate 15. Service trench abcdef between d and e. The colluvium on this slope may locally display two episodes of colluvial development and downslope movement (Layer 2 then Layer 1), or it has undergone illuviation of finer material (orange) from Layer 1 to Layer 2 to form a duplex (two-layered) profile. If the latter, it implies a fair degree of slope stability over an extended time period.

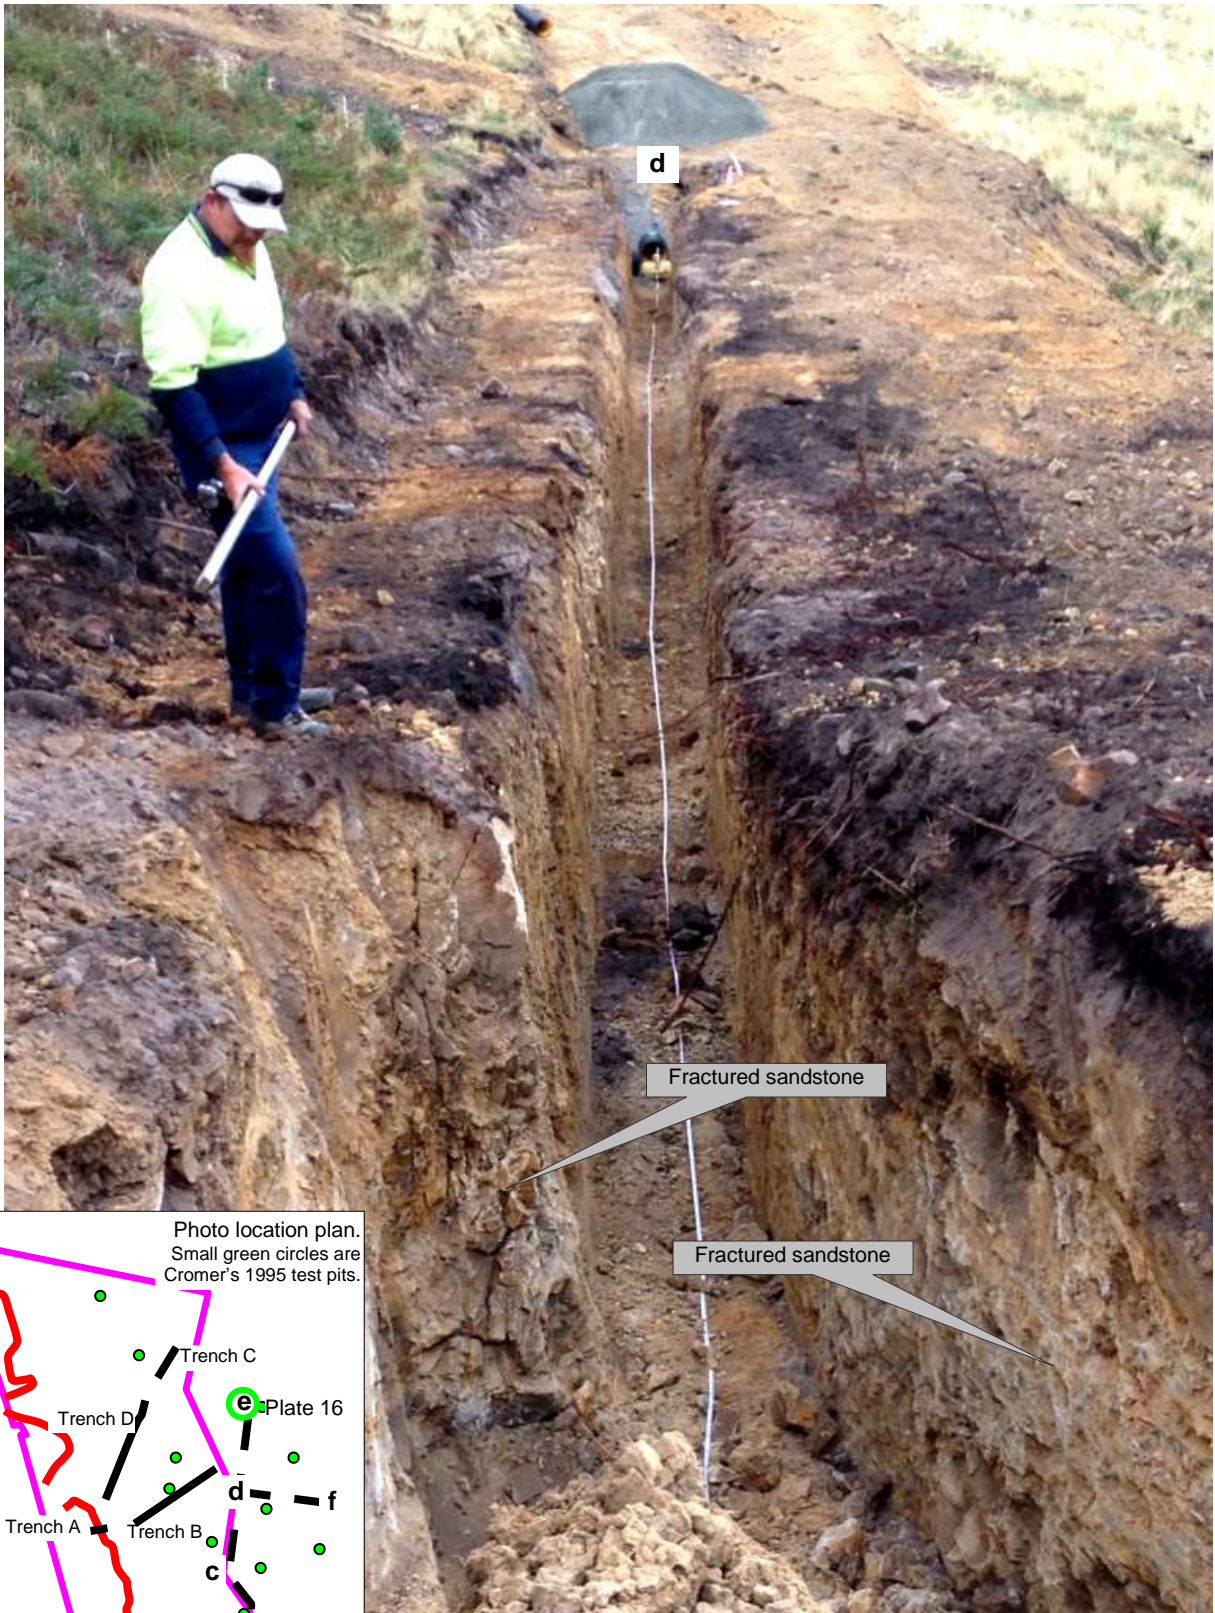
Plate 16. Service trench abcdef at e, looking downslope to d. It is not clear whether the fractured sandstone exposed in the services trench at this location (and locally elsewhere along it) is in-situ or not.

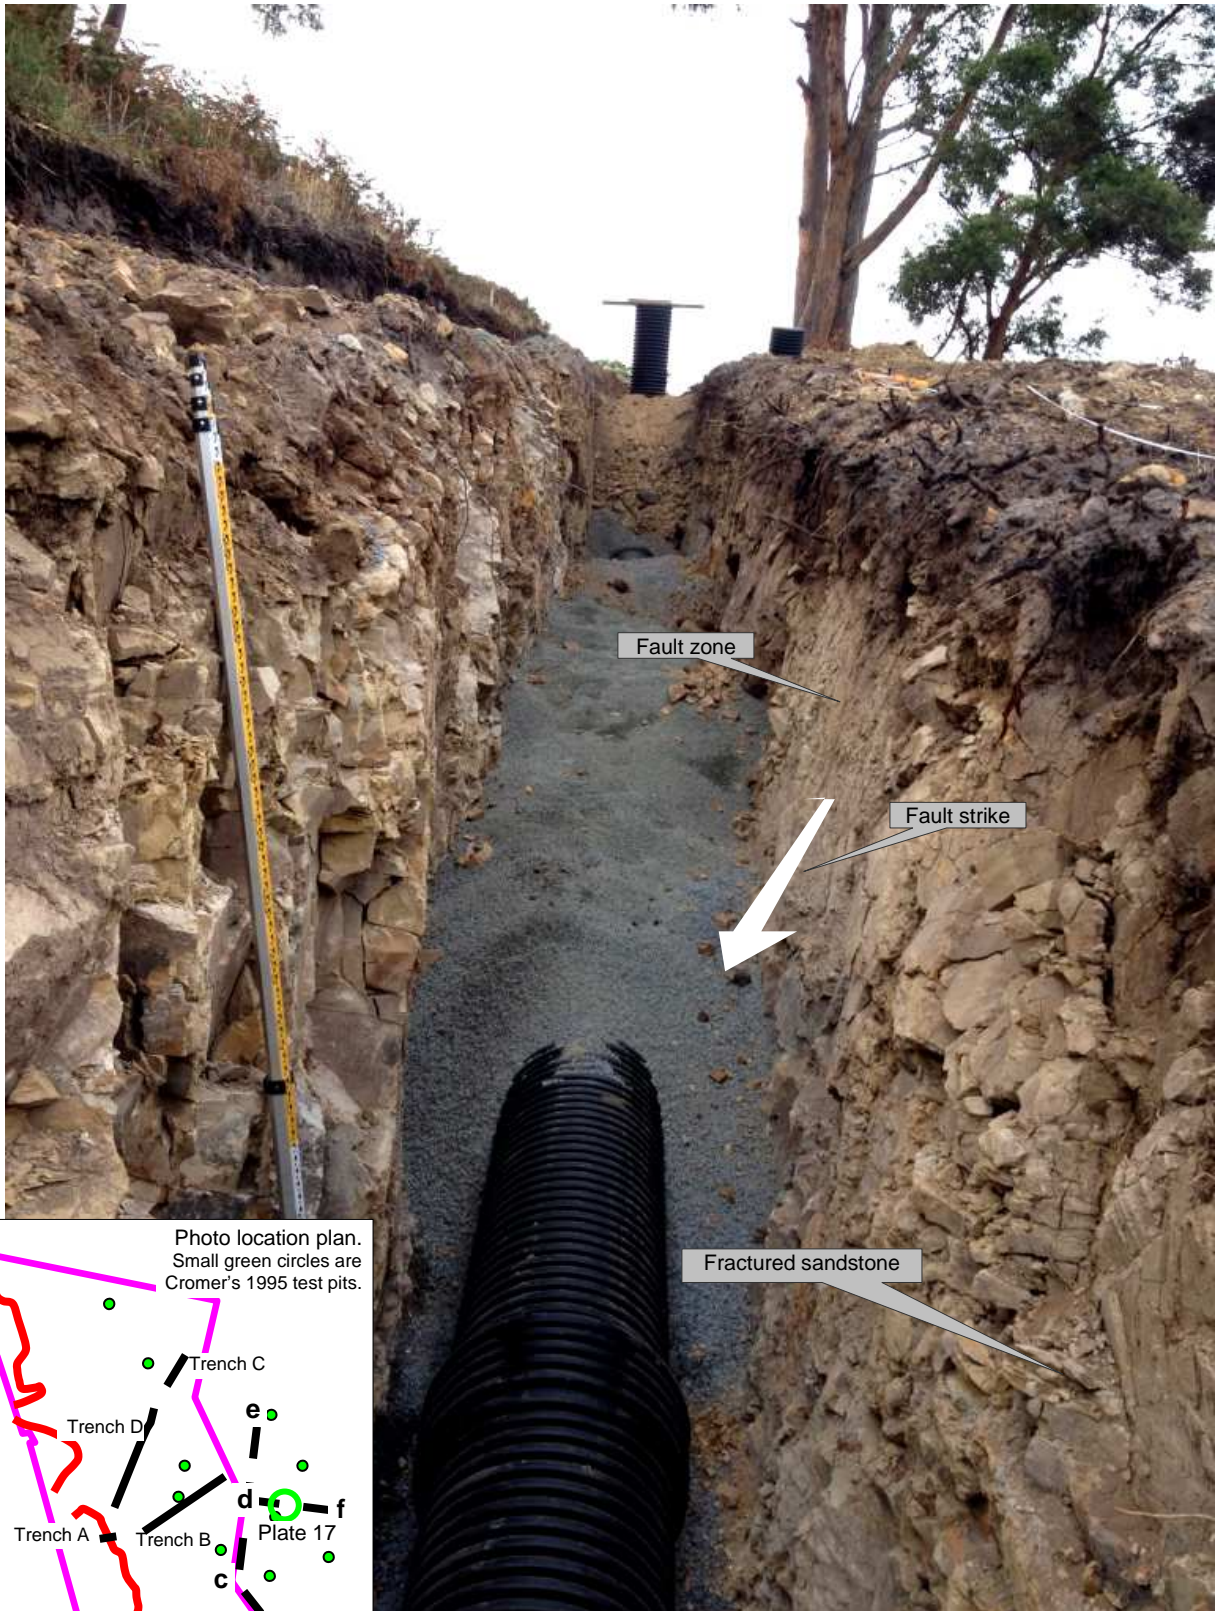
Plate 17. Service trench abcdef between d and f, looking upslope towards f. The fractured sandstone exposed in the services trench at this location appears to be in-situ. A narrow fault zone about 0.5m wide crosses the trench at an oblique angle (arrowed).
