**FARM HILL
RESIDENTIAL SUBDIVISION
WEST HOBART**

**LOT 47
GEOTECHNICAL REPORT
ADDENDUM TO 1995 GEOTECHNICAL REPORT**

This report is an Addendum to a 1995 geotechnical report.

It specifies a building envelope and conditions for residential development on Lot 47 of the Farm Hill Subdivision off Forest Road in West Hobart.

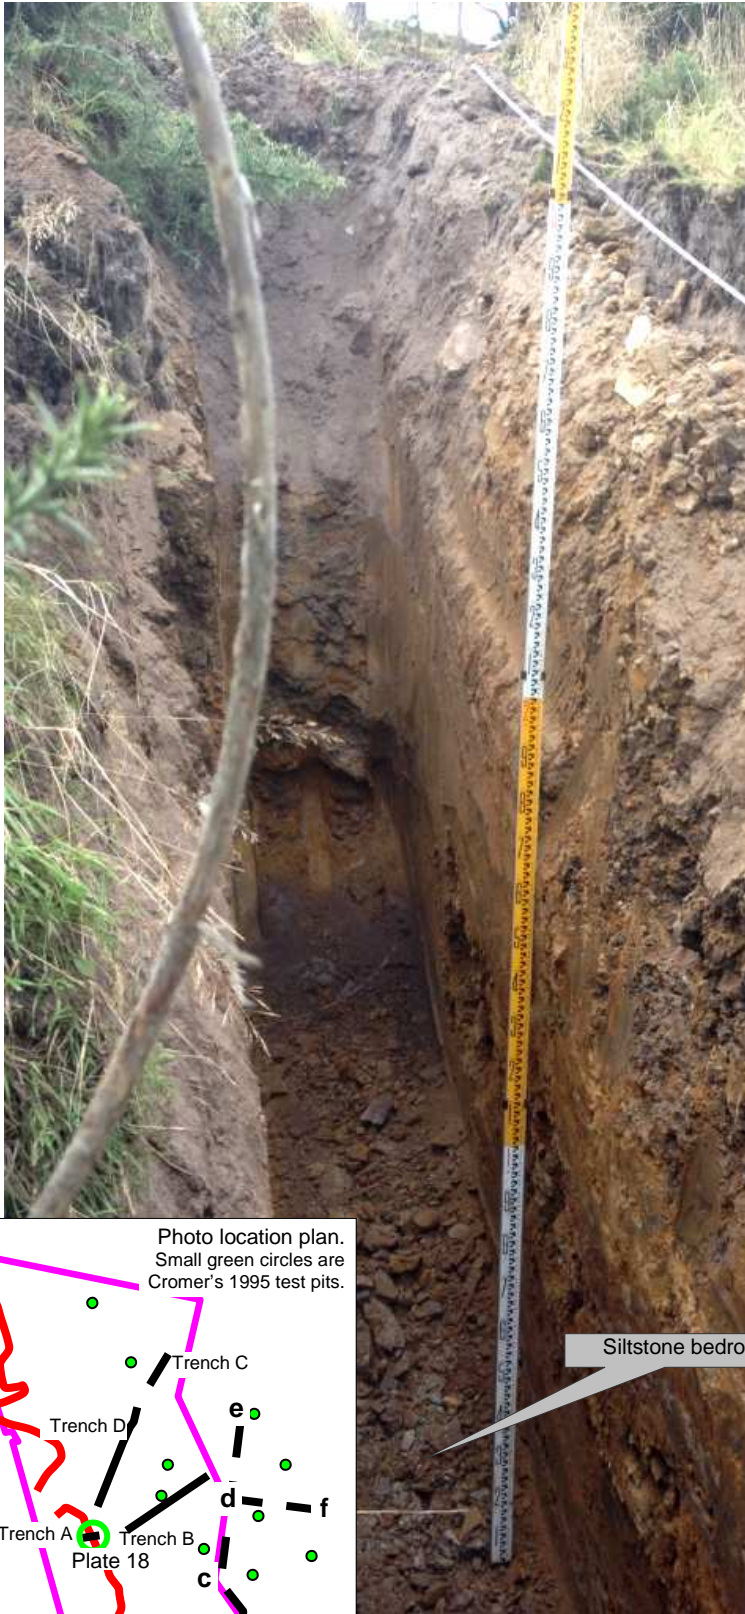
Plate 18. Investigation trench A, about 8m long, was dug across the headscarp of landslide #874. The failure surface was probably close to the camera, but not apparent. Colluvium overlies highly weathered siltstone bedrock, exposed in the base of the trench, and dipping 11° to 260° T.

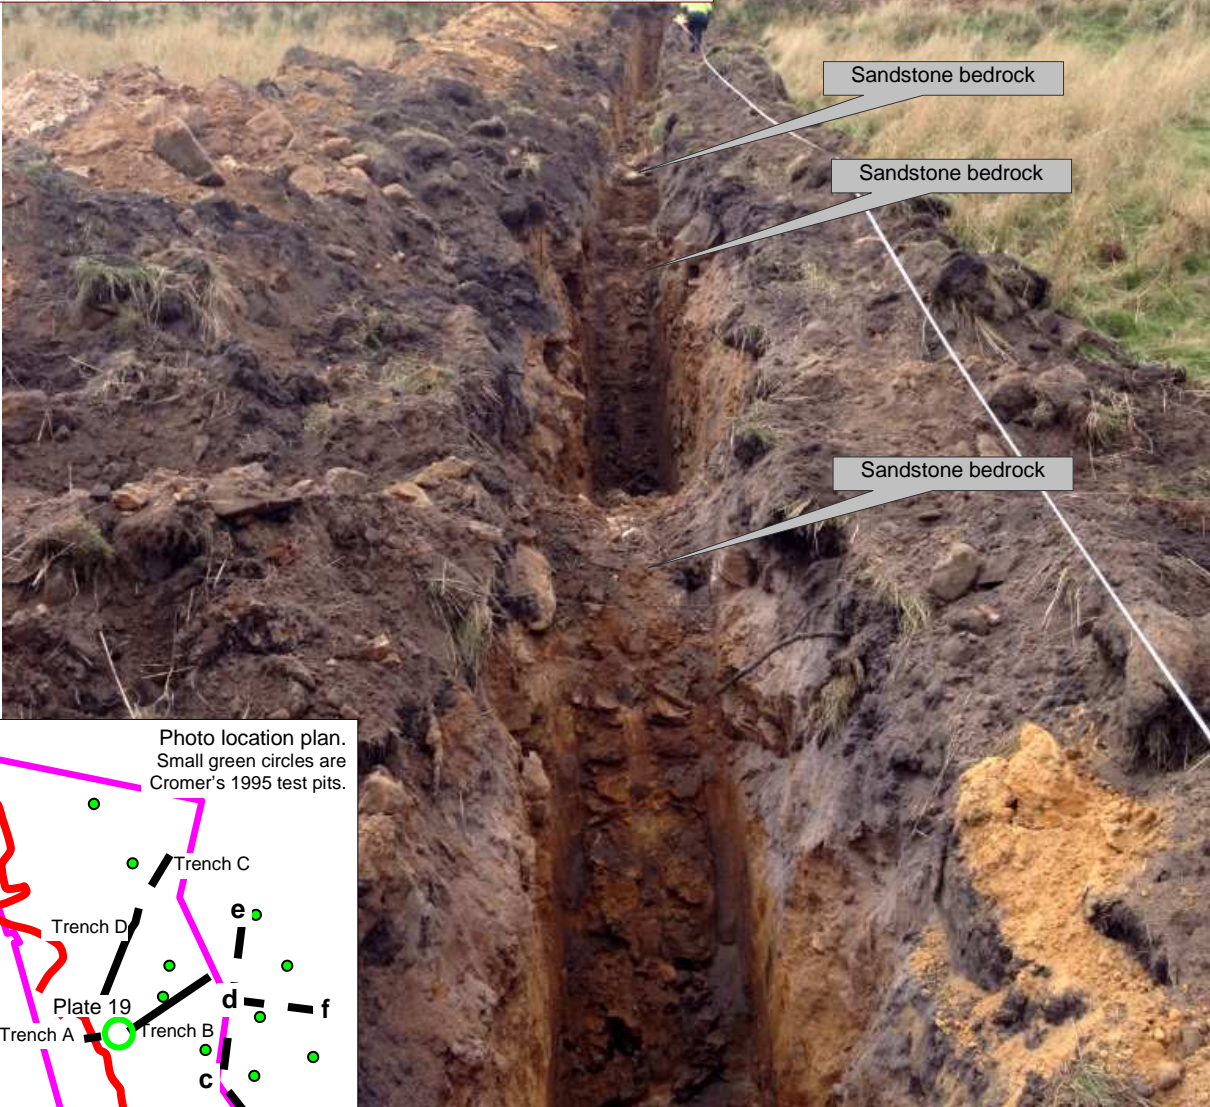
Plate 19. Investigation trench B, about 48m long, looking upslope. The slope is colluvium of variable thickness, but highly weathered sandstone bedrock was exposed along the full length of the trench at depths ranging from as shallow as 0.5m (as indicated) to about 1.8m. The dip on the bedrock is less than 5° to the north (into the slope).

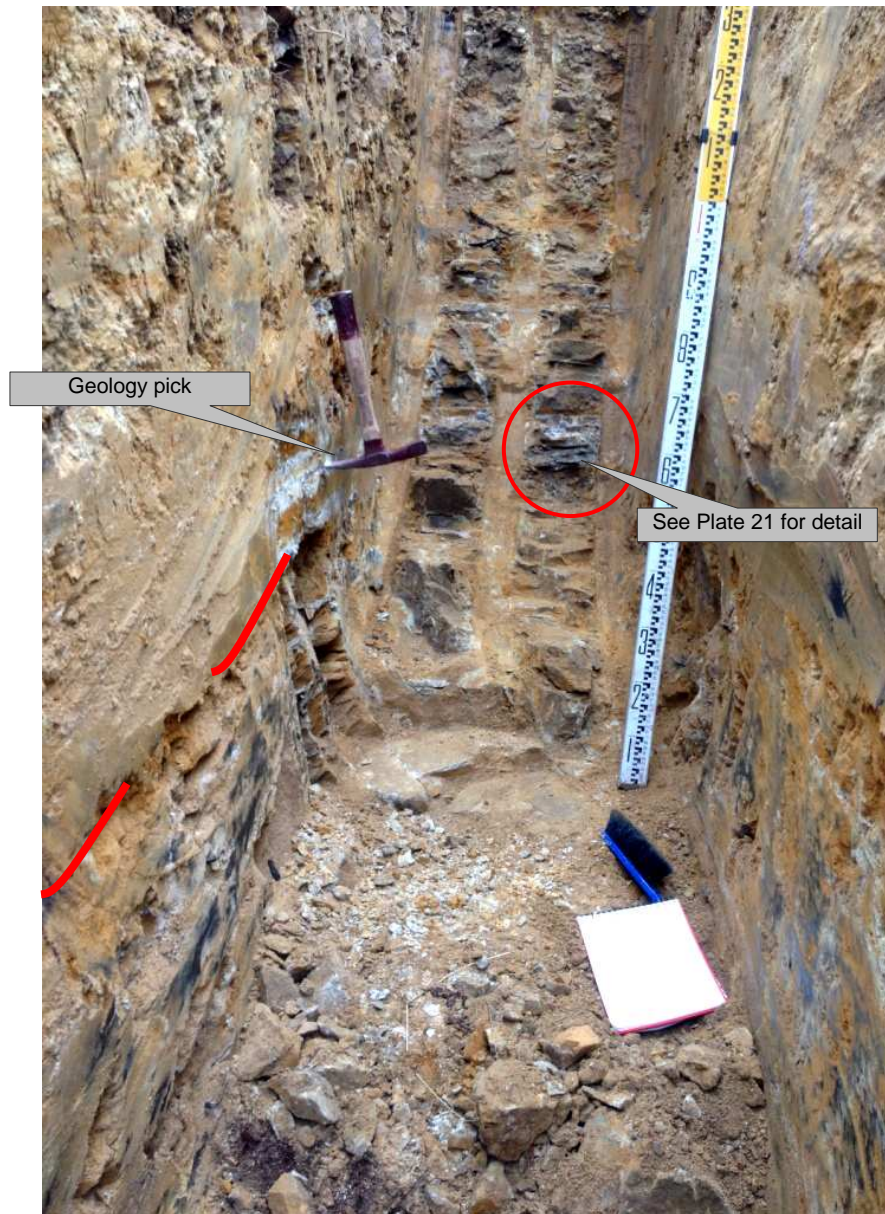
Plate 20 (left). Investigation trench B, upslope end, showing finely bedded, highly weathered sandstone and siltstone bedrock dipping 3° to 017° T. Colluvium (with some bedded sandstone) overlies the bedrock, and the boundary (red line) between them, although not very obvious, is inferred to dip towards and up to the camera in a scallop shape (the geology pick is on the boundary).

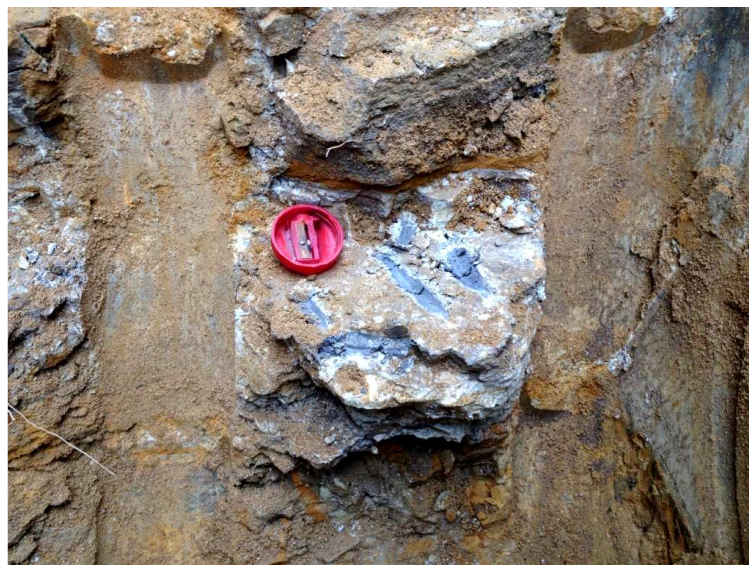
Plate 21 (below). Detail of the end of Trench B, showing grey-blue, high plasticity clay coatings several millimetres thick on a dipping joint surface. Slipping on these coatings is a likely mode of localised failure for the colluvial cover.

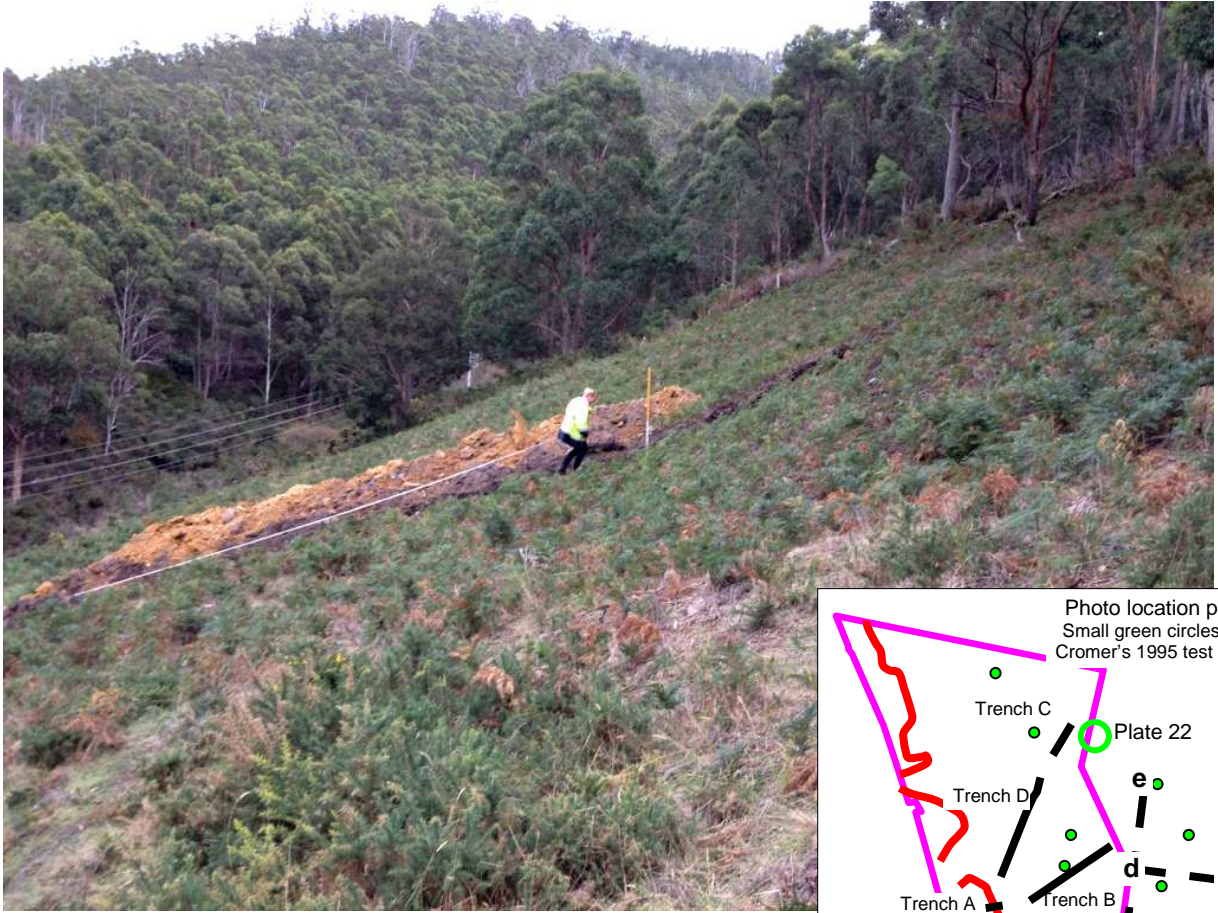
Plate 22 (above). View west at Trench C, 17.5m long. This excavation up to 2.6m deep exposed colluvial materials over high plasticity clay, with no bedrock.

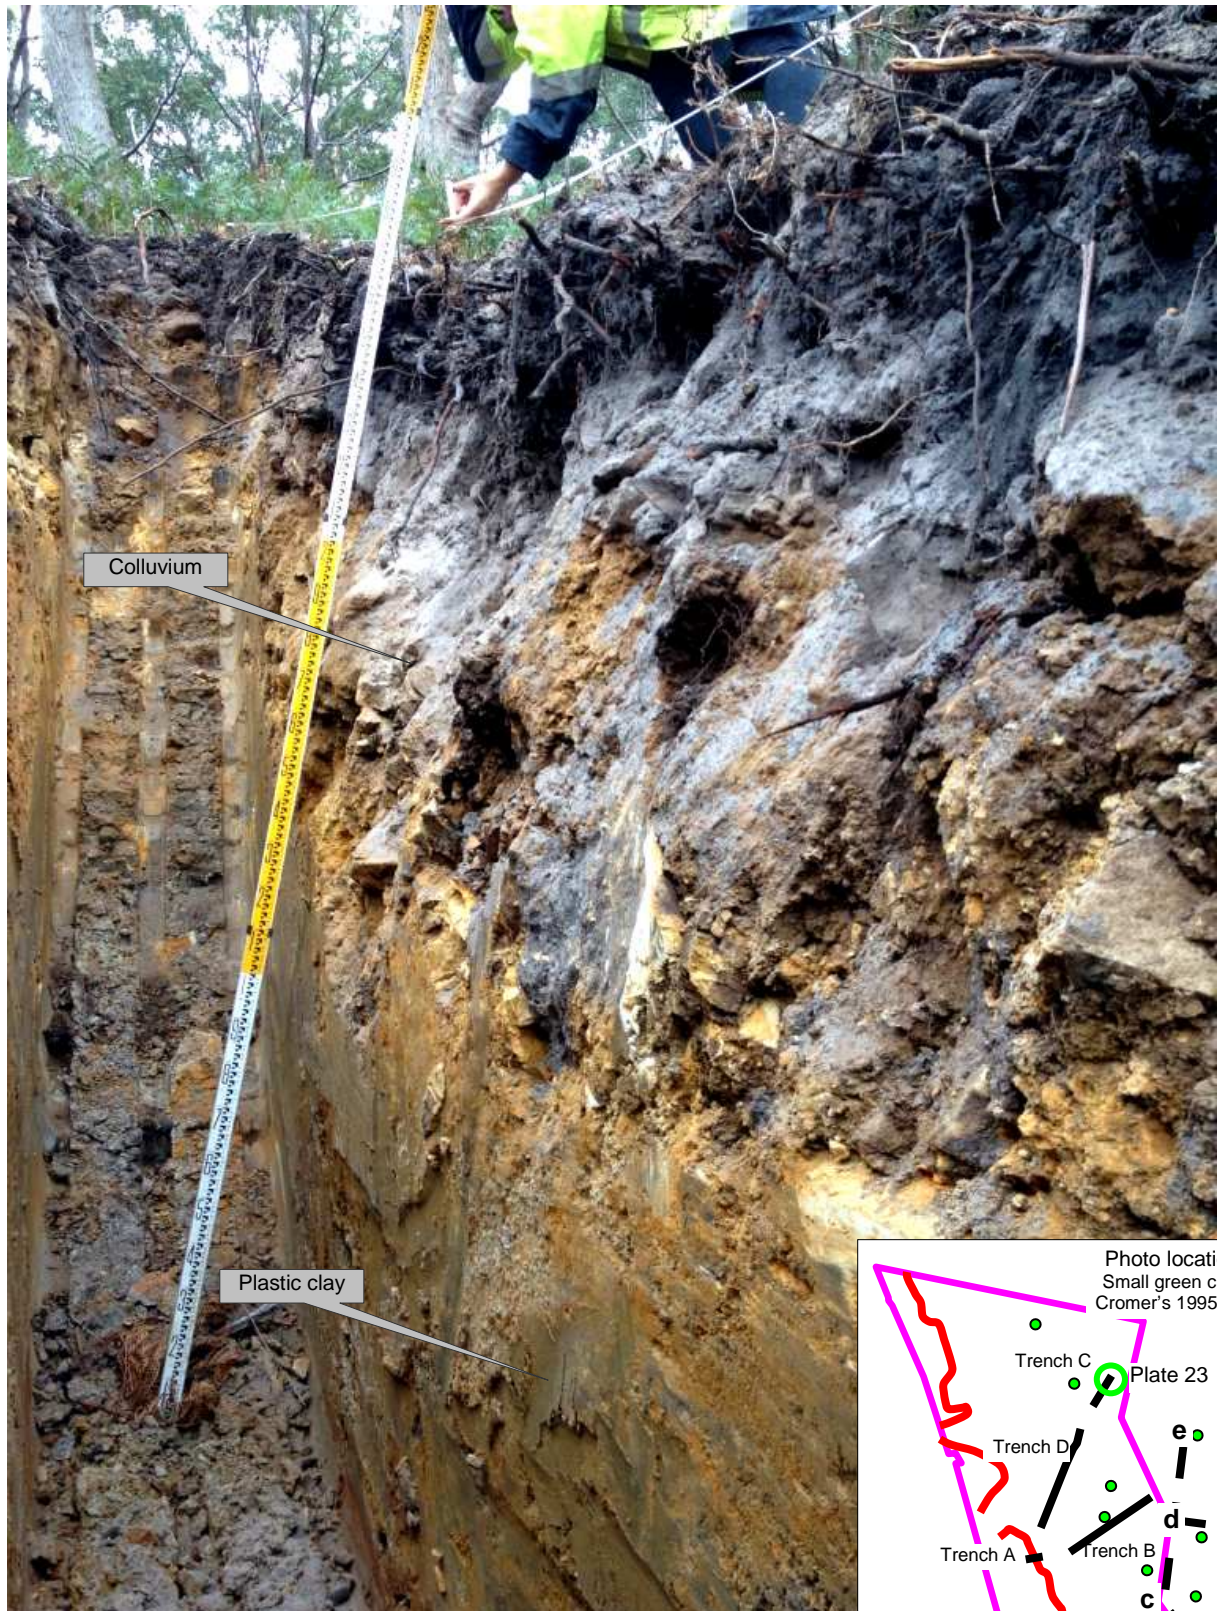
Plate 23. View north northwest at the higher end of Trench C, 17.5m long. This excavation up to 2.6m deep exposed colluvial materials over high plasticity clay, with no bedrock.

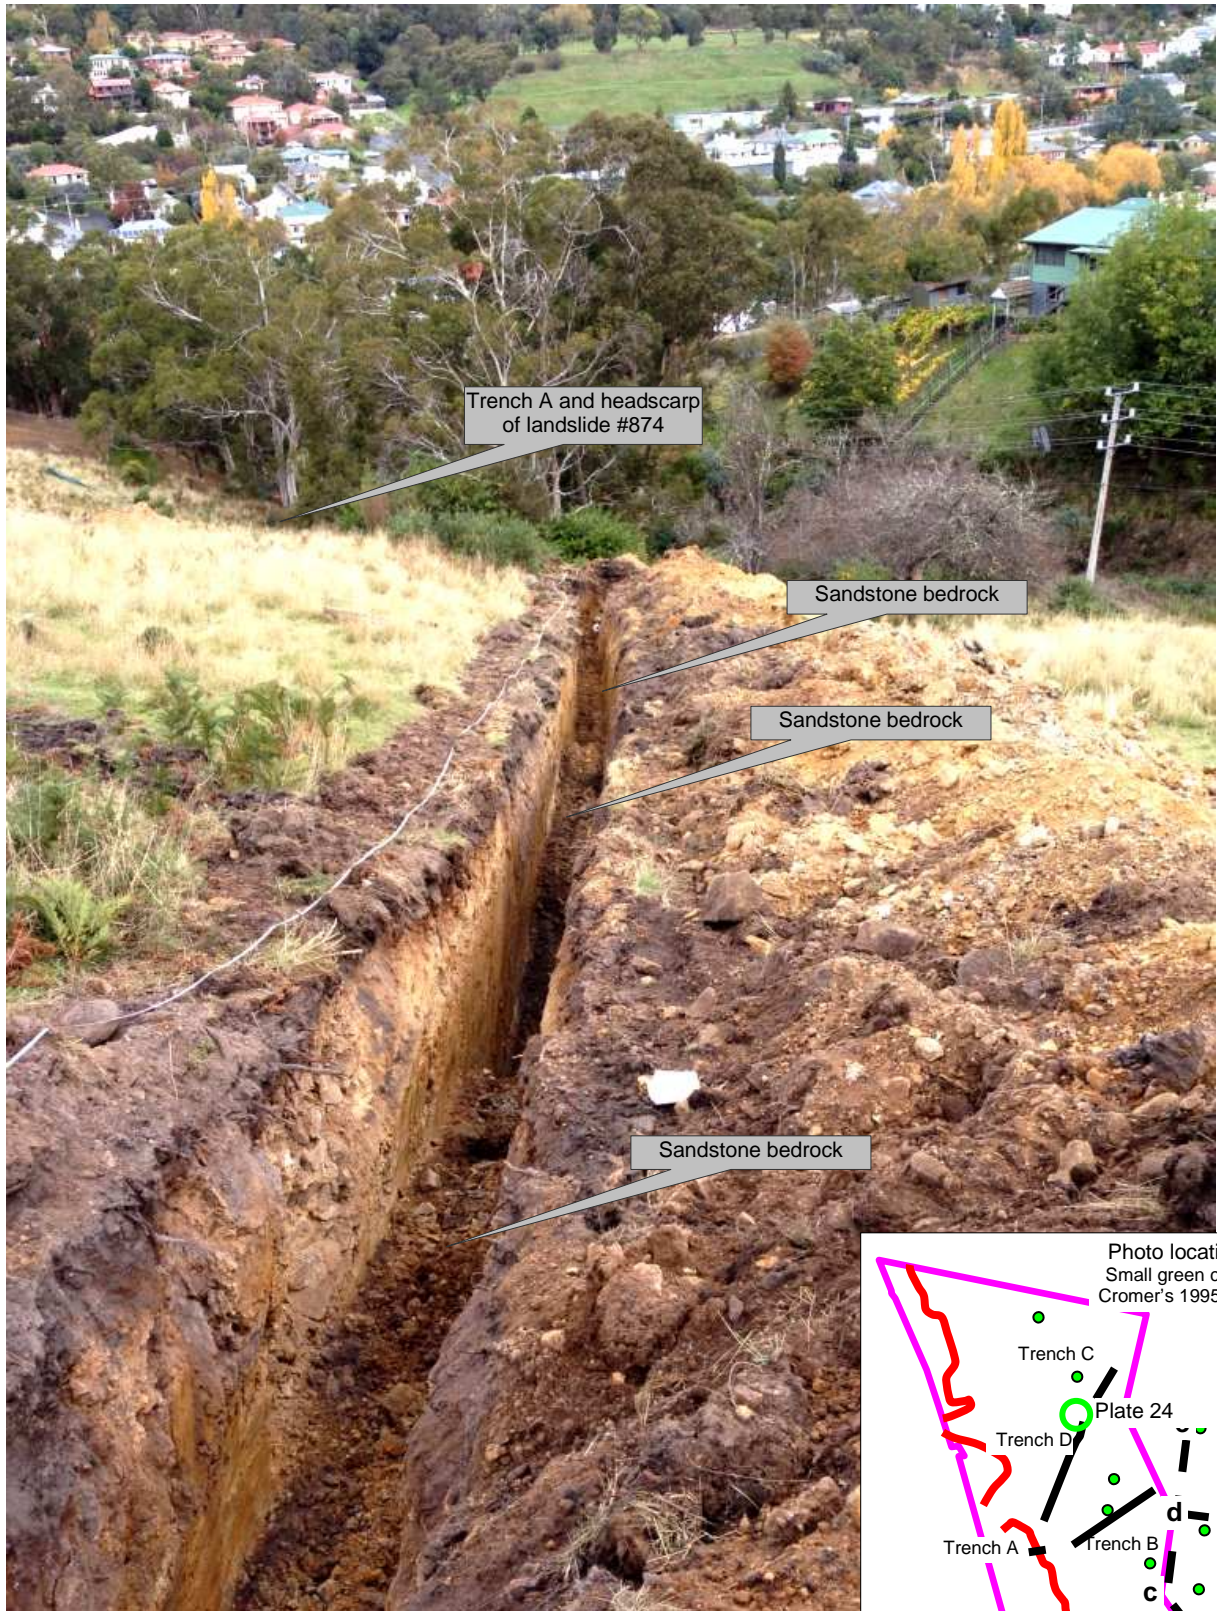
Plate 24. View downslope and along investigation trench D. Note bedrock highs in floor of trench, with colluvial material on top, and surrounding.

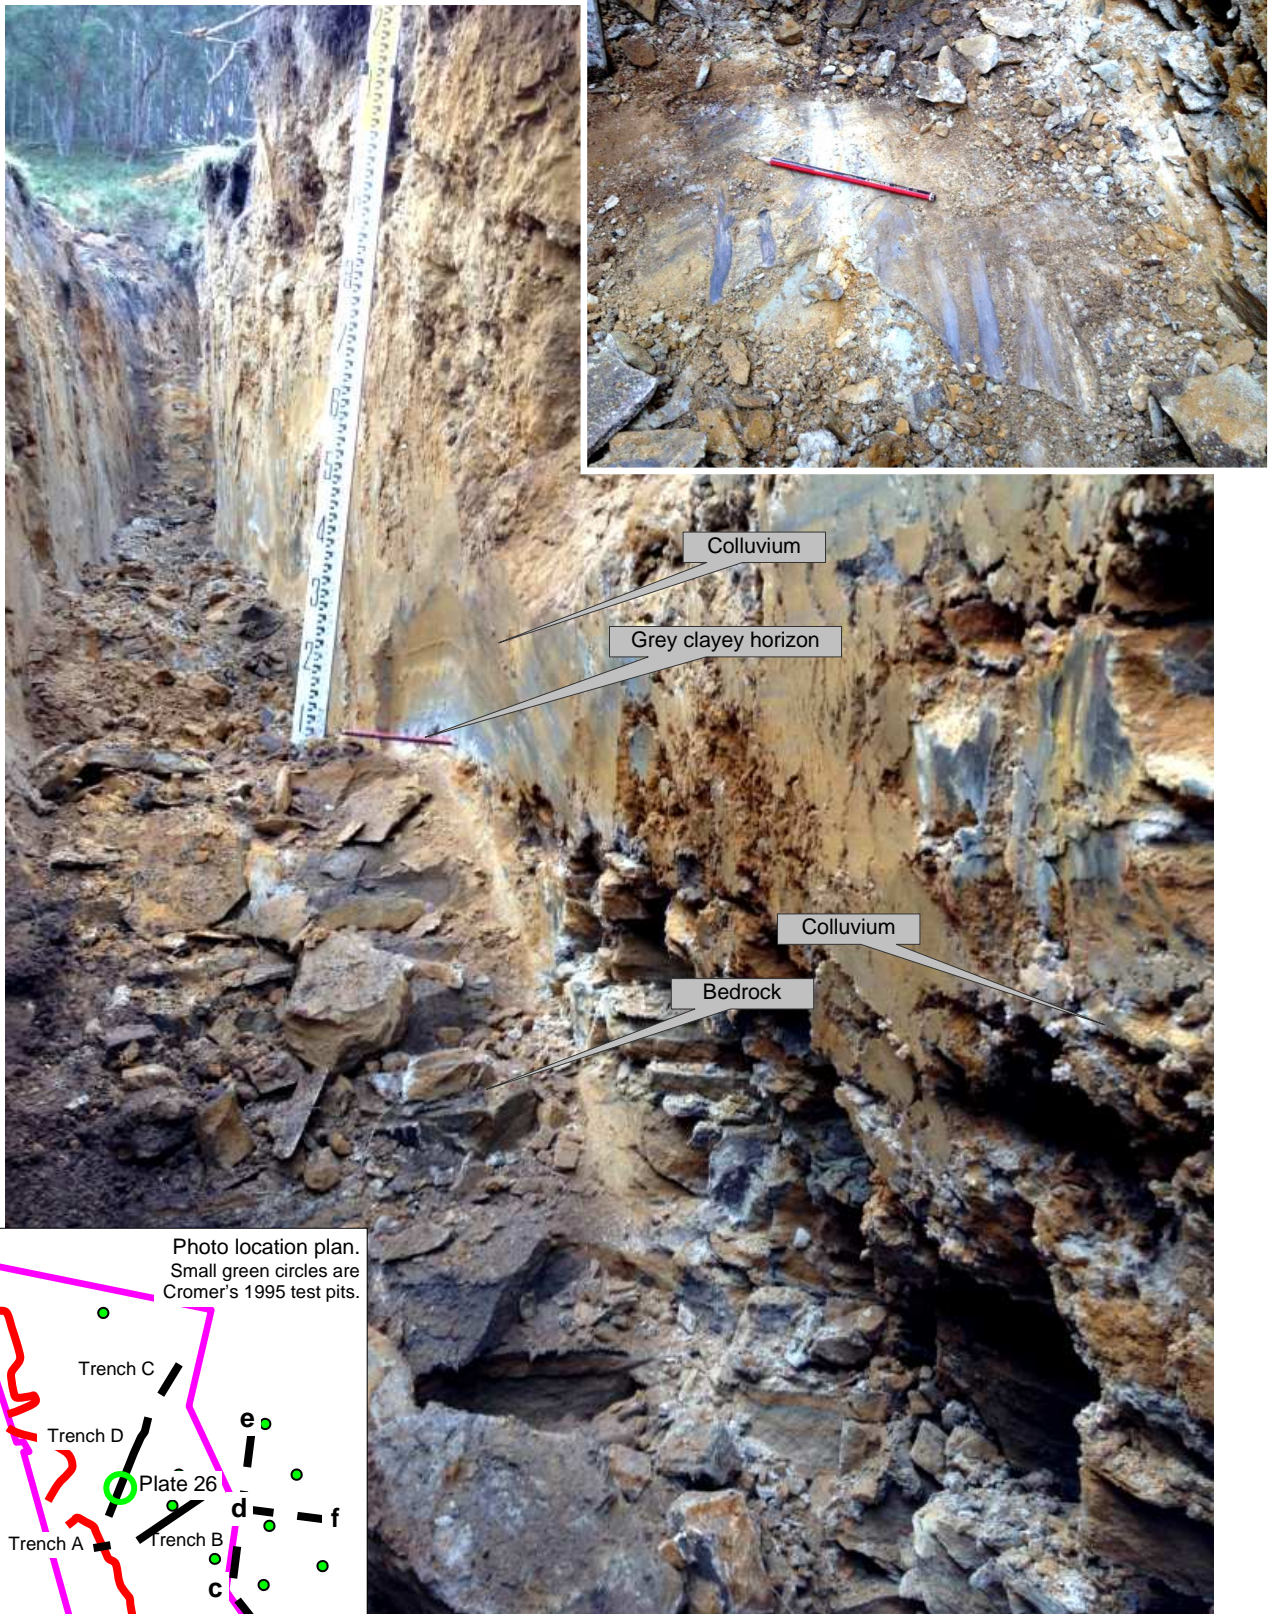
Plate 26. View upslope and along investigation trench D, showing finely bedded sandstone bedrock in floor of trench, with colluvial material on top. Local movement of colluvium over the bedrock is facilitated by grey clayey horizons on the colluvium-bedrock interface (indicated by pencil), and also probably by clay coatings on subhorizontal joints in the bedrock itself (inset photo; the striations on the clay are finger marks).

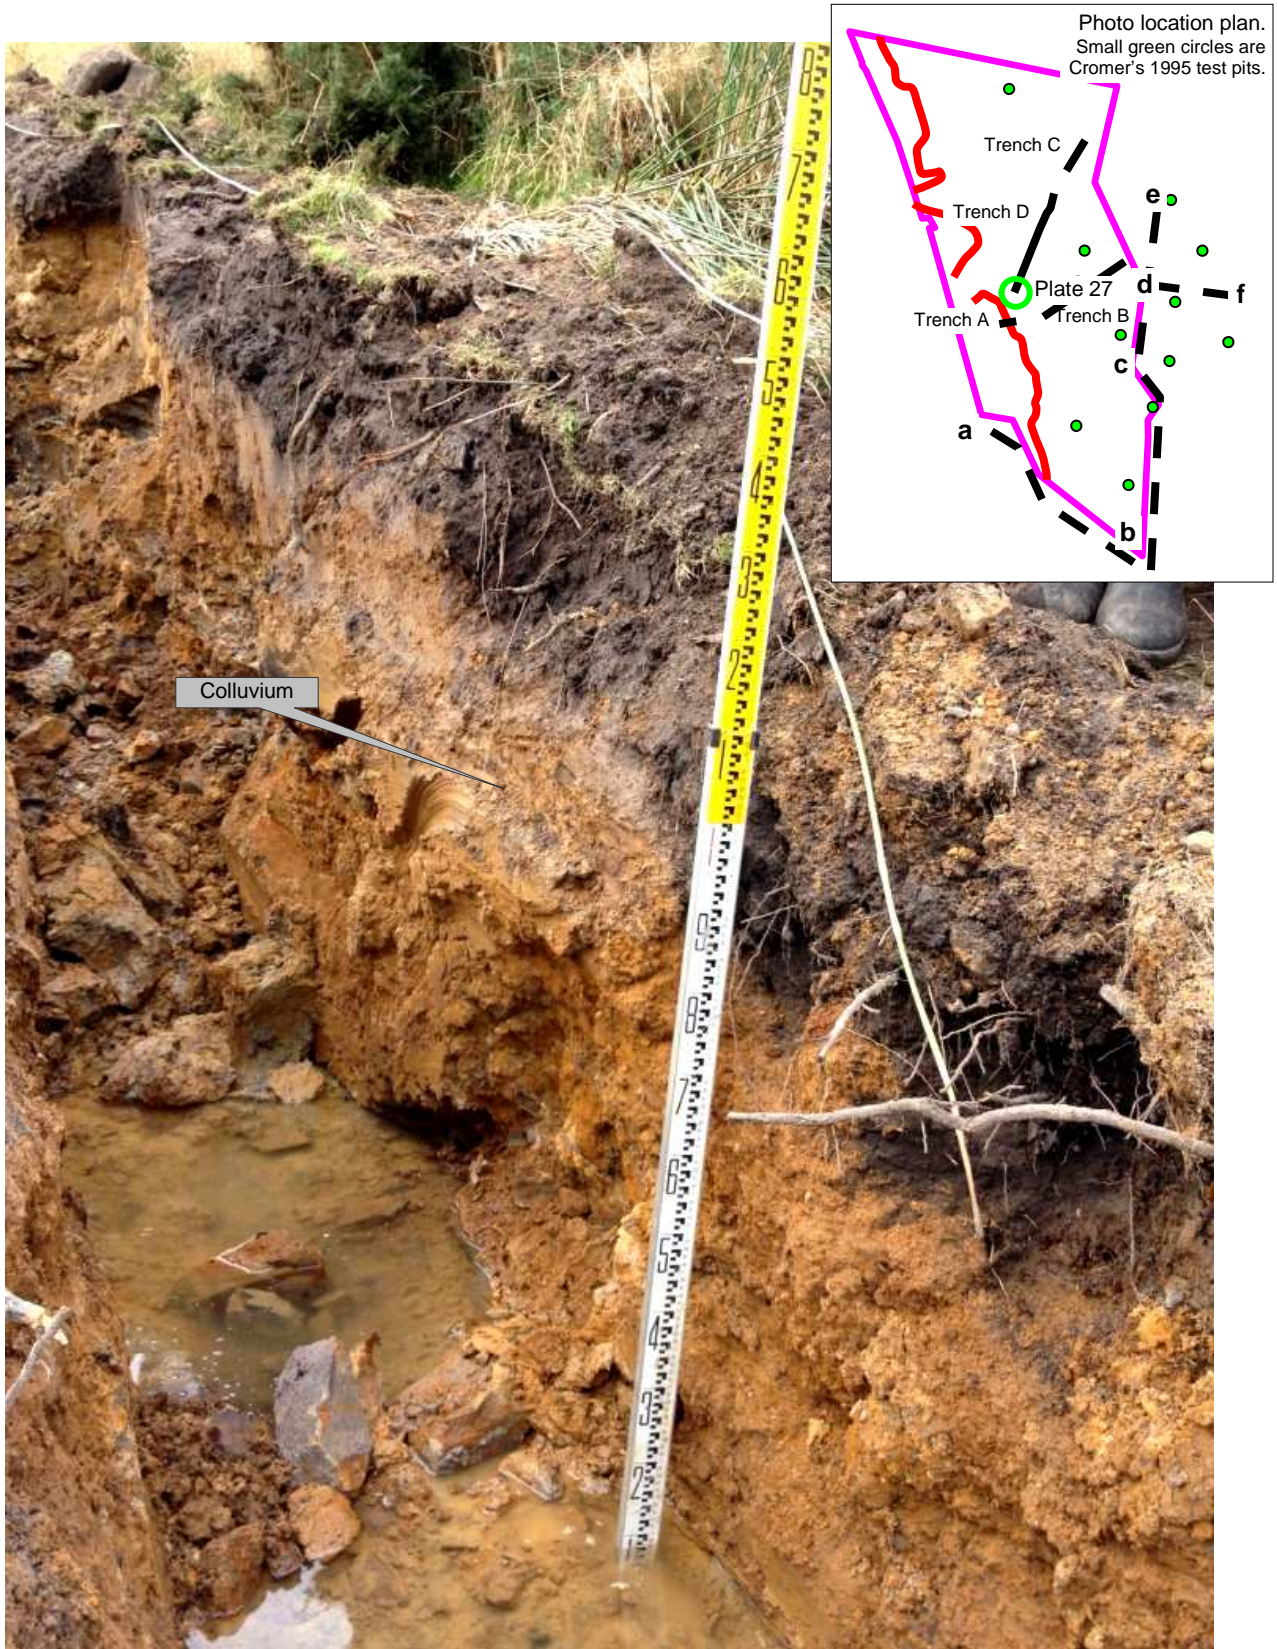
Plate 27. Shallow seepage water issued from, and accumulated at, the lower end of investigation trench D. Shown here are colluvial materials beneath organic-enriched sands soil, near the headscarp of published landslide #874. This seepage was the only instance noted in the trenches, although Cromer (1995) noted minor seepages in nearby test pit 6 at a depth of 3, and 20L/min seepages at 4.8m

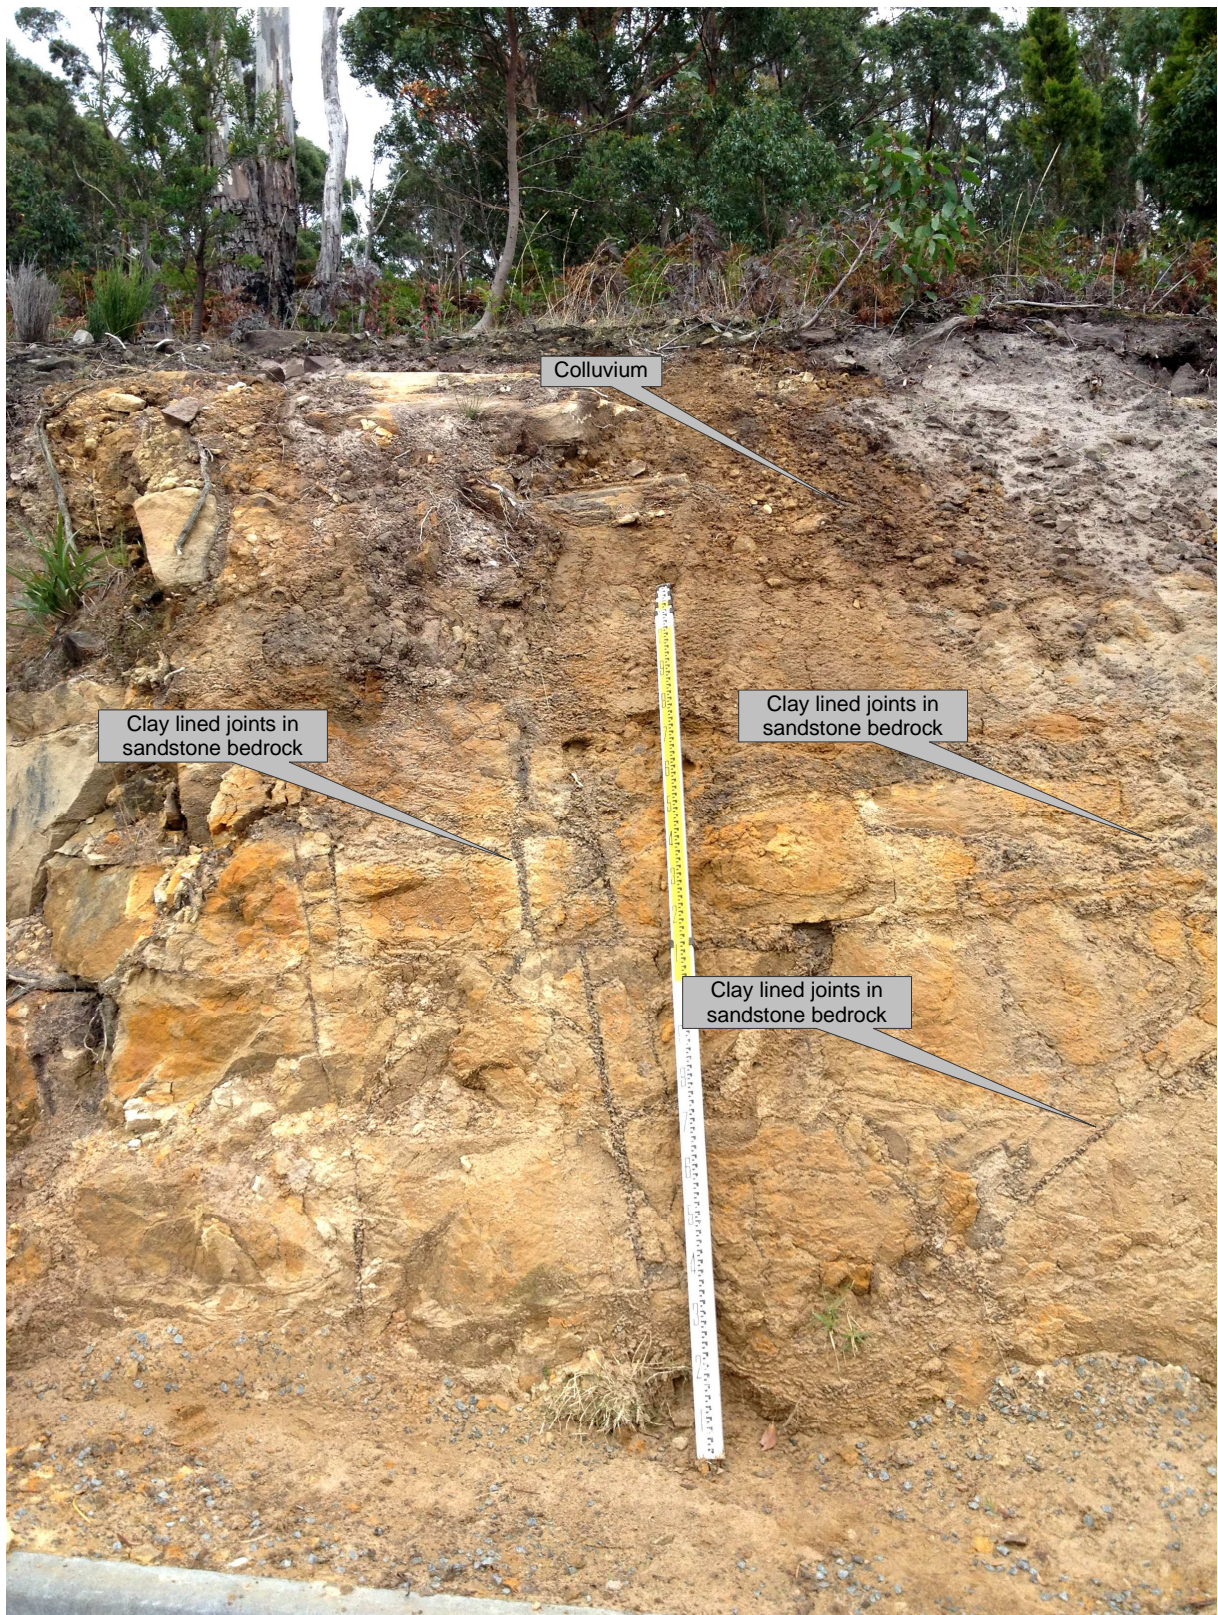
Plate 28. Triassic sandstone with joints coated with high plasticity grey clay are very common on the Farm Hill subdivision and neighbouring areas. This photograph of the cutting at the junction of Thelma Road and Forest Hill Road shows mainly subvertical, clay-lined joints, but subhorizontal and dipping ones, too. Some joint coatings taper to less than a millimetre thick, and it is inferred that they were emplaced in the liquid or semi-liquid state, filling open fractures. The origin of the clay is unclear – perhaps it represents clay enriched (B-horizons) which have been mobilised under wet conditions (cold? less vegetation cover?) and slope instability.

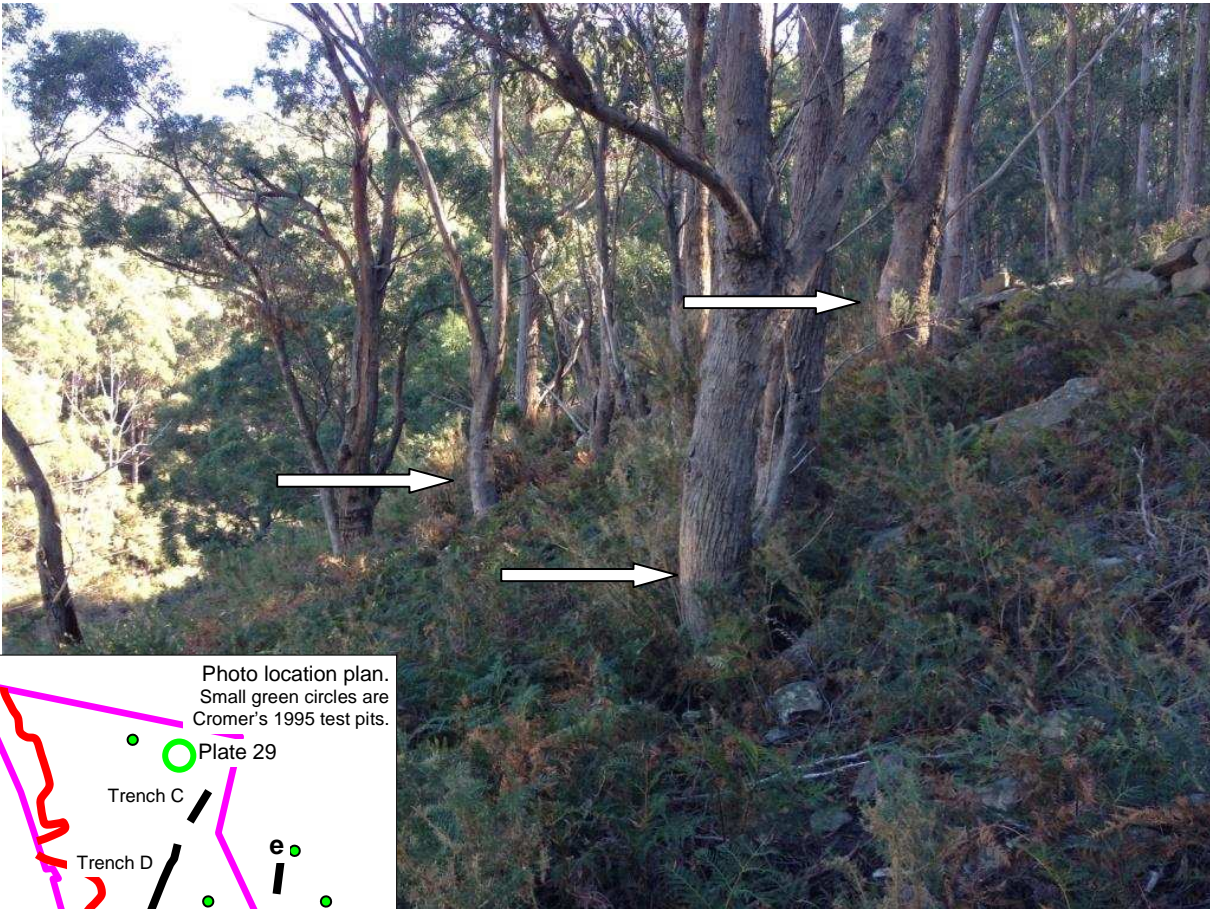
Plate 29. Curved tree trunks near the higher, northern boundary to Stage 4 suggest episodes of downslope soil movement.

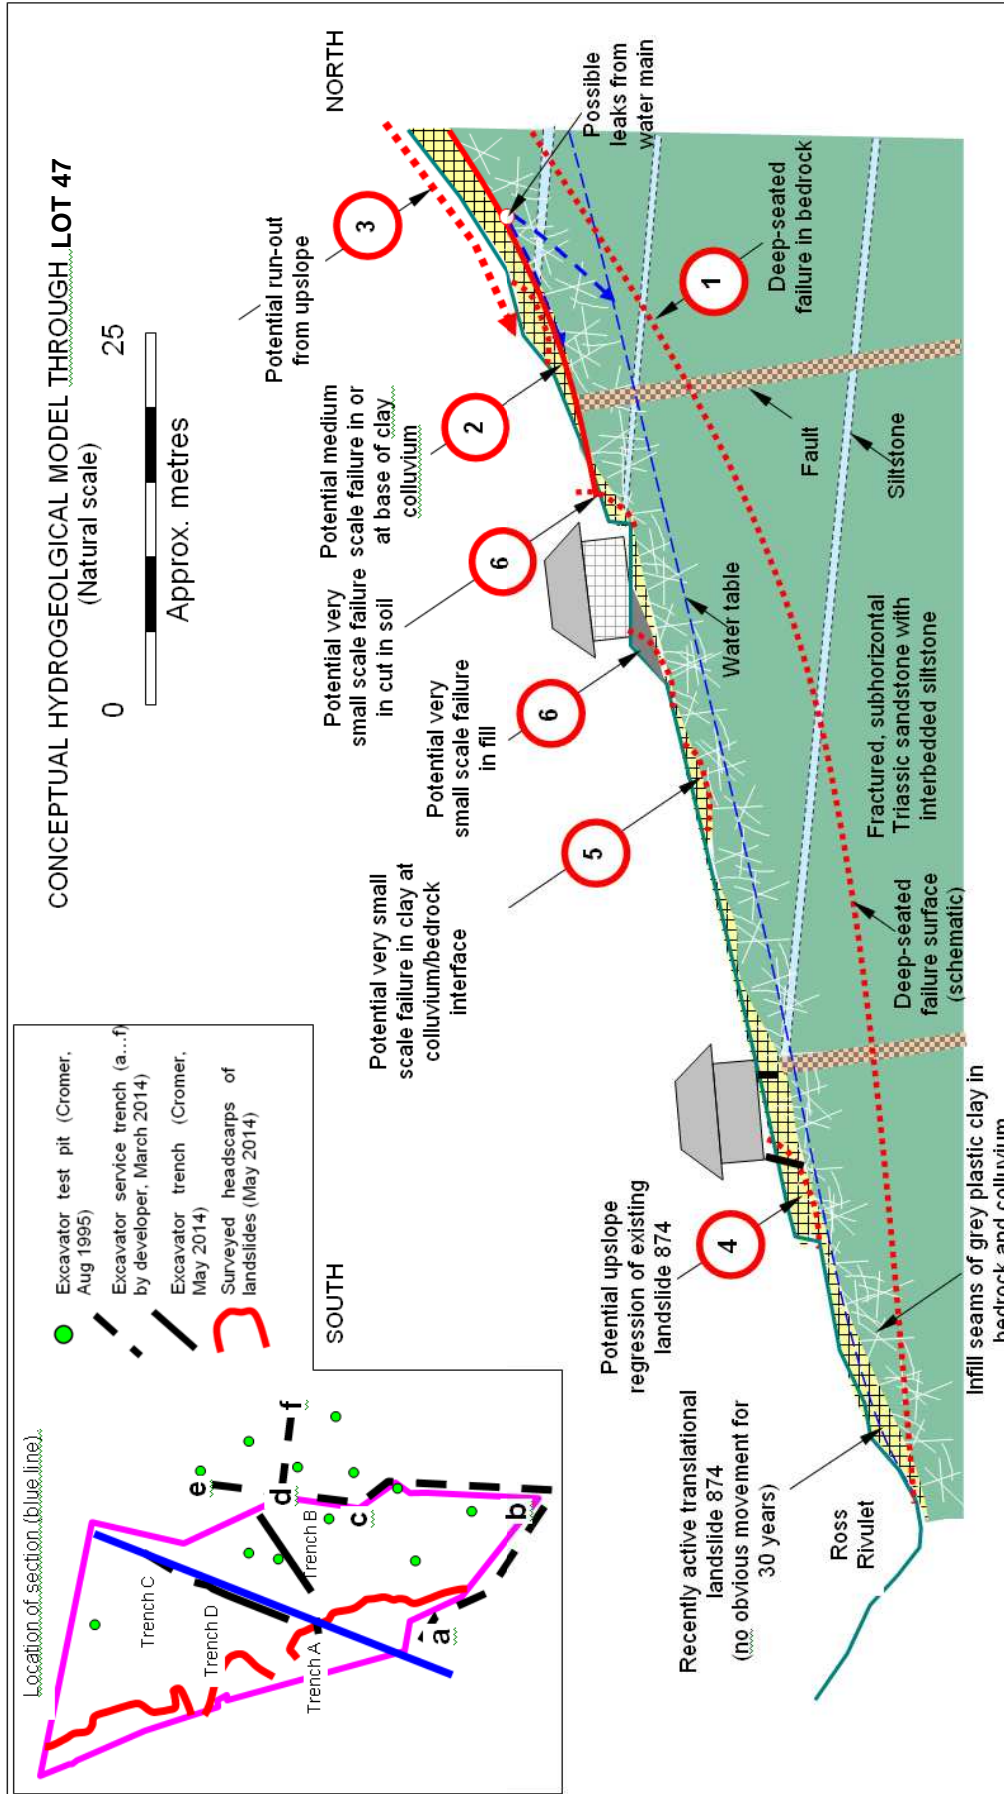
Figure 10.4. Conceptual hydrogeological model through Lot 47 at Farm Hill, based on all geotechnical evidence presented in this report. Five landslide scenarios are indicated by the numbered red circles. Scenarios 1 – 4 are pre- and post-development; scenario 5 is post-development.

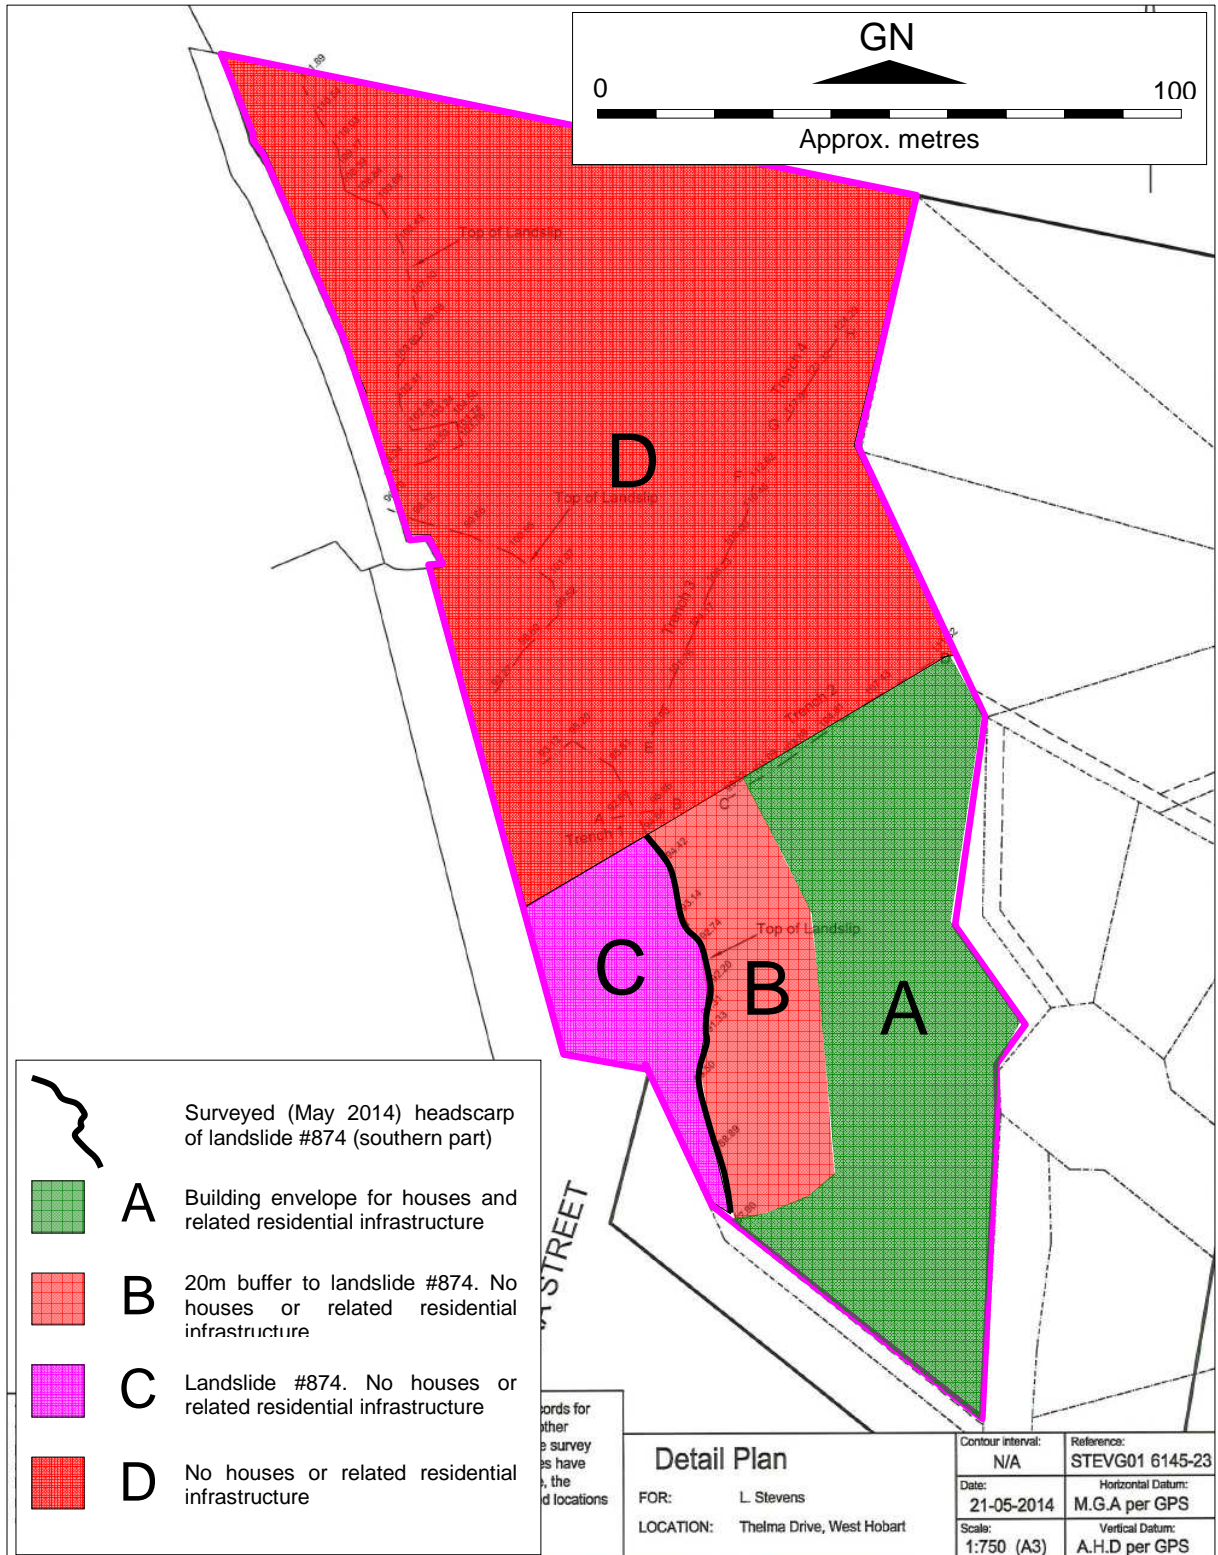
Figure 10.5 Recommended building envelope (A) and no-development areas (B, C, D) for subdivision and residential development of Lot 47 of the Farm Hill subdivision.

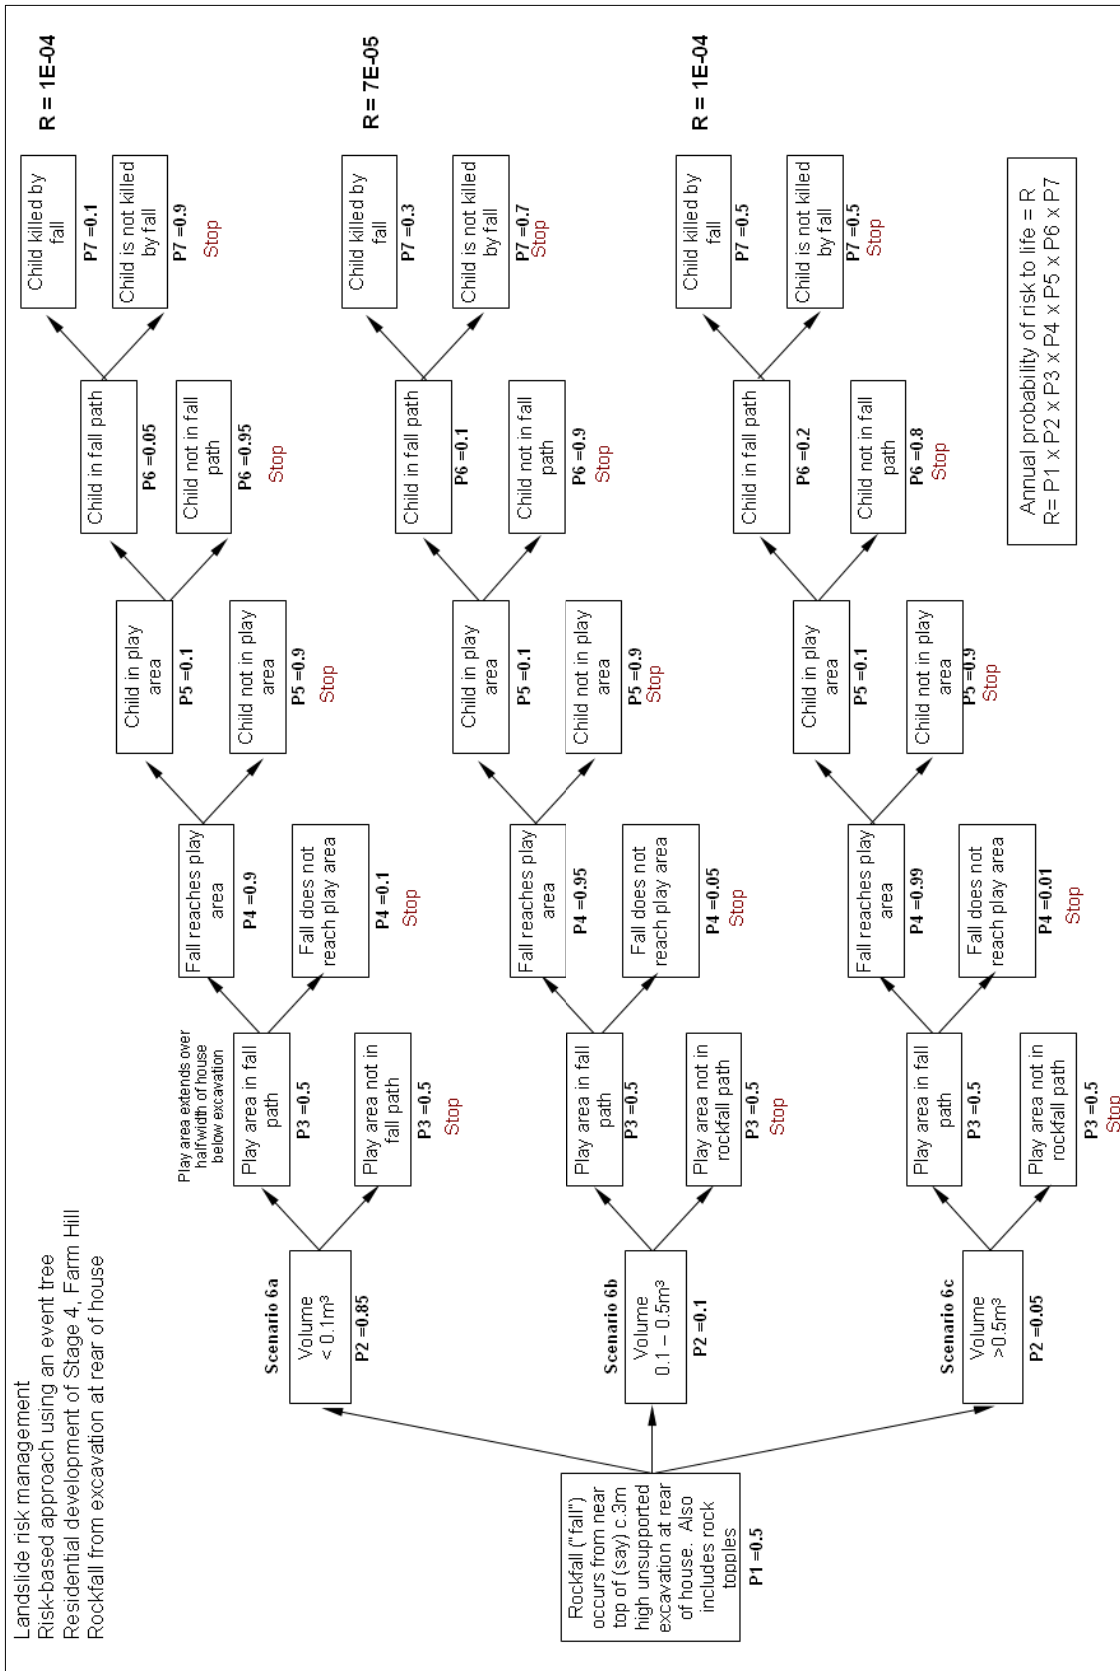
Figure 10.6 Event tree setting out steps in assessing quantitative risk to life to a child playing at the base of an unsupported earth/rock wall at the rear of a house on a property in Lot 47 of the Farm Hill subdivision (Scenario 6 in Table 10.3). Risks are shown at right of the tree, and are compared to acceptability criteria in the Societal Risk Graph in Figure 10.7. These levels of risk should be treated or monitored.
