**FARM HILL
RESIDENTIAL SUBDIVISION
WEST HOBART**

**LOT 47
GEOTECHNICAL REPORT
ADDENDUM TO 1995 GEOTECHNICAL REPORT**

This report is an Addendum to a 1995 geotechnical report.

It specifies a building envelope and conditions for residential development on Lot 47 of the Farm Hill Subdivision off Forest Road in West Hobart.

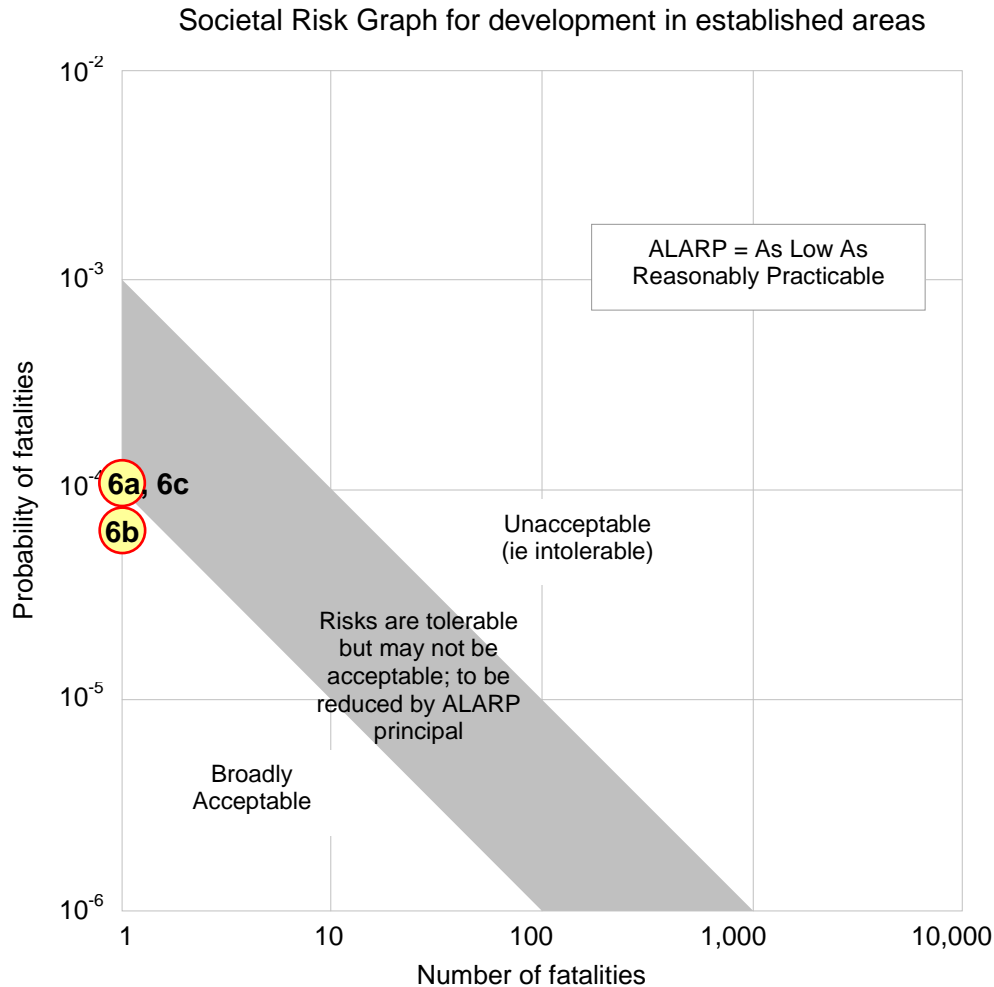
Figure 10.7 Societal Risk Graph showing the estimated individual risks for a rock fall in an unsupported excavation at the rear of a house.
