**PROPOSED
RESIDENTIAL REDEVELOPMENT
(ADDRESS)**

**GEOTECHNICAL ASSESSMENT
AND AS2870 SITE CLASSIFICATION**

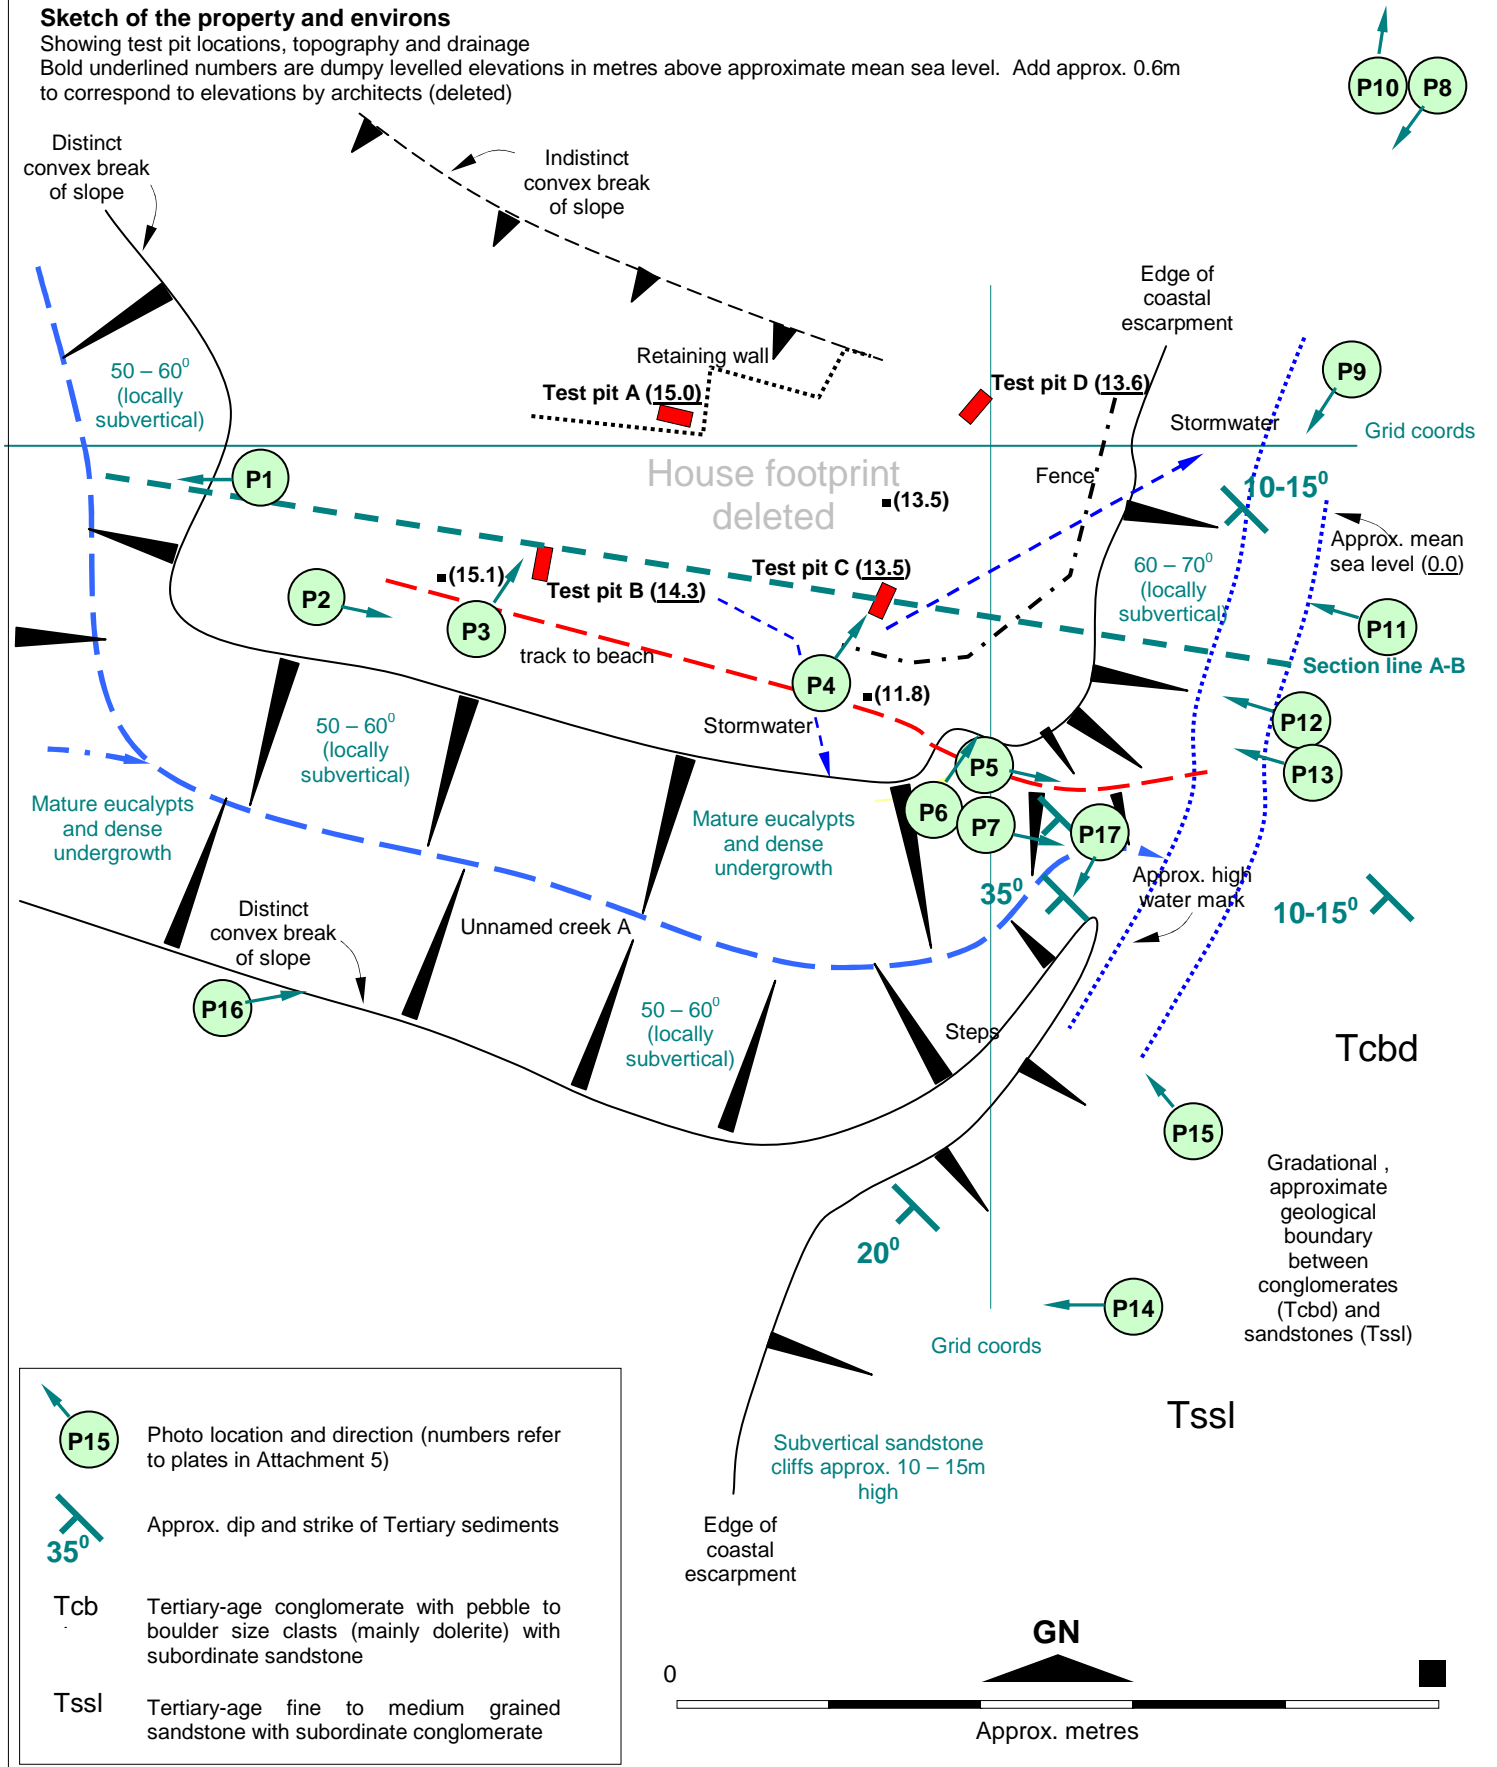
Showing test pit locations, topography and drainage

Bold underlined numbers are dumpy levelled elevations in metres above approximate mean sea level. Add approx. 0.6m to correspond to elevations by architects (deleted)

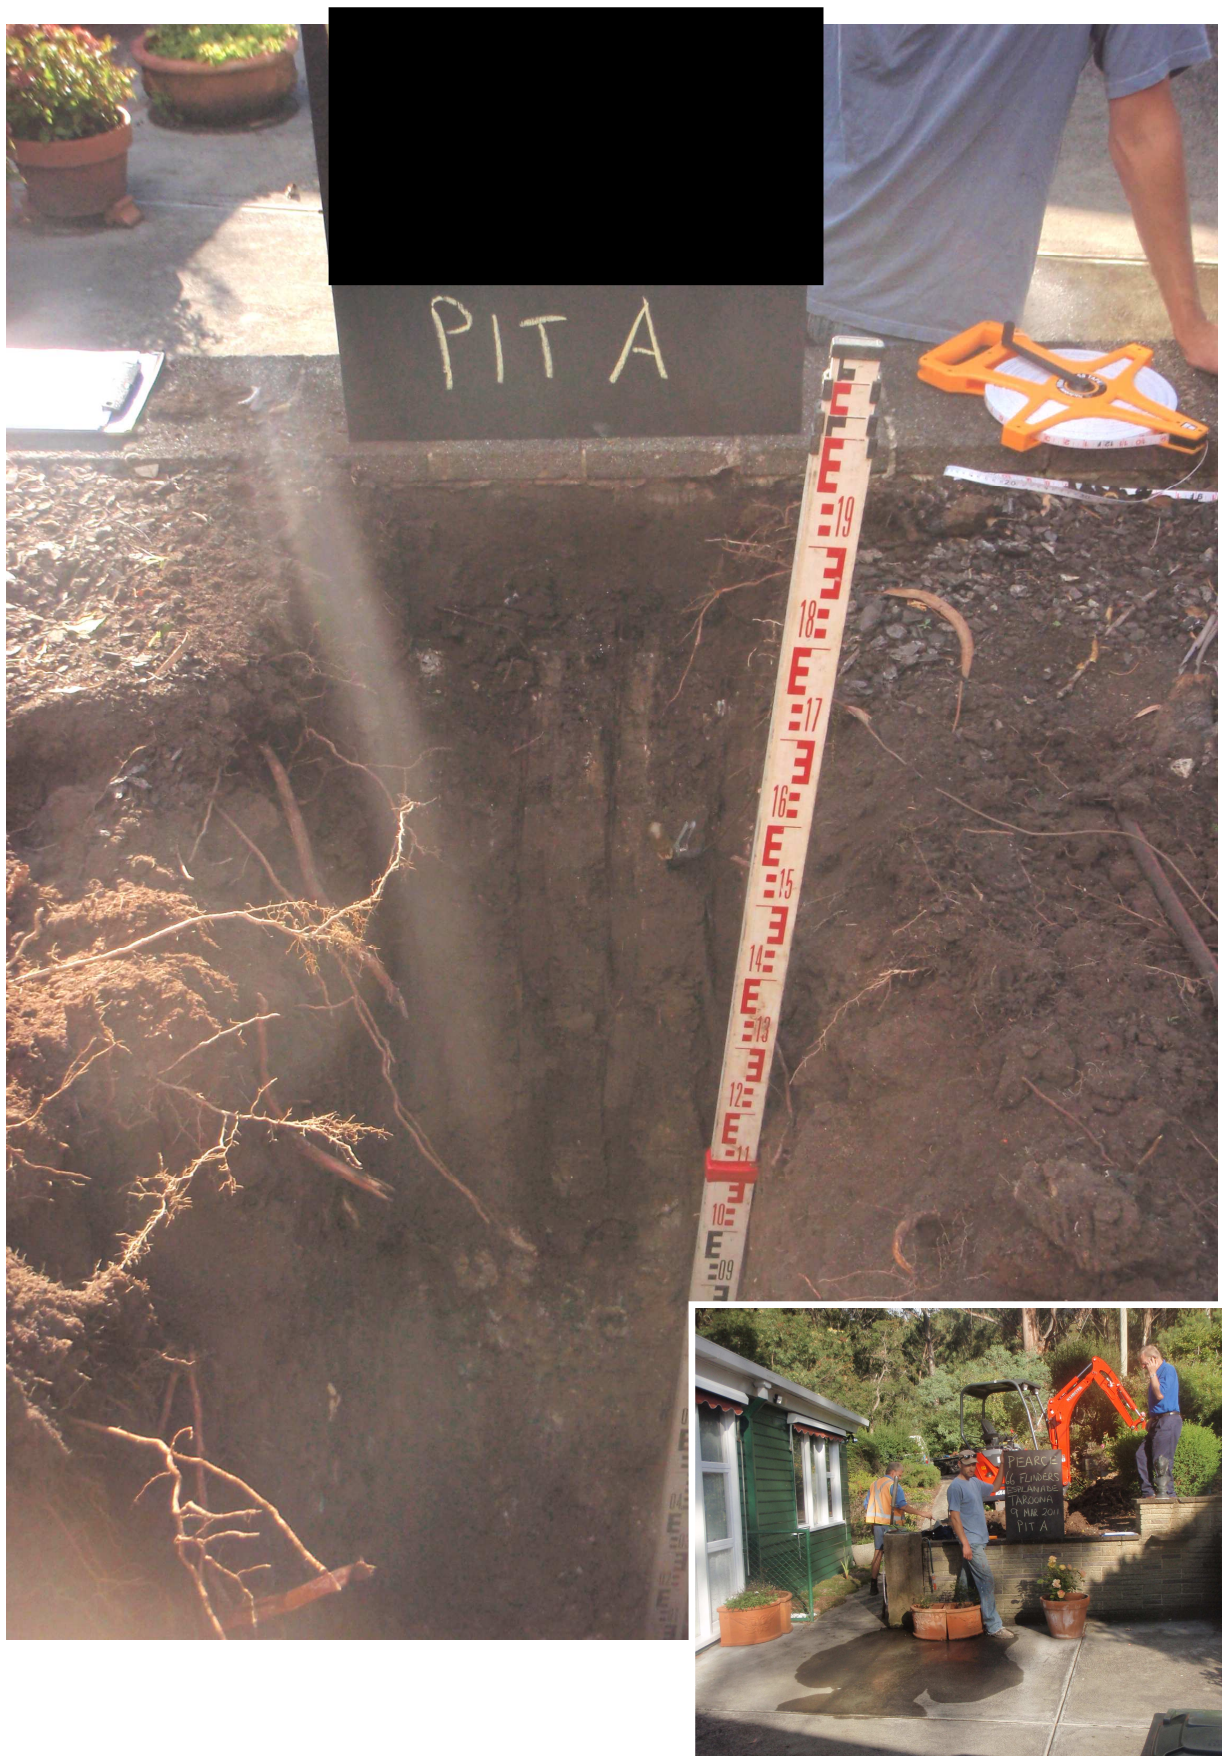
0.5	CH	CLAY: mottled orange and grey brown; high plasticity; trace sand and gravel	M<PL	H	550			Soil developed on Quaternary colluvium or valley fill
		U50		1.0					450

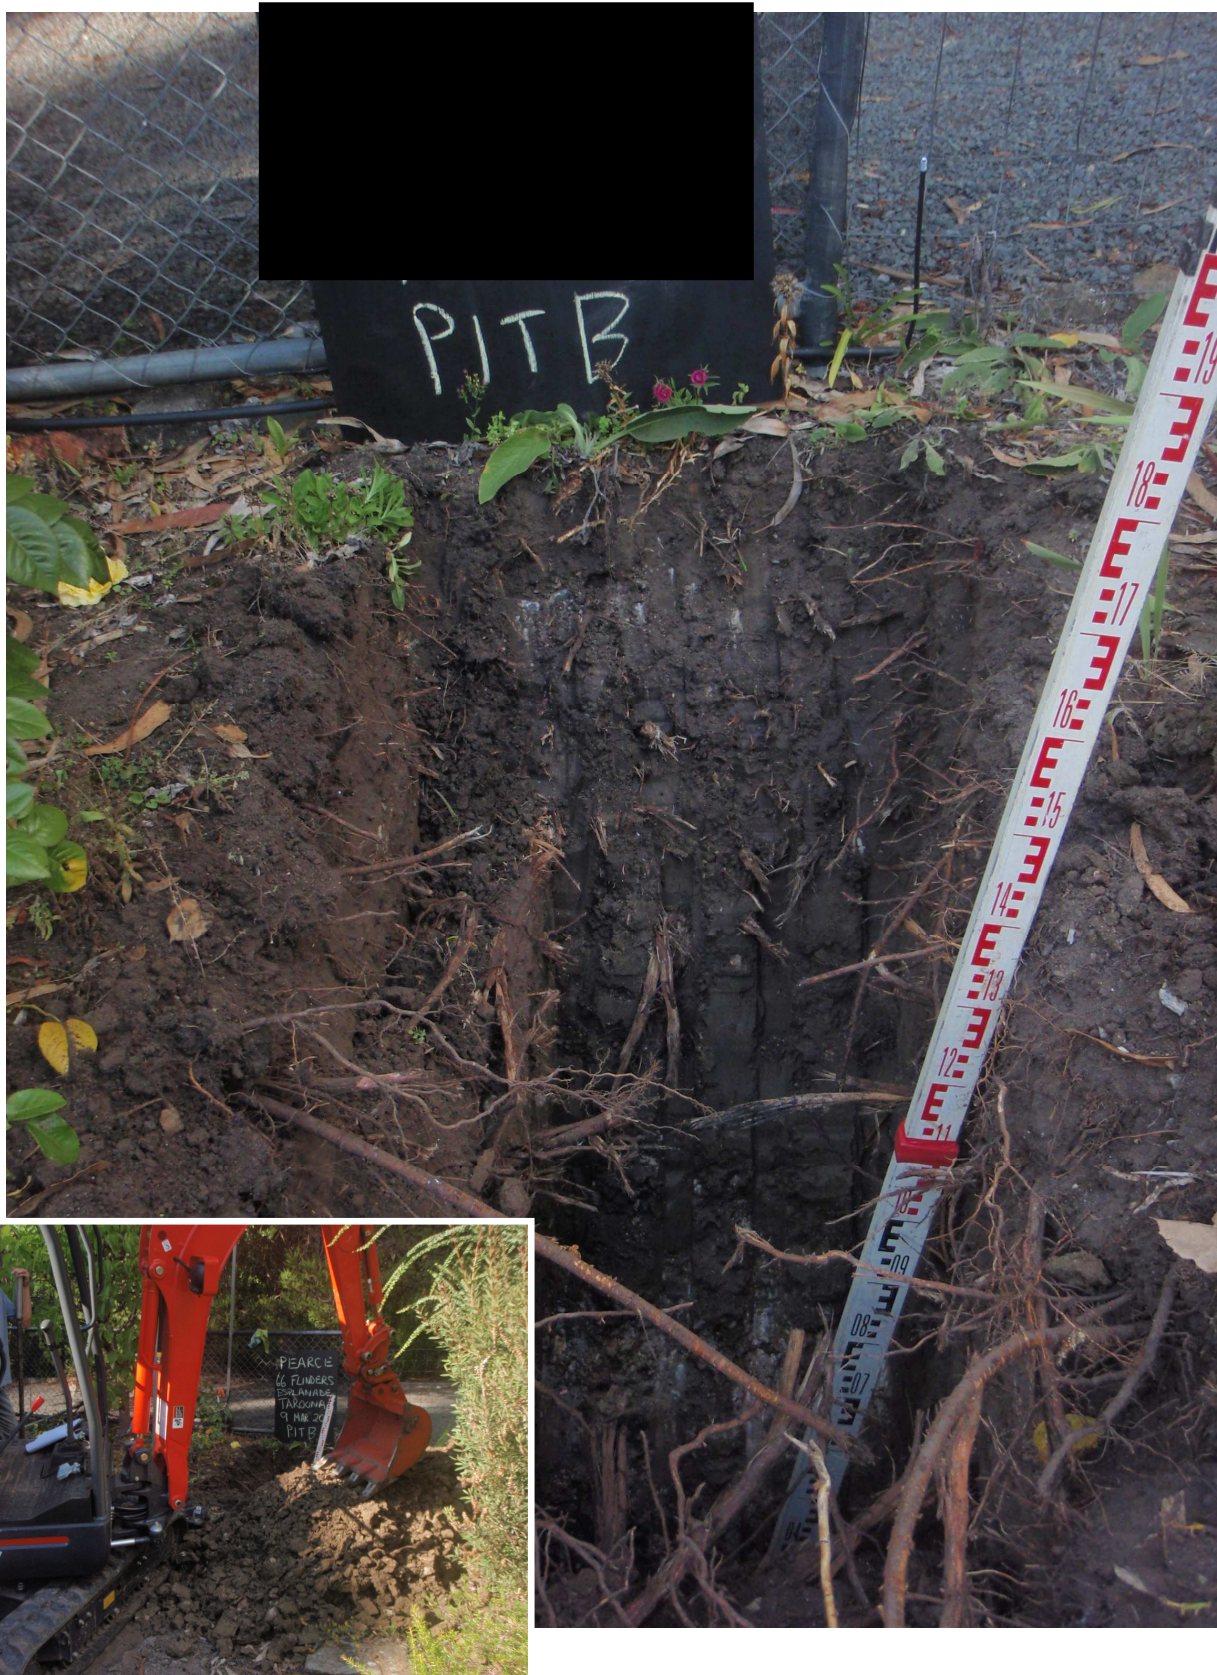
Penetration	Water	Notes	metres	Depth	USCS	Materials	Moisture condition	Consistency	Strength			Structure, geology and interpretation
									Hand penetrometer (kPa)	Shear Vane (kPa)	Dynamic cone penetrometer (Blows per 100mm)	
1 2 3			RL	Depth	USCS	Materials	Moisture condition	Consistency	25	50	100	Structure, geology and interpretation
									200	300	400	
									>400			
									>500			
									>500			
				Depth	USCS	Materials	Moisture condition	Consistency	>400			Structure, geology and interpretation
									>500			
									>500			
									>500			
									>500			
				Depth	USCS	Materials	Moisture condition	Consistency	>400			Structure, geology and interpretation
									>500			
									>500			
									>500			
									>500			
				Depth	USCS	Materials	Moisture condition	Consistency	>400			Structure, geology and interpretation
									>500			
									>500			
									>500			
									>500			
				Depth	USCS	Materials	Moisture condition	Consistency	>400			Structure, geology and interpretation

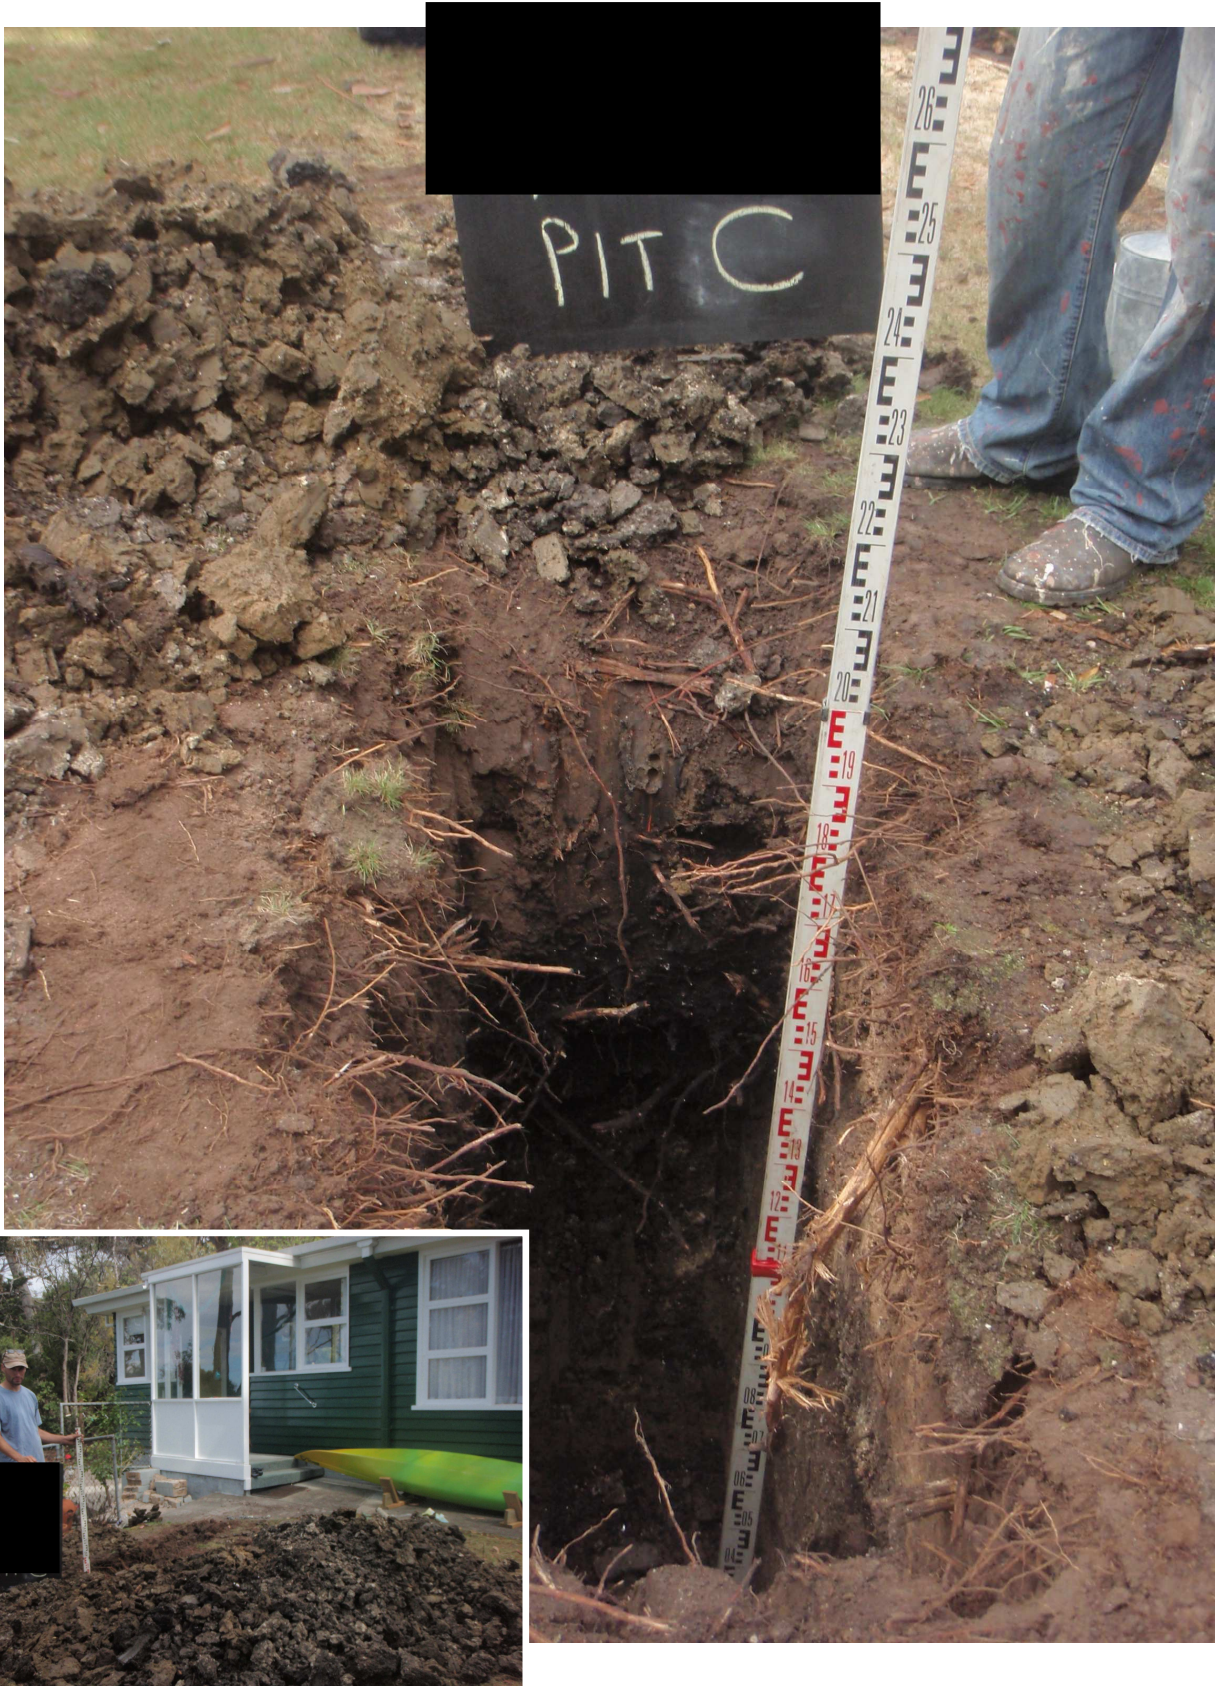
Penetration	Water	Notes <small>Samples and tests</small>	metres <small>RL Depth</small>	Graphic log	USCS	Materials <small>Soil type, colour, plasticity or particle characteristics, secondary and minor components</small>	Moisture condition	Consistency	Strength			Structure, geology and interpretation
									Hand penetrometer (kPa)	Shear Vane (kPa)	Dynamic cone penetrometer (Blows per 100mm)	
1 2 3 4			RL Depth				D M<PL	D H	25 50 100 200 400	25 50 100 200 400	25 50 100 200 400	
		Excavator <div style="border: 1px solid black; padding: 2px; display: inline-block;">U50</div>	0.5	SC CH		Clayey SAND; brown; nonplastic CLAY: greyish brown; high plasticity; some sand and occasional sandstone clasts increasing to 10-20% below about 1.2m			>400			FILL Soil developed on Quaternary colluvium or valley fill Quaternary – age colluvium or valley fill
		Hand auger	1.0						>500
