ECoast Homes Pty Ltd

EASTMAN'S GREEN SUBDIVISION  
PENQUITE ROAD, NEWSTEAD

GEOTECHNICAL ASSESSMENT

ADDENDUM REPORT  
MAY 2011

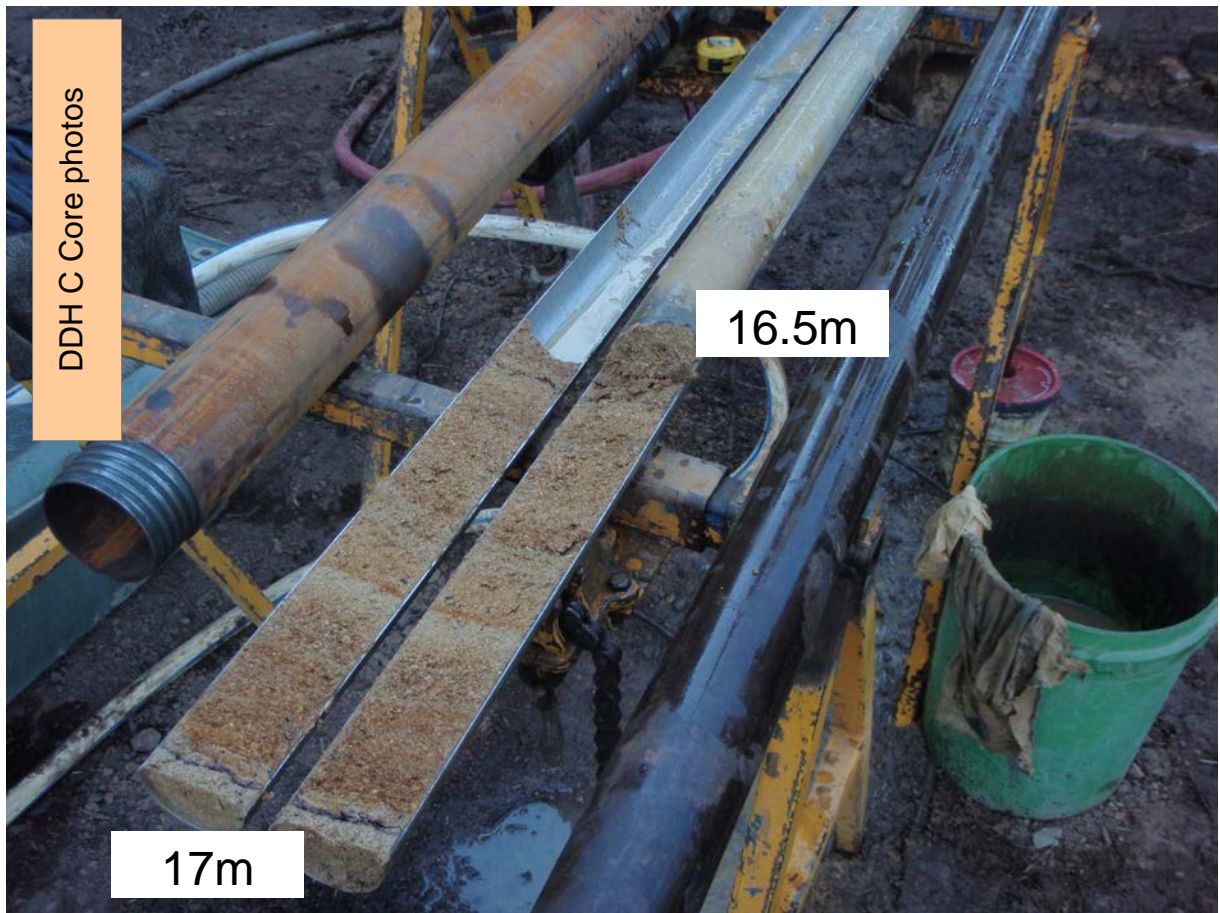
Weakly cemented low strength and coarse grained sandstone in DDH C near 17m.

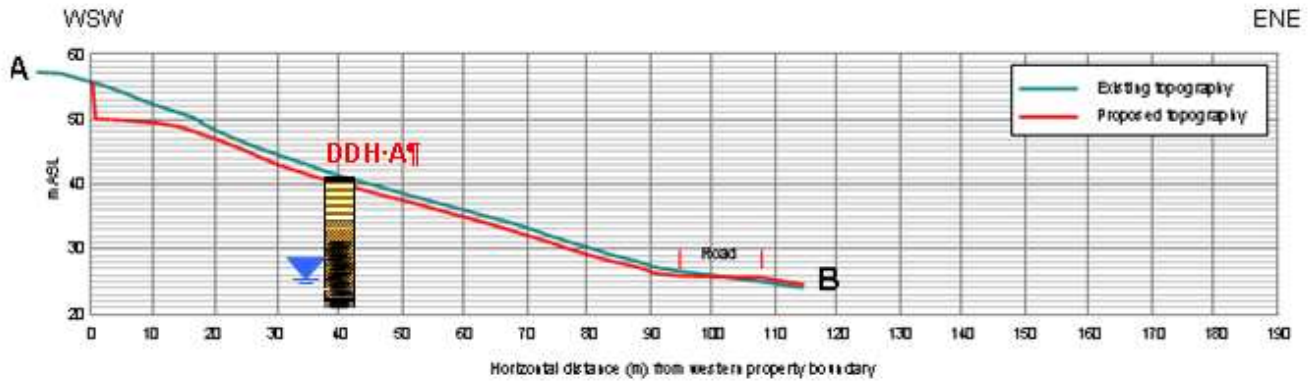
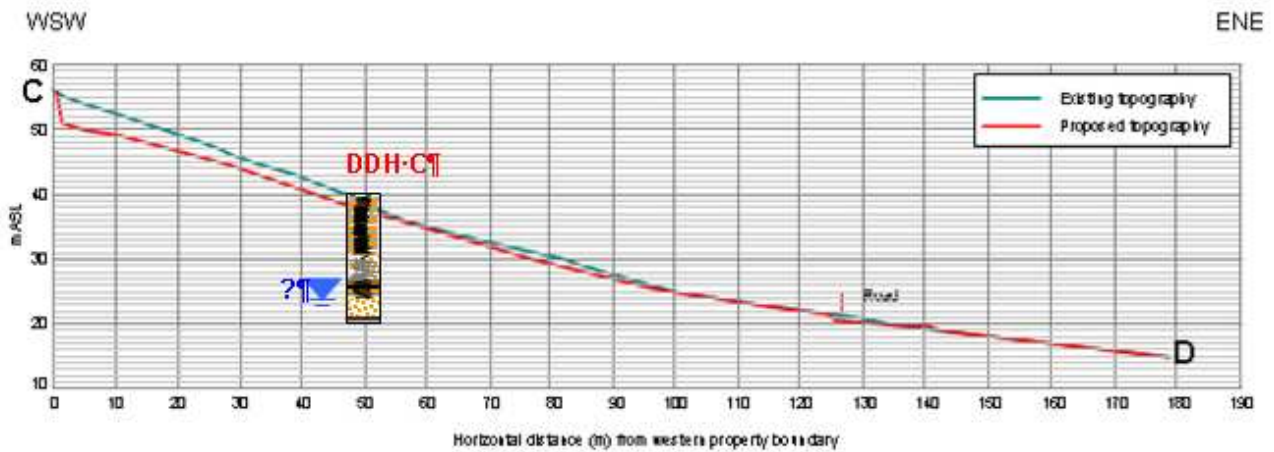
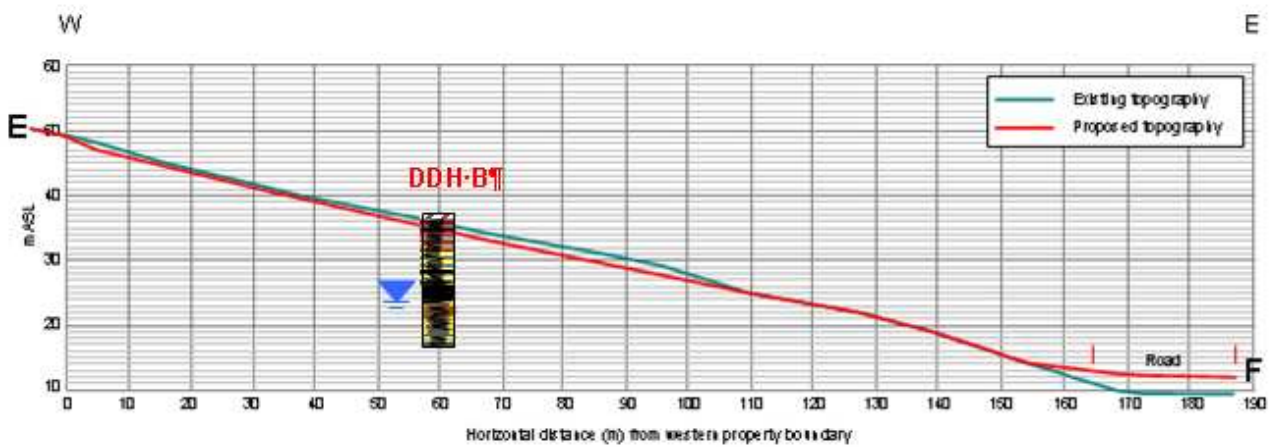
**Geological cross-sections from 2009 report with 2010 and 2011 diamond-drill-holes added.**  
 Ignore red line (proposed topography)

There is thus a rough correlation across the slope between the three holes (Attachment 7), with a near-surface clayey unit between 7 – 10m thick, overlying a sandstone unit of more variable thickness (about 3 – 11m) which in turn overlies claystone in DDH A and DDH B (but not DDH C which is located between them).

- Subhorizontal surfaces at around 14.4m in DDH B and 10.5m in DDH C separating disparate dip directions are interpreted as former failure surfaces. They are tight and sealed, suggesting ancient, not recent, deep seated movement.
