**FARM HILL
RESIDENTIAL SUBDIVISION
WEST HOBART**

**LOT 47
GEOTECHNICAL REPORT
ADDENDUM TO 1995 GEOTECHNICAL REPORT**

This report is an Addendum to a 1995 geotechnical report.

It specifies a building envelope and conditions for residential development on Lot 47 of the Farm Hill Subdivision off Forest Road in West Hobart.

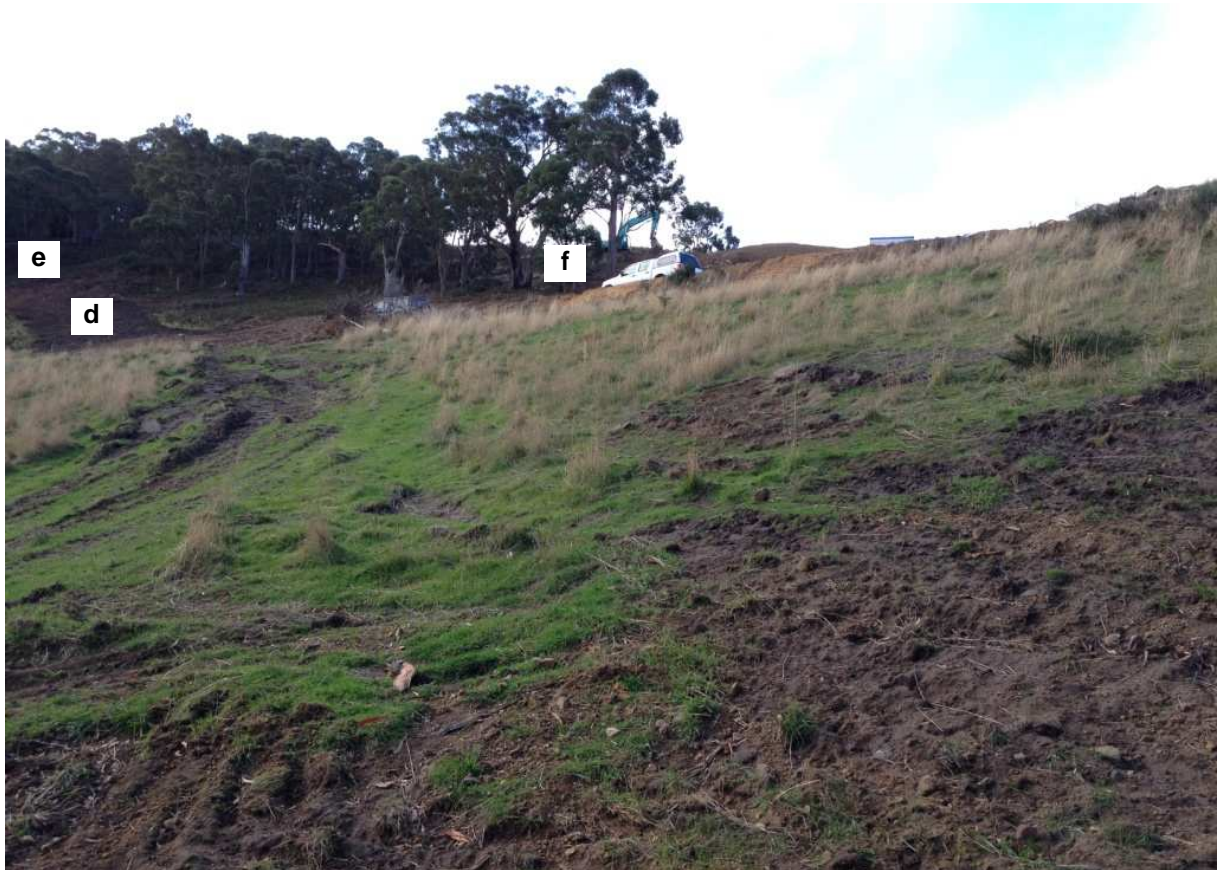
Plate 7 (above). View north over Lot 47 from its lower, southern boundary.

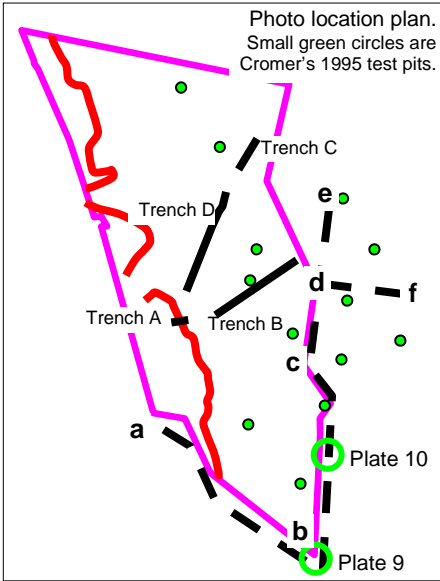
Plate 9 (above). Service trench abcdef at b, 28 March 2014. Subhorizontal Triassic sandstone bedrock exposed at depths less than 0.5m.

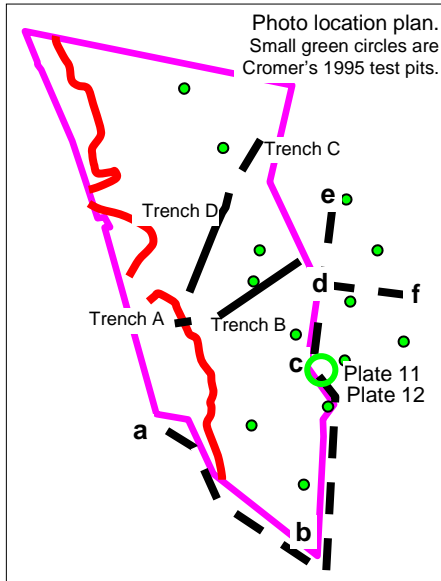
Plate 11 (above). Service trench abcdef at c. Subhorizontal Triassic sandstone bedrock exposed at depths less than 1m, but bedrock is interspersed with zones of colluvium comprising dry, friable to dense non-plastic to low plasticity sandy gravel-gravelly sand and clayey varieties.

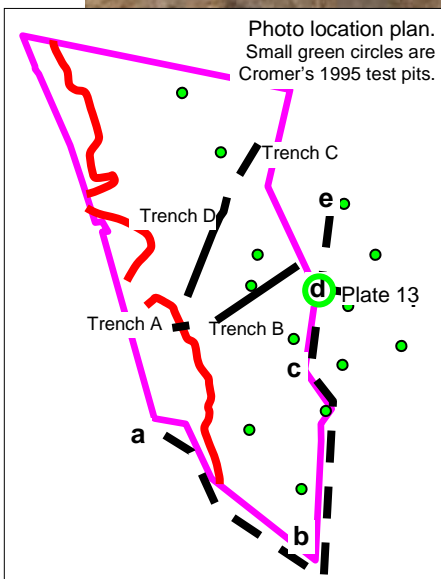
Plate 13. Service trench abcdef at d, looking upslope to e. The profile is mainly dry non-plastic colluvium, interspersed with patches of strongly fractured sandstone which may be in-situ bedrock, and other patches of strongly fractured sandstone underlain by colluvial material and therefore not in-situ.

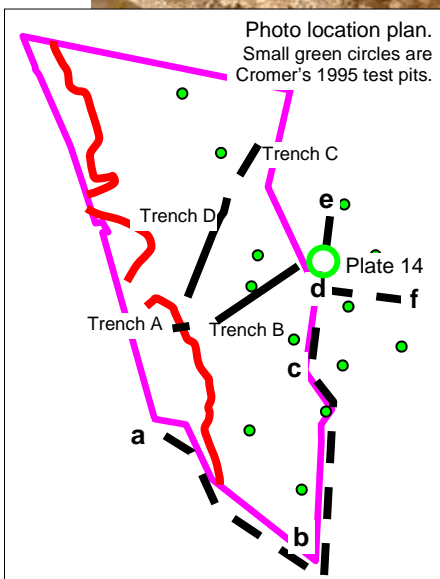
Plate 14. Service trench abcdef between d and e. A patch of strongly fractured sandstone showing joint alignment (and therefore minor bulk disruption and probably minimal downslope transport) is underlain by colluvial material.

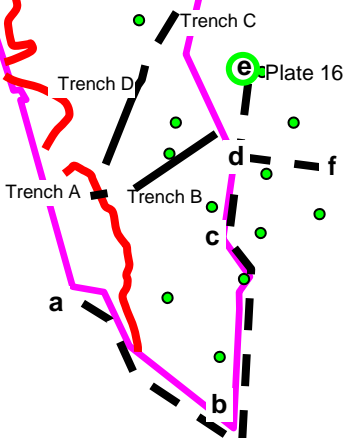
Plate 16. Service trench abcdef at e, looking downslope to d. It is not clear whether the fractured sandstone exposed in the services trench at this location (and locally elsewhere along it) is in-situ or not.

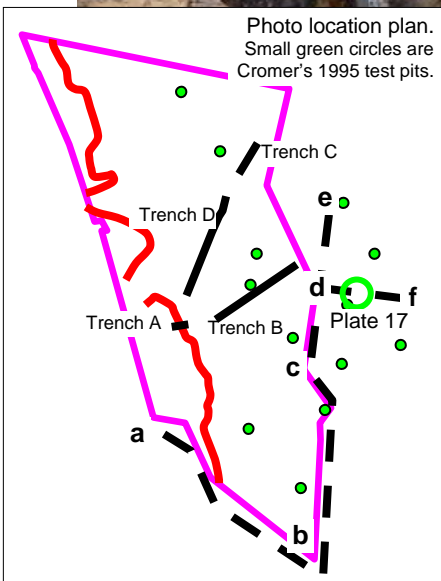
Plate 17. Service trench abcdef between d and f, looking upslope towards f. The fractured sandstone exposed in the services trench at this location appears to be in-situ. A narrow fault zone about 0.5m wide crosses the trench at an oblique angle (arrowed).

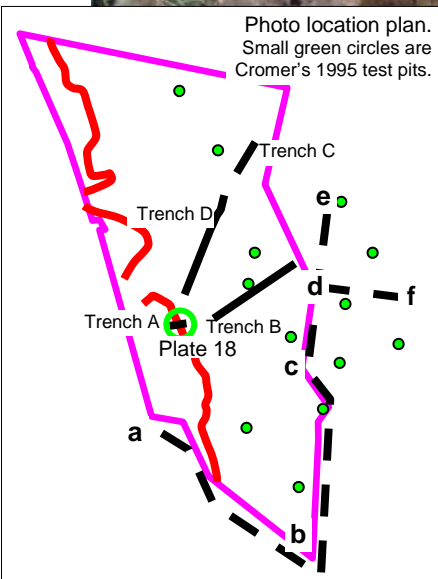
Plate 18. Investigation trench A, about 8m long, was dug across the headscarp of landslide #874. The failure surface was probably close to the camera, but not apparent. Colluvium overlies highly weathered siltstone bedrock, exposed in the base of the trench, and dipping 11° to 260° T.

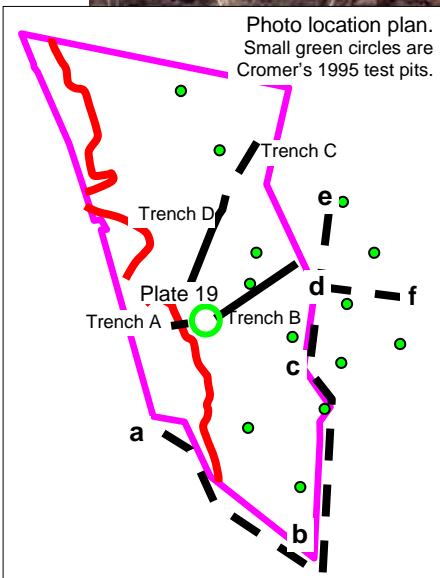
Plate 19. Investigation trench B, about 48m long, looking upslope. The slope is colluvium of variable thickness, but highly weathered sandstone bedrock was exposed along the full length of the trench at depths ranging from as shallow as 0.5m (as indicated) to about 1.8m. The dip on the bedrock is less than 5° to the north (into the slope).

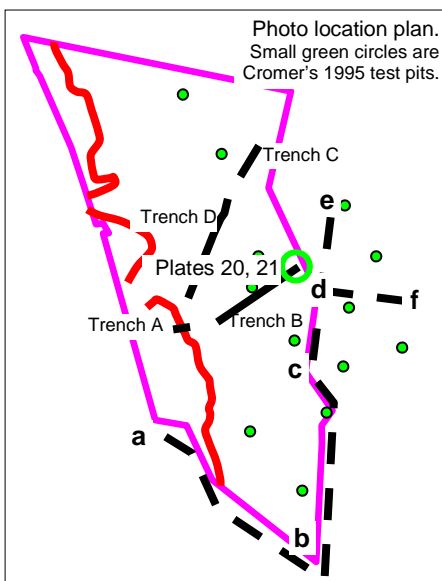
Plate 21 (below). Detail of the end of Trench B, showing grey-blue, high plasticity clay coatings several millimetres thick on a dipping joint surface. Slipping on these coatings is a likely mode of localised failure for the colluvial cover.

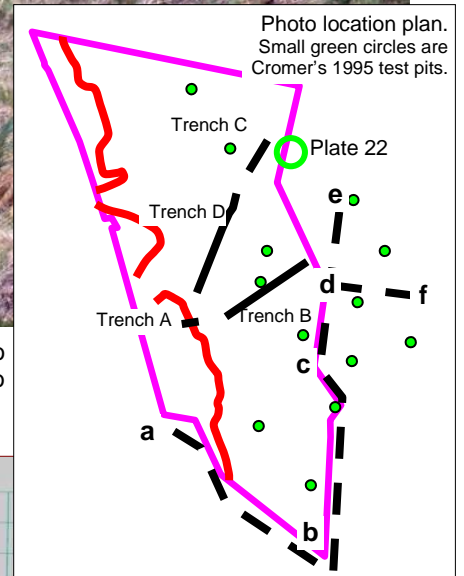
Plate 22 (above). View west at Trench C, 17.5m long. This excavation up to 2.6m deep exposed colluvial materials over high plasticity clay, with no bedrock.

- includes the observation that the higher, steeper slopes of Lot 47 show undulating ground (and Trench C exposed over 2m of colluvial clay); these slopes may be run-out material from a previously un-mapped, relatively old and now probably inactive, moderately-sized armchair-shaped depression (shown in Attachment 8) upslope from Lot 47. On these steep slopes near the higher, northern property boundary, curved tree trunks indicate sporadic downslope soil movement (see Plate 29 in Attachment 9).

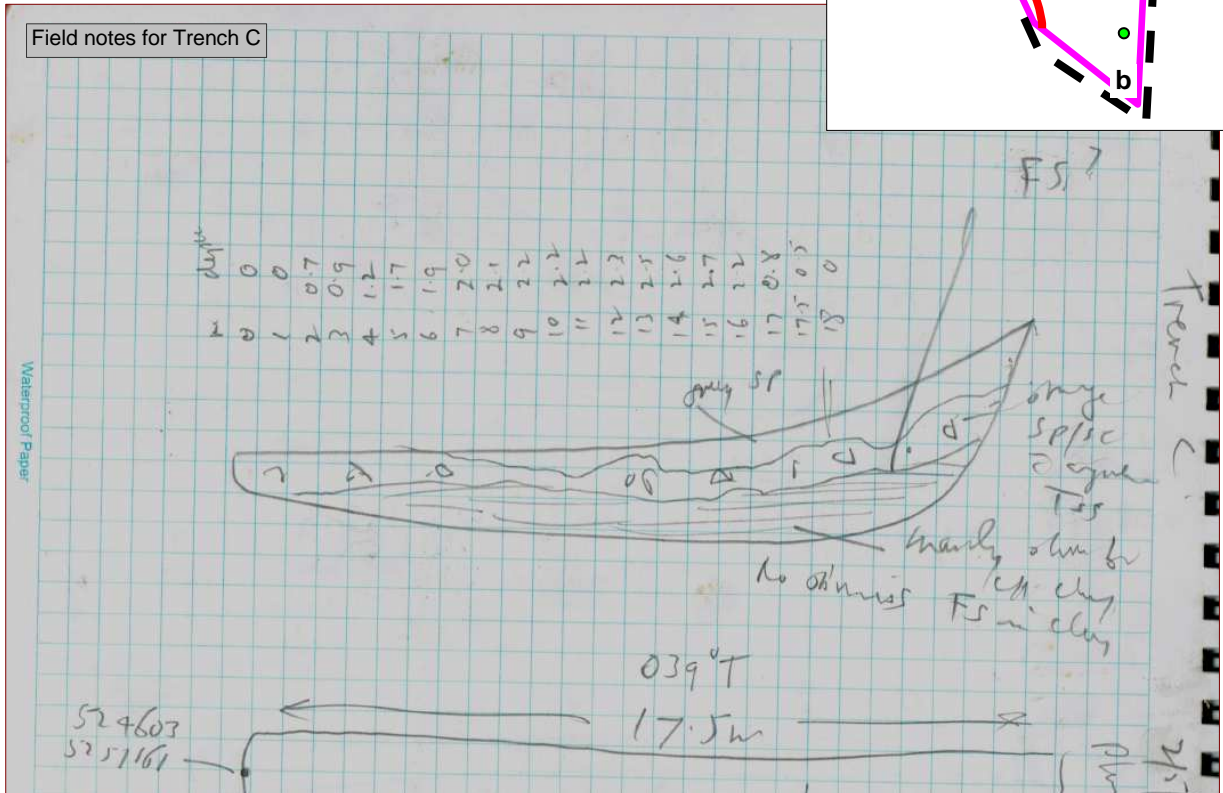
Plate 23. View north northwest at the higher end of Trench C, 17.5m long. This excavation up to 2.6m deep exposed colluvial materials over high plasticity clay, with no bedrock.

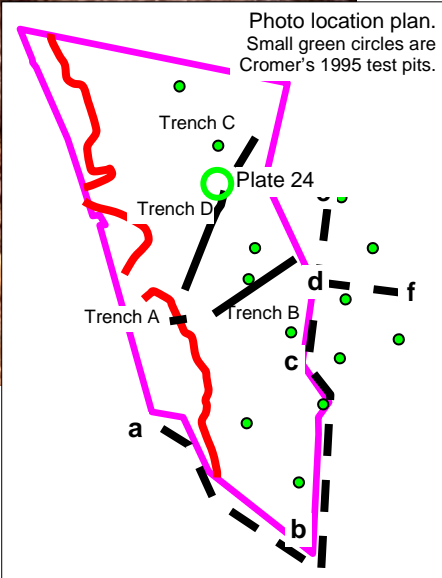
Plate 24. View downslope and along investigation trench D. Note bedrock highs in floor of trench, with colluvial material on top, and surrounding.

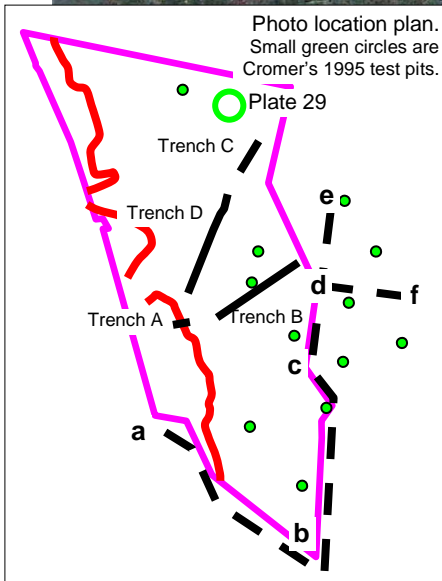
Plate 29. Curved tree trunks near the higher, northern boundary to Stage 4 suggest episodes of downslope soil movement.

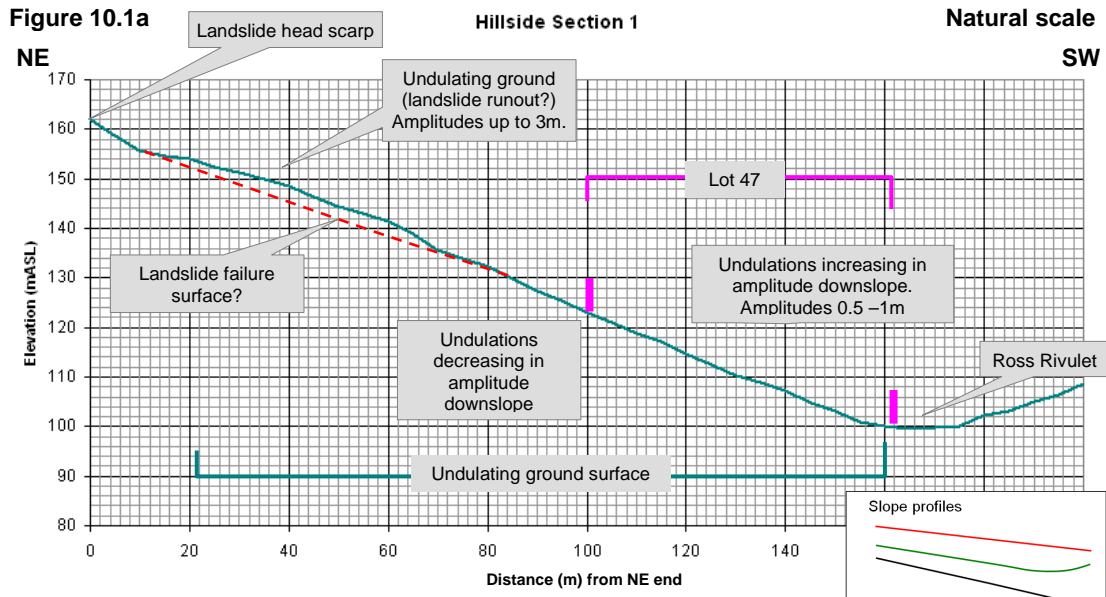
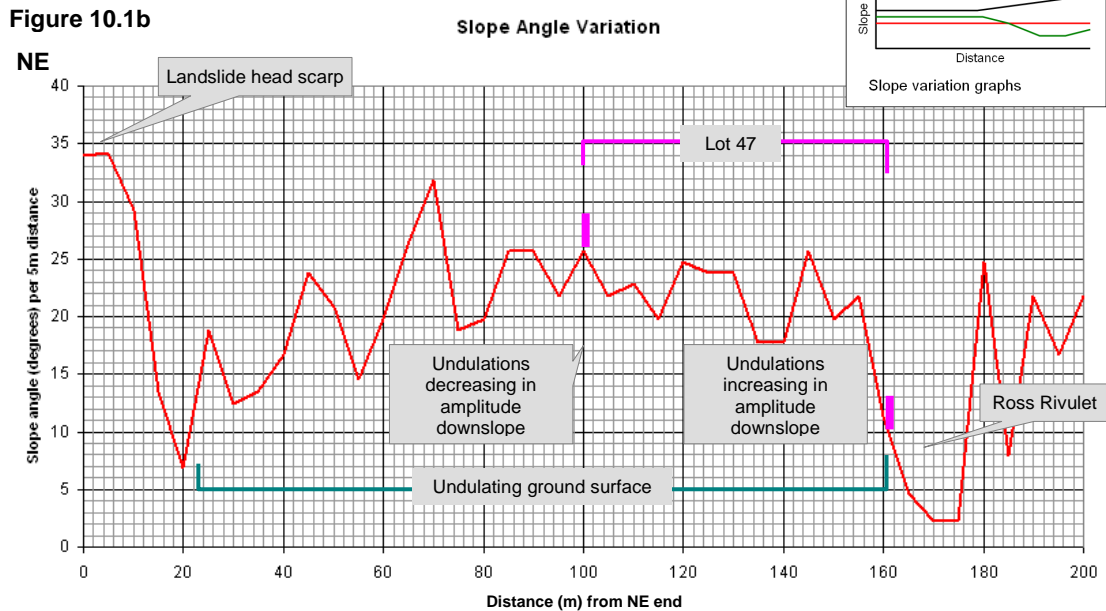
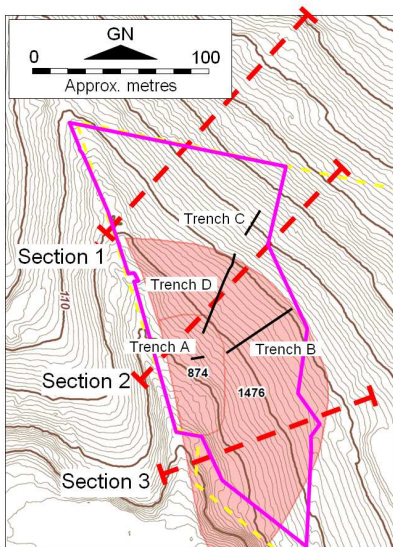
Figure 10.1a. This 200m NE – SW natural-scale section through the northwestern corner of Lot 47 and the hillside above it shows the previously unmapped landslide on higher ground, and an undulating surface on the slopes leading down to Ross Rivulet. The average slope angle is 22°.

Figure 10.1b shows variations in slope angle, calculated each 5m (the graph for a uniformly dipping slope would be a horizontal line). The undulations in the ground surface are readily apparent, Amplitudes downslope from the landslide are up to 3m (landslide runout?), but decrease downslope to about 0.5m before increasing towards Ross Rivulet to 0.5 – 1m. Slope angles are steep (35°) at the headscarp of the landslide, and again on segments of undulating ground to distances up to 80m (landslide runout?), but then remain in the 20 – 25° range until the edge of Ross Rivulet.

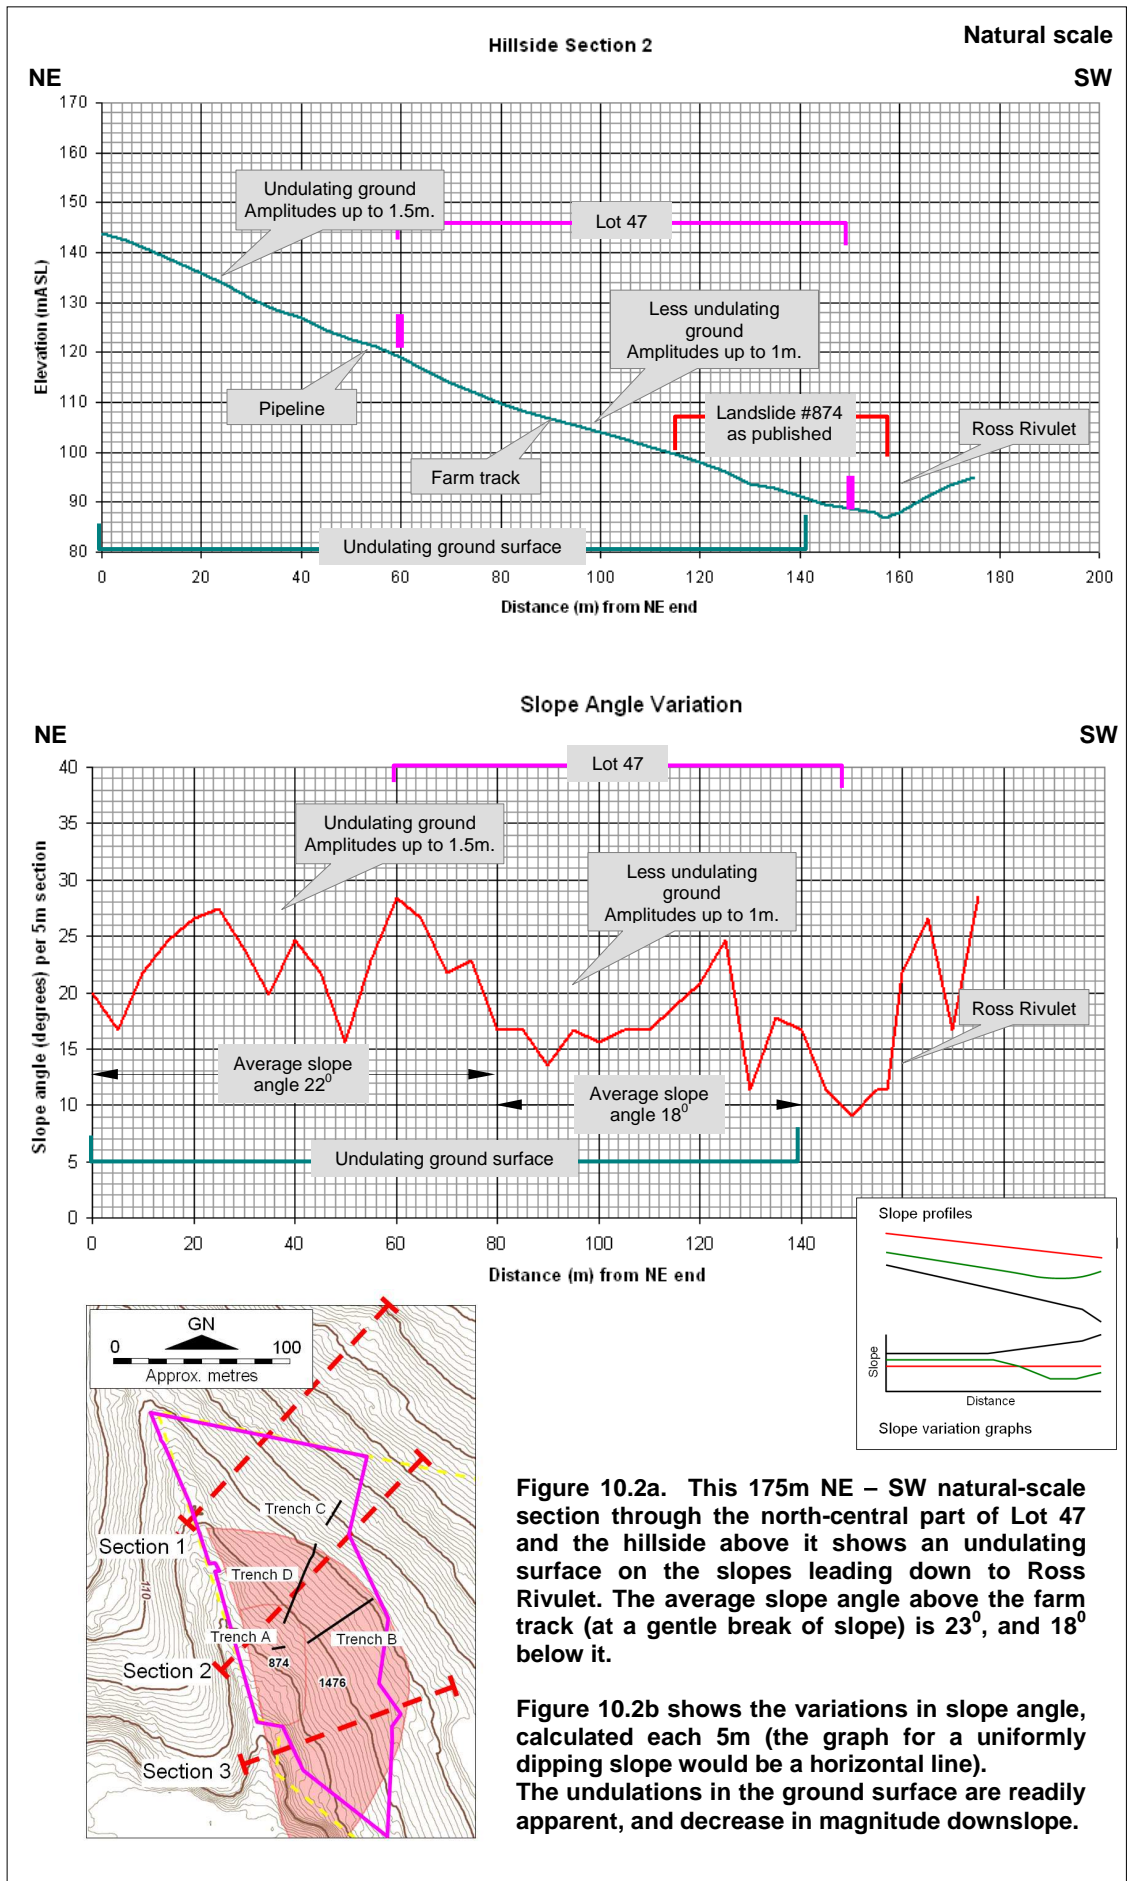
Figures 10.1a, 10.2a and 10.3a (this Attachment) are natural-scale NE – SW cross sections at three locations through the hillside including Lot 47 at Farm Hill. Figures 10.1b, 10.2b and 10.3b show the variation in slope angles down the hillside, calculated from 1m LiDAR contours for each 5m of horizontal distance. Each of these slope graphs highlights slope irregularities not readily apparent in the natural-scale cross sections. A key feature of the slopes are surface undulations with amplitudes mostly in the 0.5 – 1m range (locally up to 3m) and downslope lengths in the 5 – 50m range, which indicate shallow translational slope instability. These surface undulations are less developed on Section line 3.
