EASTMANS GREEN SUBDIVISION NEWSTEAD

GEOTECHNICAL NOTES TO ACCOMPANY AS2870 (“SOIL TEST”) REPORTS FOR INDIVIDUAL LOTS

Introduction

William C Cromer Pty Ltd has been engaged by Ecoast Homes Pty Ltd to prepare separate site classification ("soil test") reports for about 50 lots in the Eastmans Green Subdivision at Newstead.

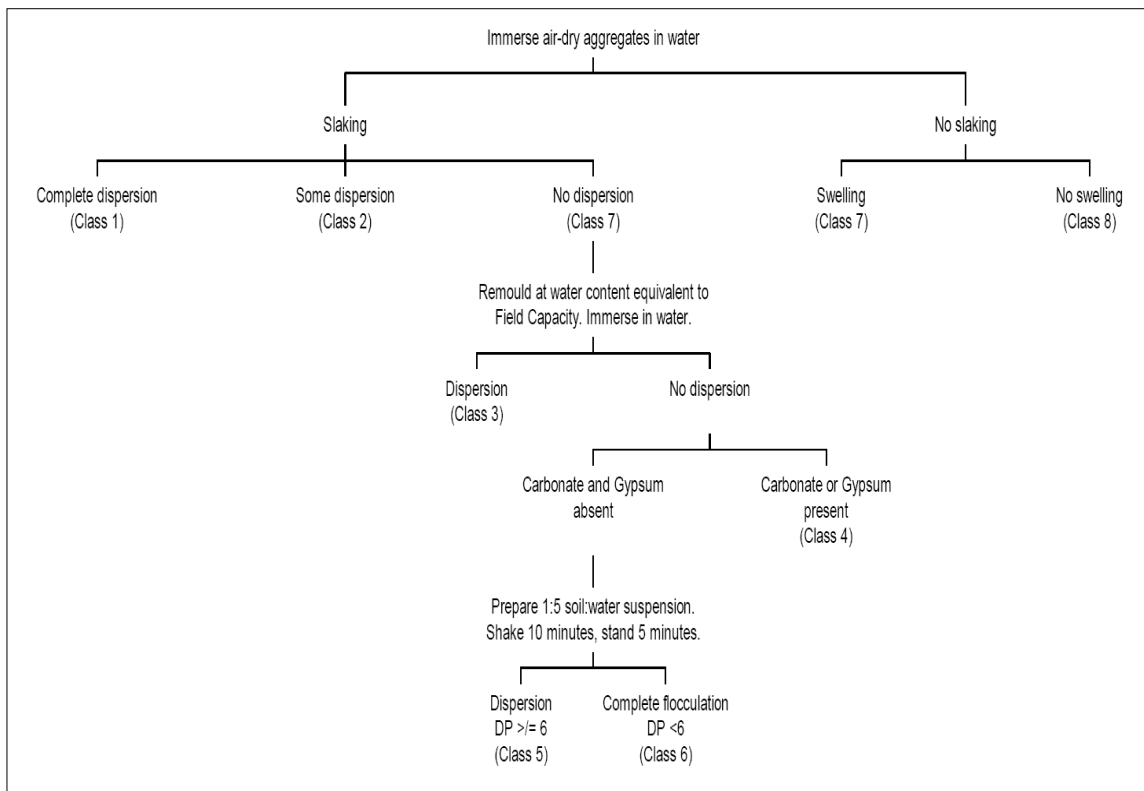
Figure 3.2

Interpretation of dispersion testing of soil samples from the subdivision

Results compiled so far are summarised in Figure 3.2.
